BECTEST

Property Condition Assessment For:

First Congregational Church of Christ

RE: Property Condition Assessment (PCA) For:
2503 Main Street, La Crosse, WI 54601

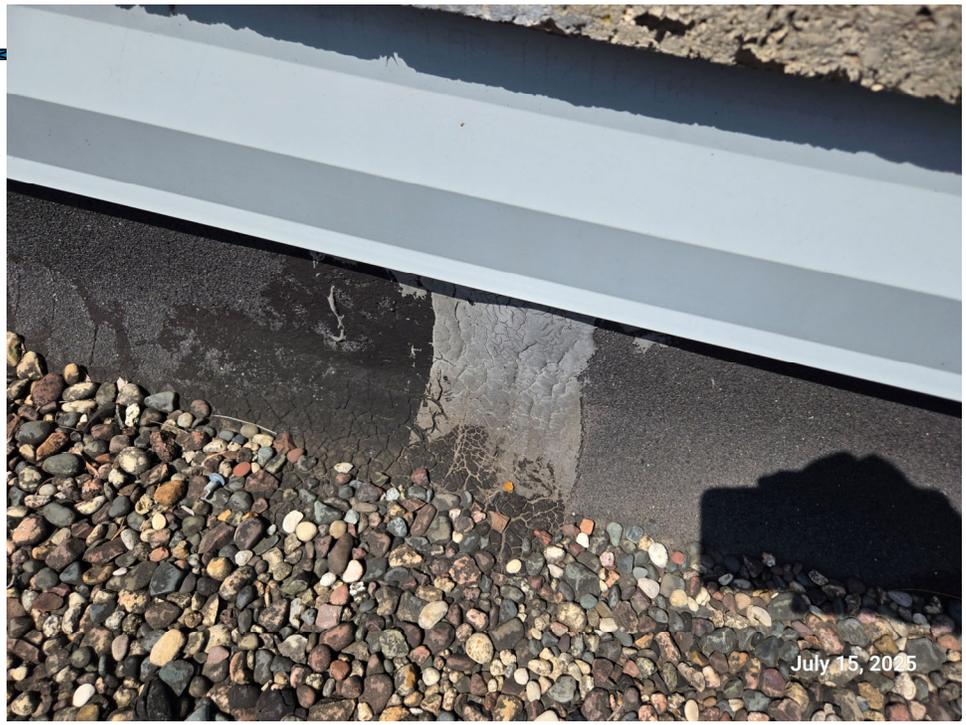
Photo 4:

Description:
Closeup of sealant in
previous photo.

Note: Cracks and
fissures in parapet
flashing sheets.

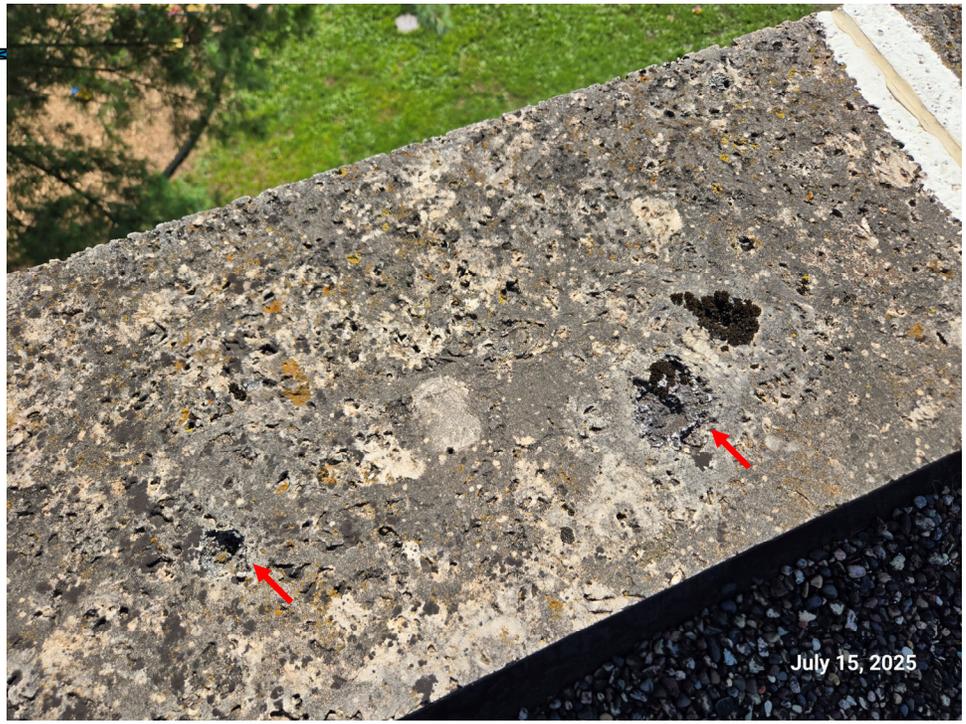
Photo 13:

Description:
Spalled coping stone.

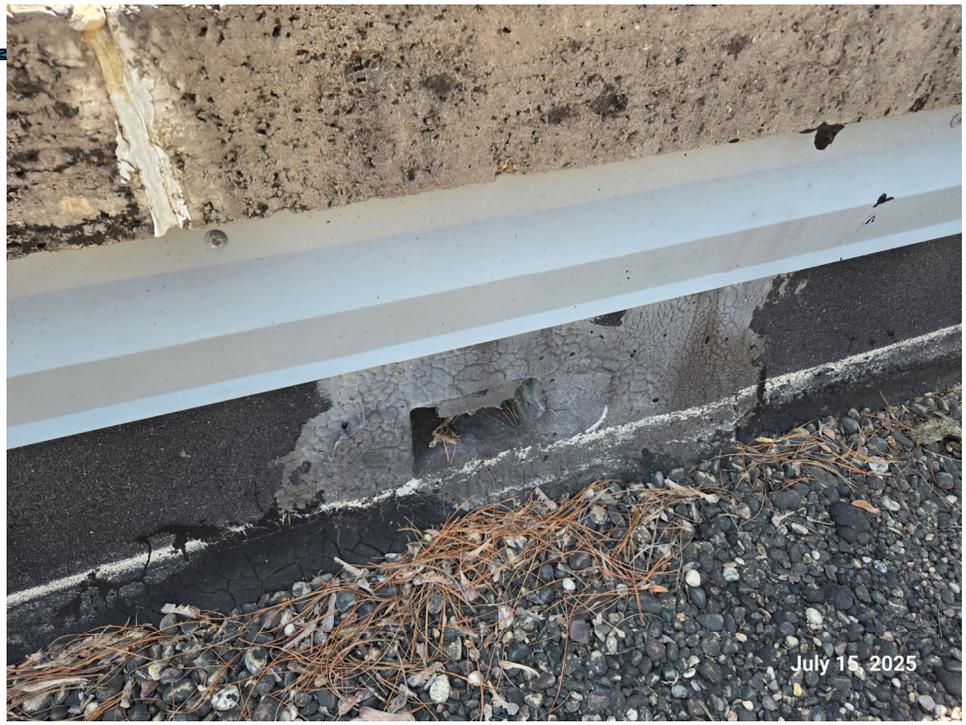
Photo 14:

Description:
Typical condition of roof drain on east parapet wall.

Note: Cracks and fissures in sealant around drain.

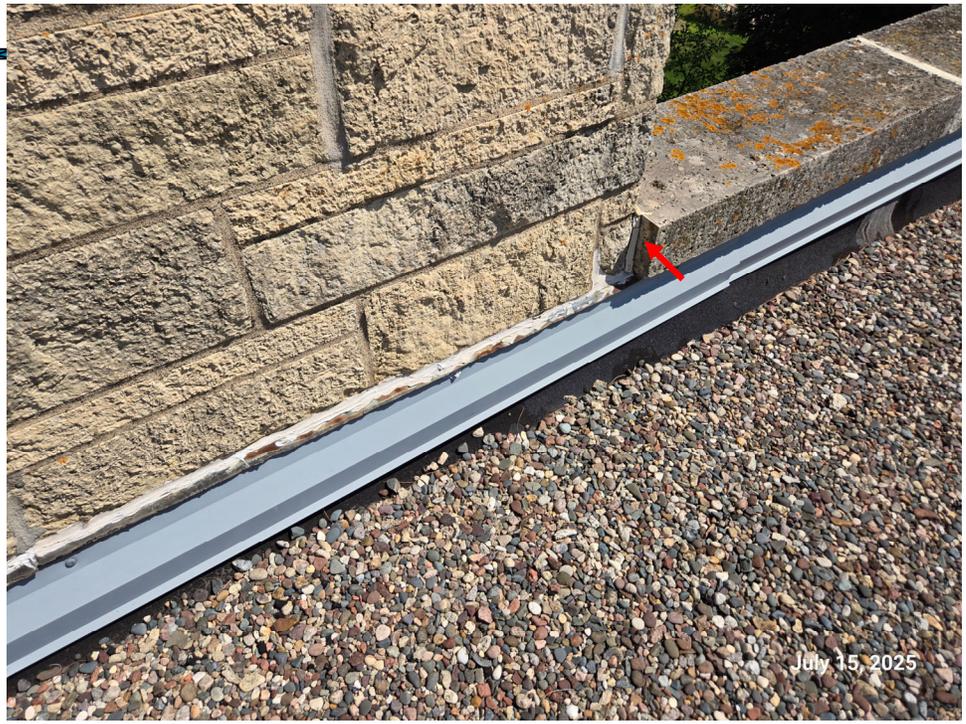
Flashing details to chimney.

Note: Failed sealant at cap stone.

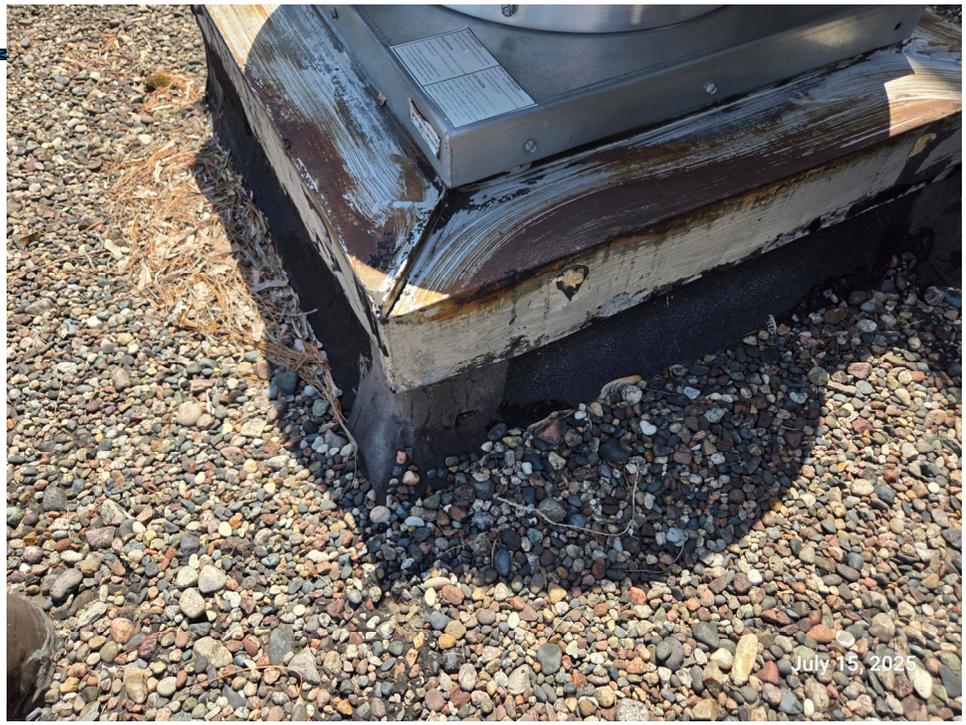
Photo 20:

Typical condition of flashing details for roof penetrations.

Note: Cracks and fissures in flashing sheets and sealant.

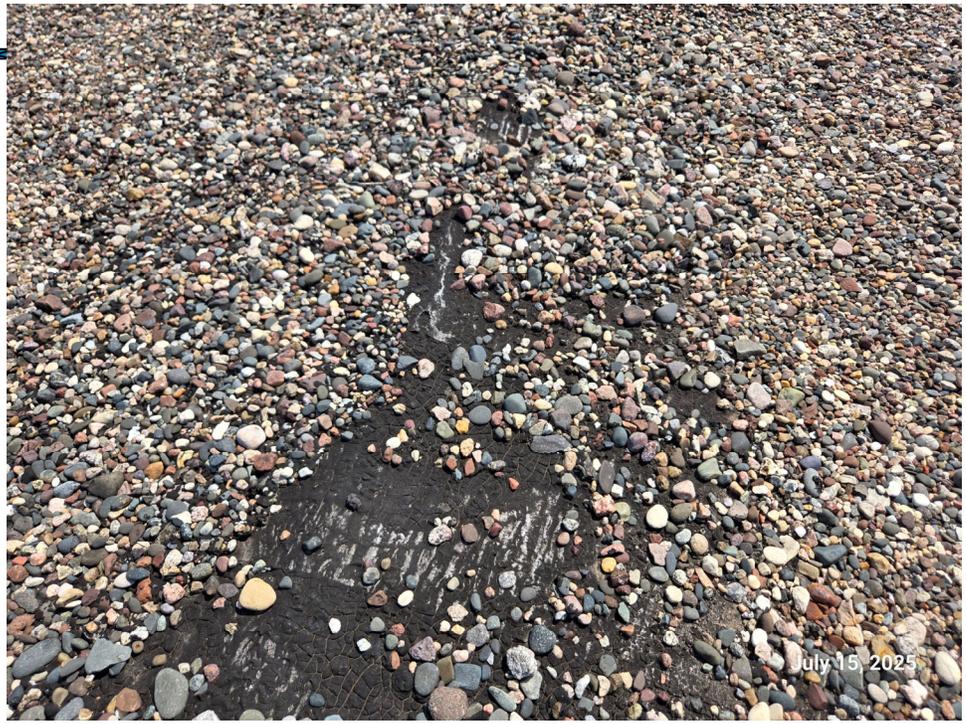
Photo 47:

The roof area had a ridge in the center and spans east-west. Gaps where stone was displaced revealed the BUR at the ridge had cracks and fissures as well as exposed reinforcement mesh (photo 47). Some coping stones were out of plane on the north and south parapet walls (photo 28 and façade report section photo 41). Metal flashing sealant was aged or failed (photos 23, 25).

Area of exposed ridge with fiberglass reinforcement mesh exposed as well as cracks and fissures.

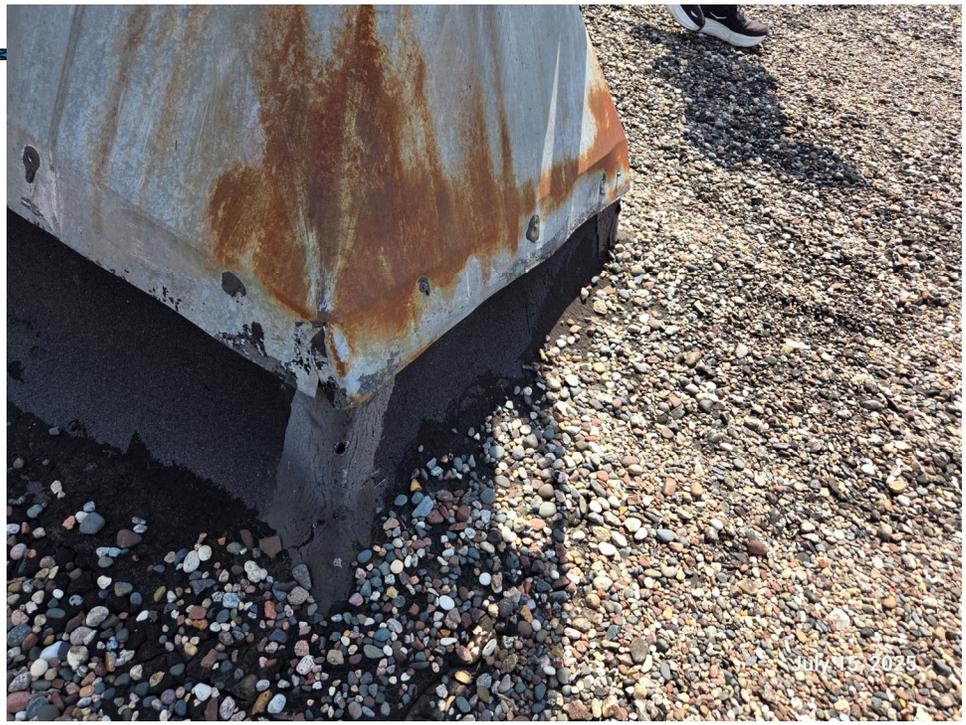
Photo 48:

Typical condition of flashing details for roof penetrations.

Note: Cracks and fissures in flashing sheets and sealant.

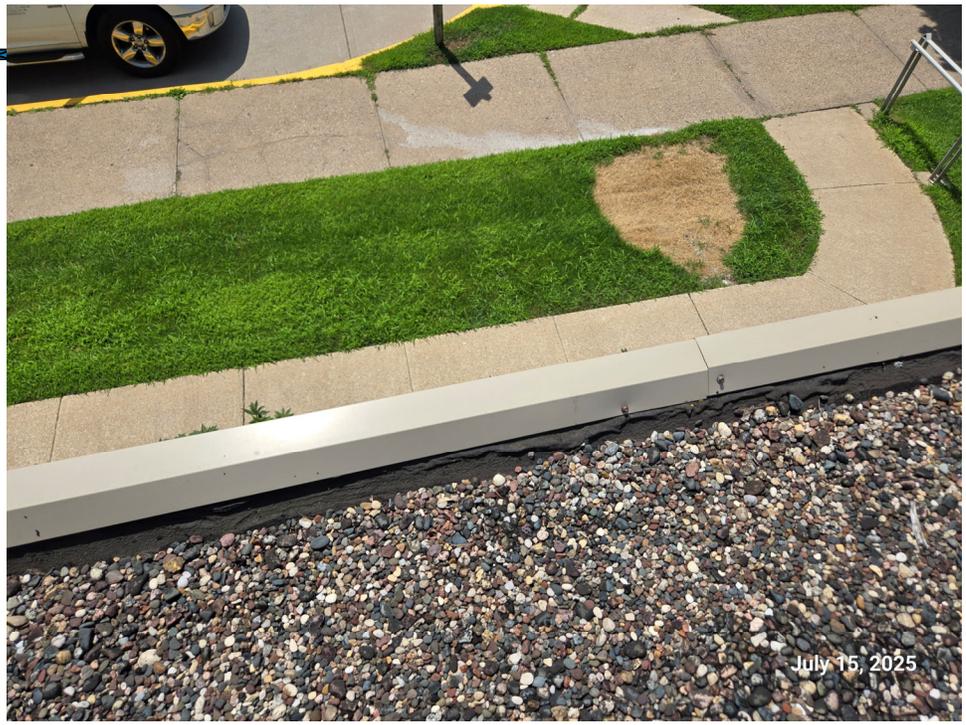
Photo 64:

Typical condition of south edge metal.

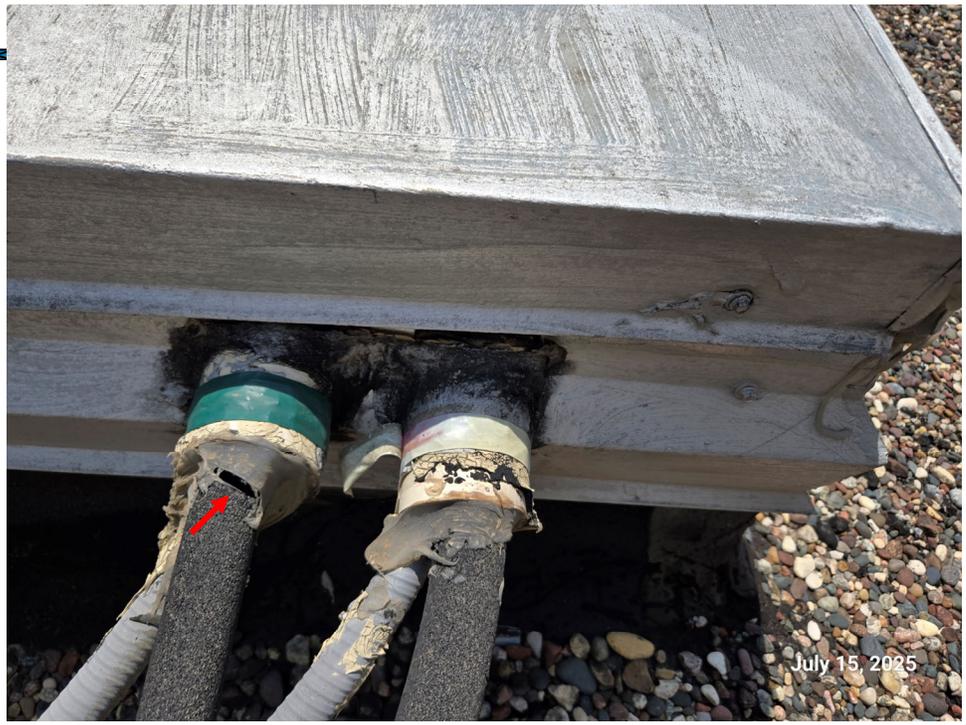
Photo 66:

Description:
Failed sealant around hose penetration.

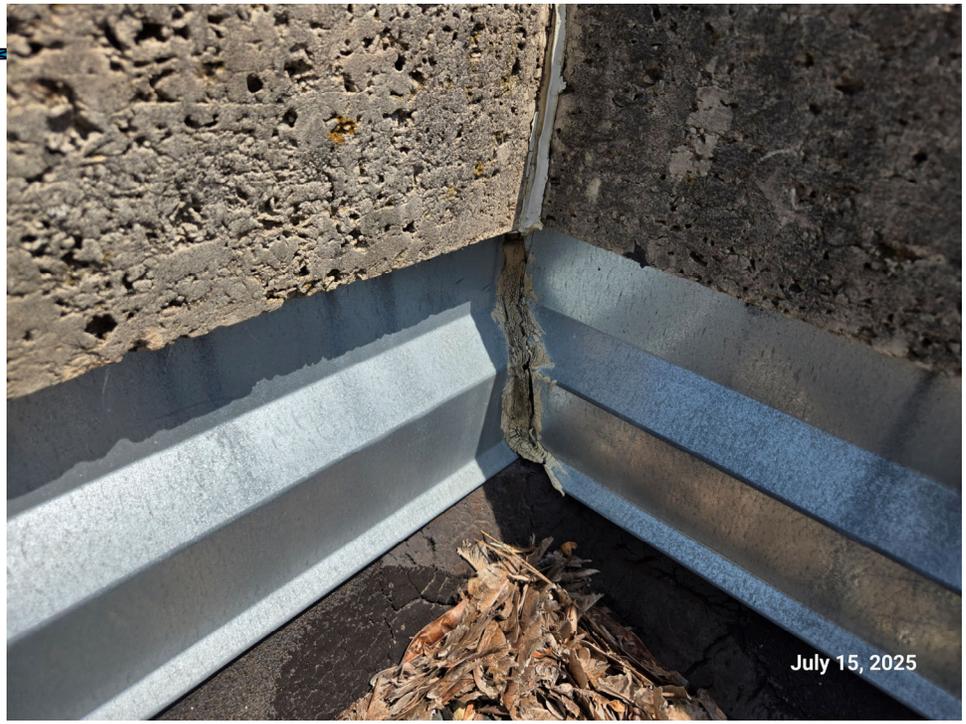
Photo 71:

Description:
Failed flashing sealant in
northeast corner.

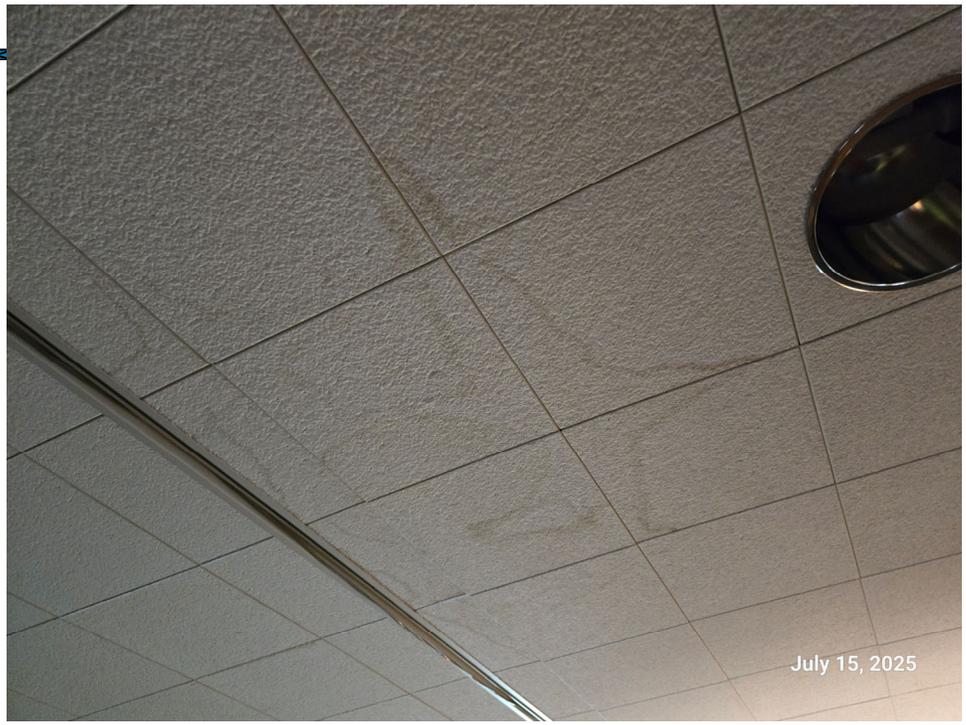
Photo 2:

Description:
Another angle of stain in previous photo.

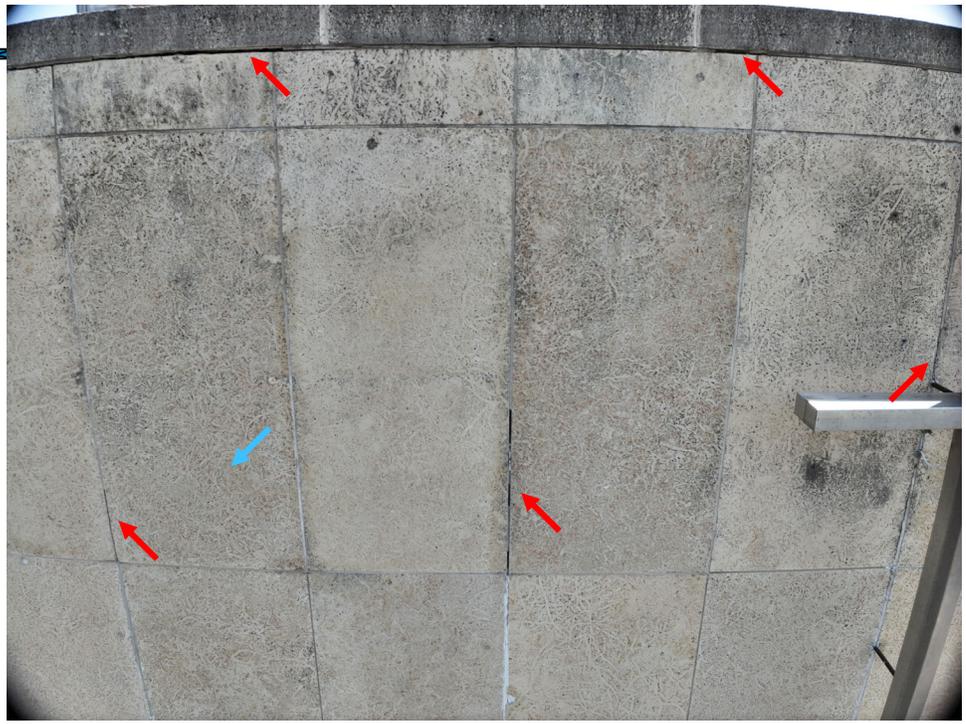
Photo 5:

Description:
Additional examples of failed mortar joints and out-of-plane panel.

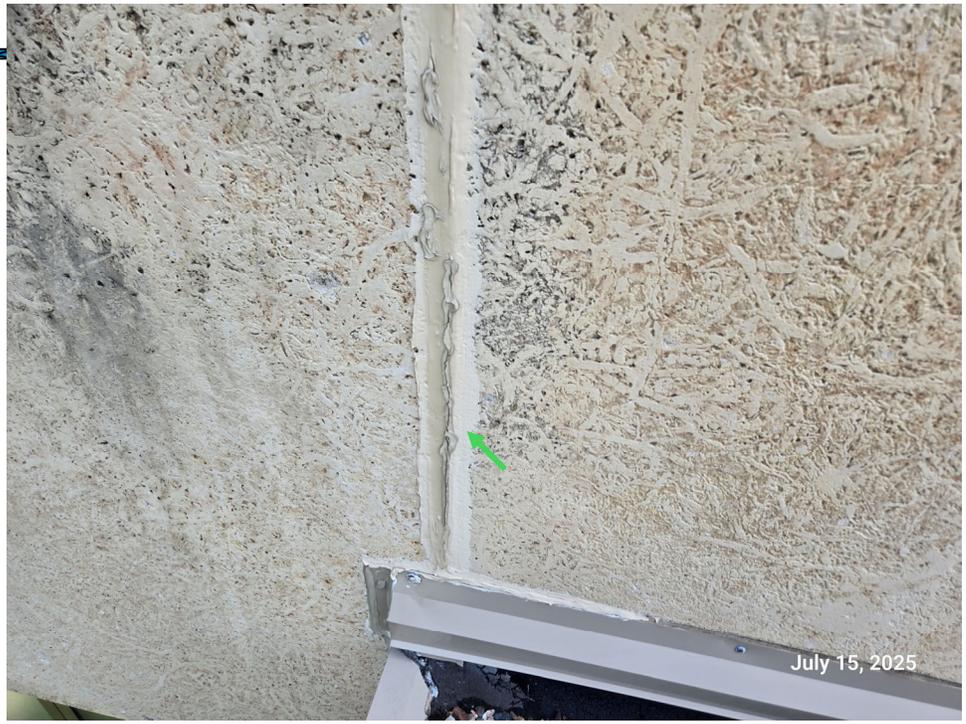
Photo 9:

Description:
Failed sealant.

1. Remove and replace failed sealant around windows, metal flashing details and between coping stones. Work should be completed by a qualified professional.
2. Reposition and secure the four panels that were discovered out of plane. Work should be completed by a qualified professional. Ensure no materials behind the panels are compromised from moisture before repositioning and securement.
3. Fill spalling in the stones and panels to minimize risk of water intrusion or monitor to ensure spalling does not worsen. Work should be completed by a qualified professional.
4. Spray foam areas should be replaced with more permanent repairs such as mortar or sealant with a backer. Work should be completed by a qualified professional.
5. Wall cladding on all elevations should be tuck pointed on and around the indicated areas in the following photo report by a qualified contractor.

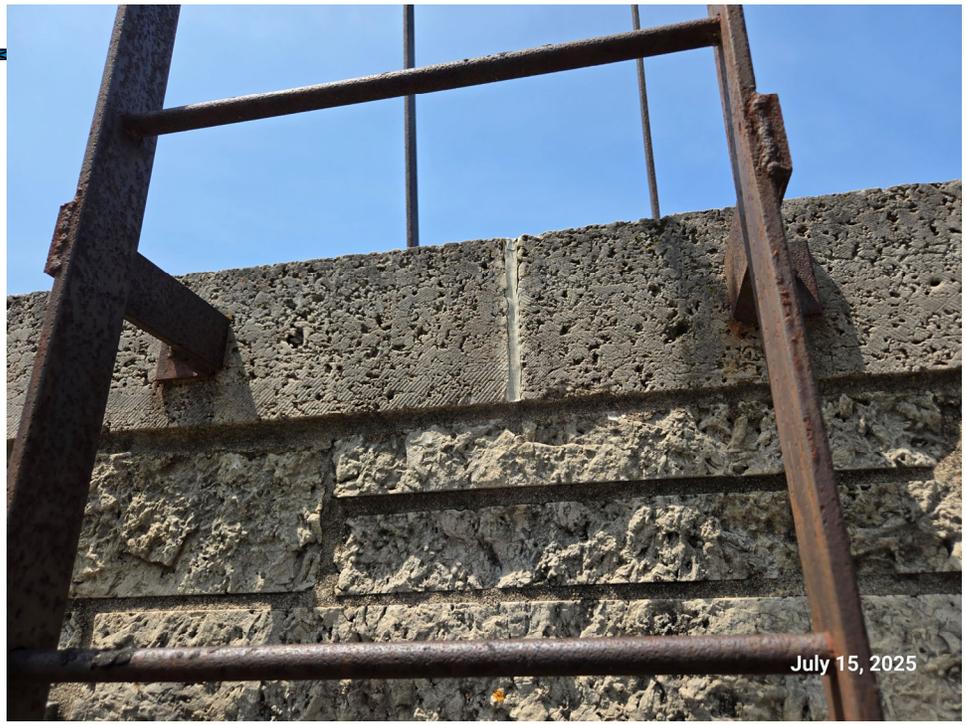
Photo 12:

Description:
Failed cap stone sealant.

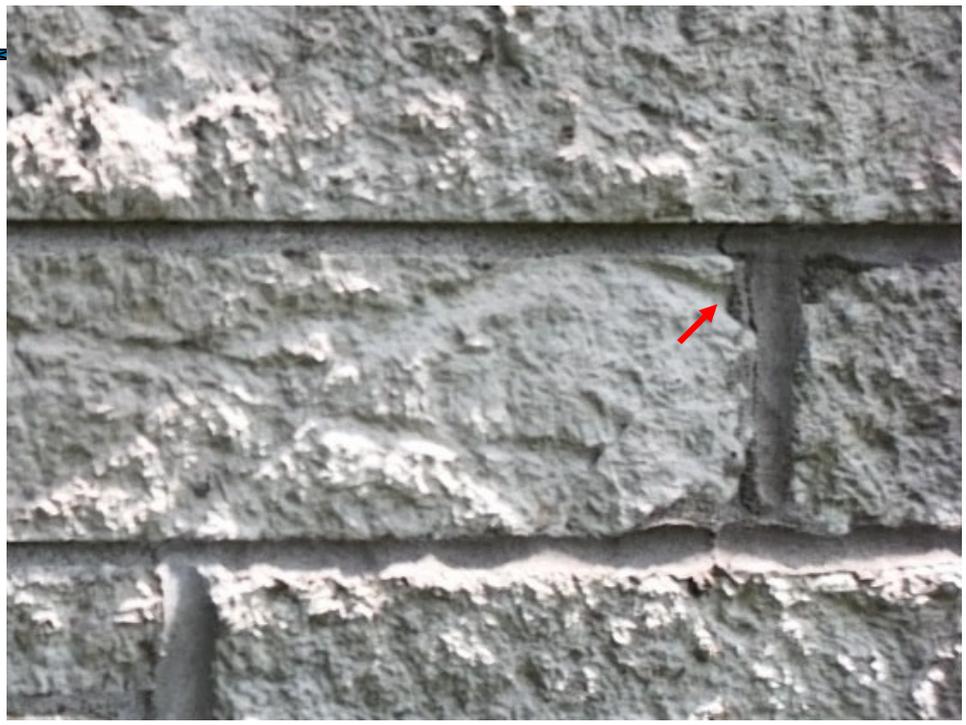
Photo 16:

Closeup of failed mortar joint in prior photo.

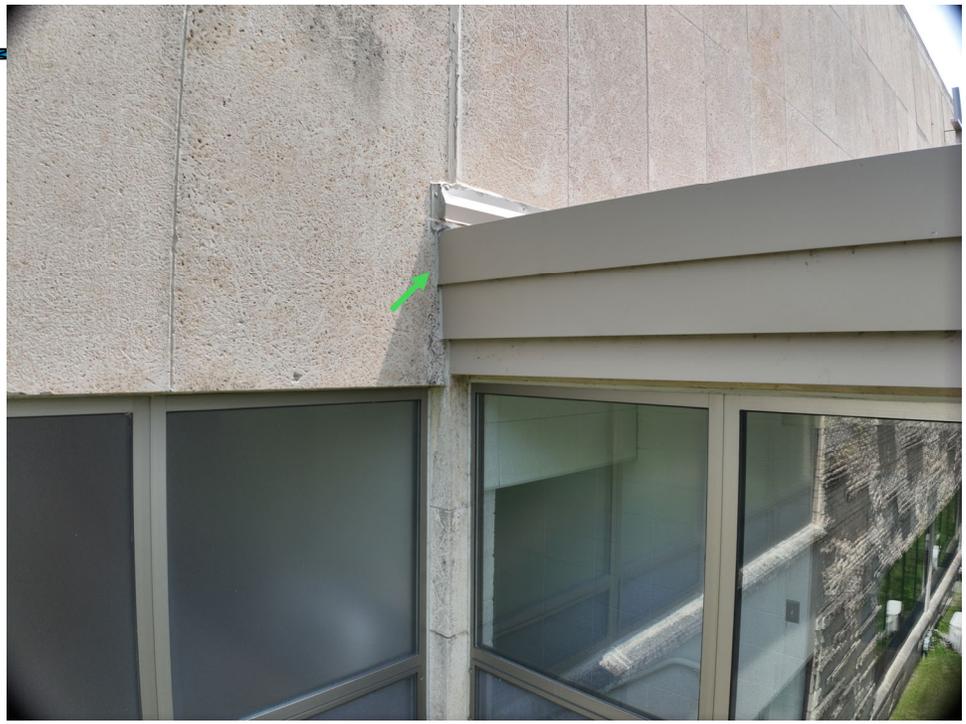
Photo 19:

Description:
Failed sealant.

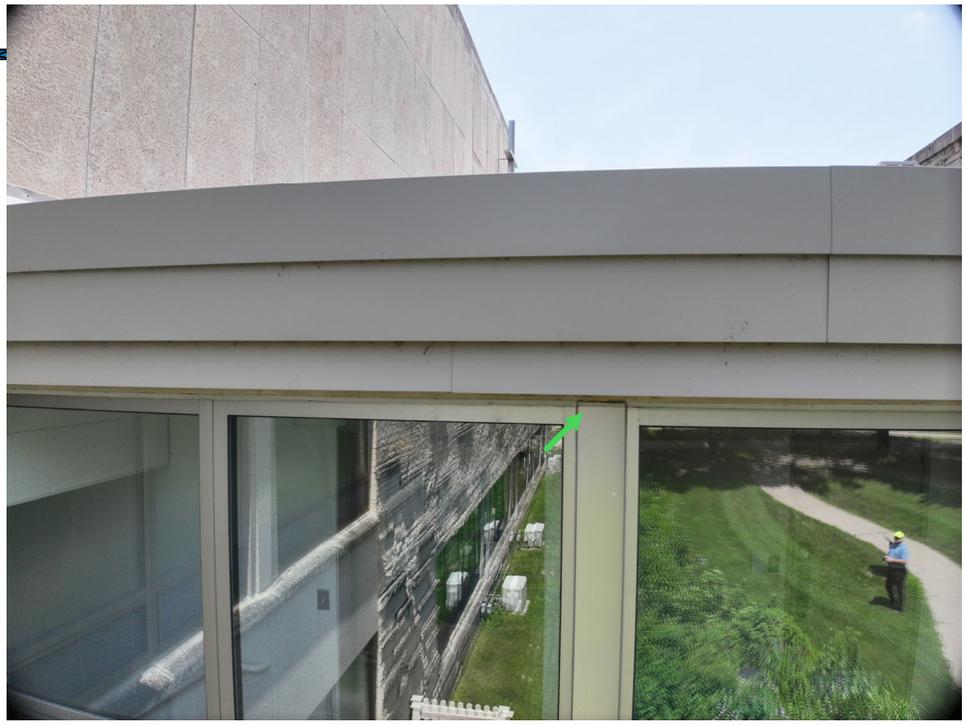
Photo 20:

Description:
Failed sealant.

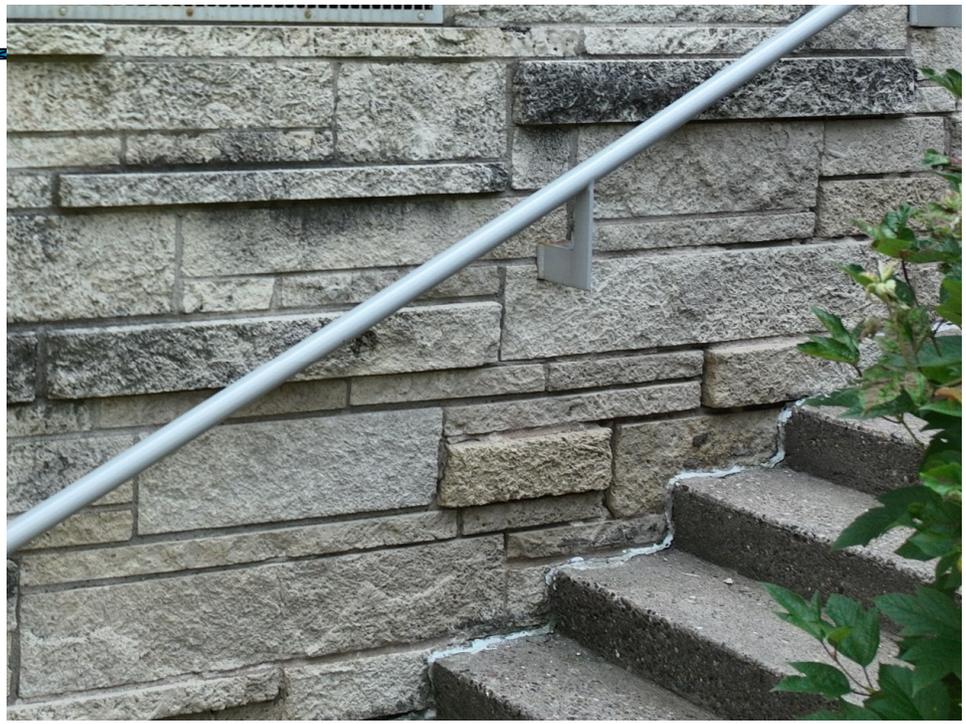
Photo 21:

Description:
Failed mortar and sealant on and above stairwell.

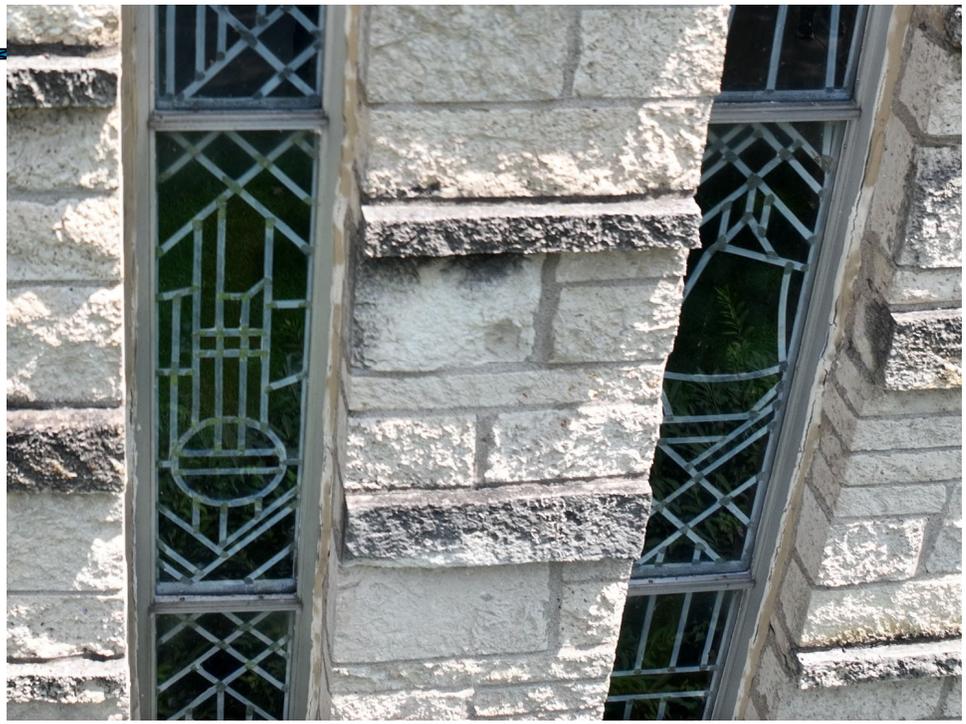
Photo 23:

Description:
Example of failed sealant around windows.

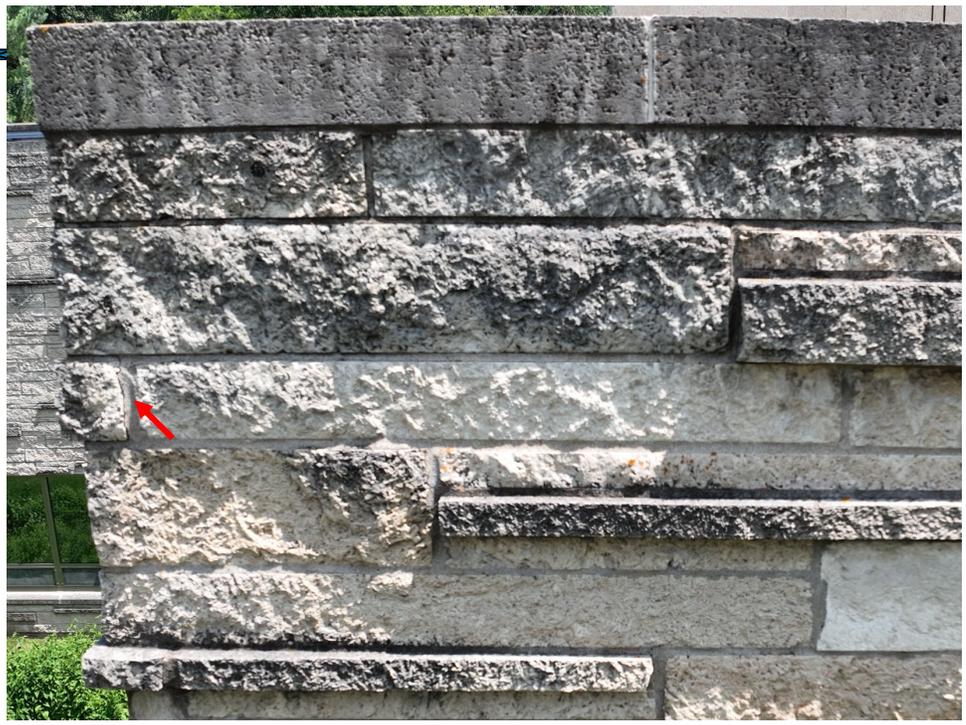
Photo 24:

Description:
Example of a failed mortar joint.

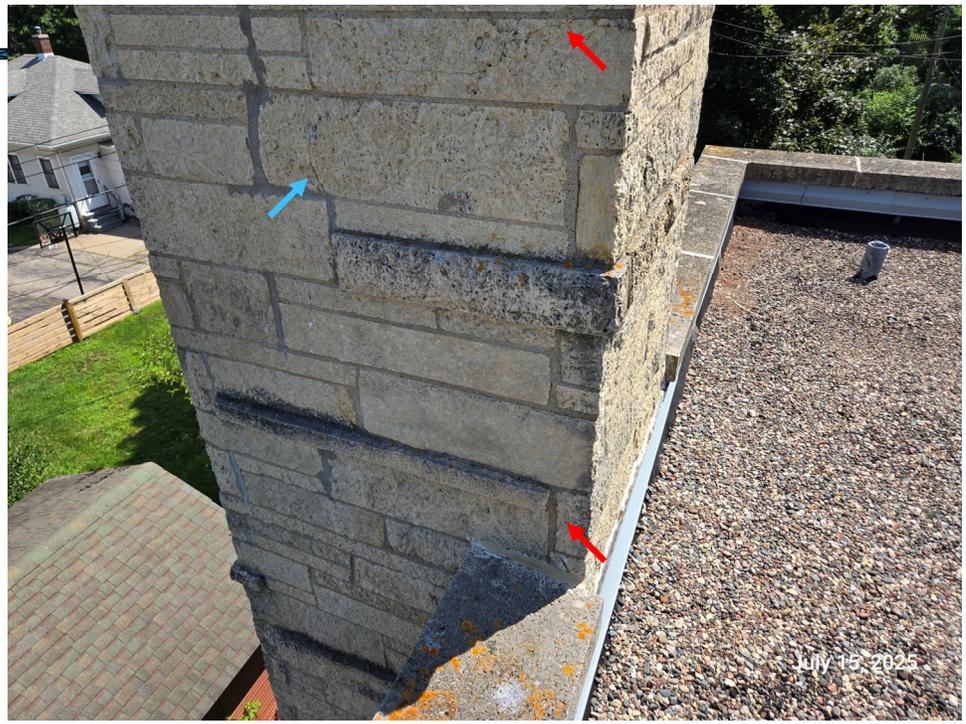
Photo 27:

Location:
North Elevation
West Side of Chimney

Description:
Cracks in stone and mortar.

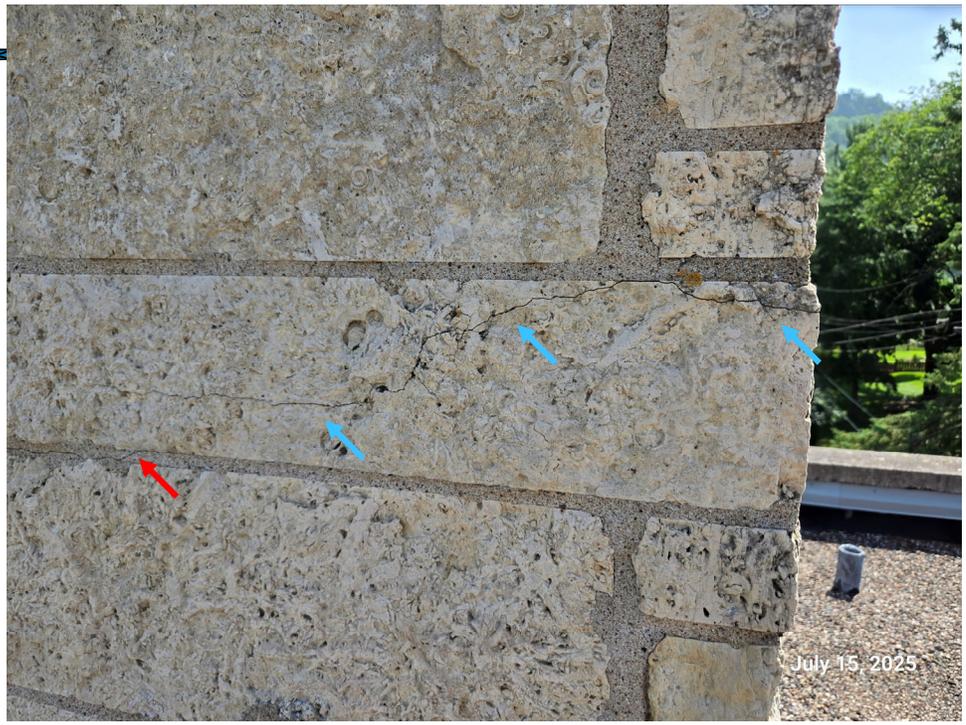
Photo 28:

Description:
Closeup of upper crack.

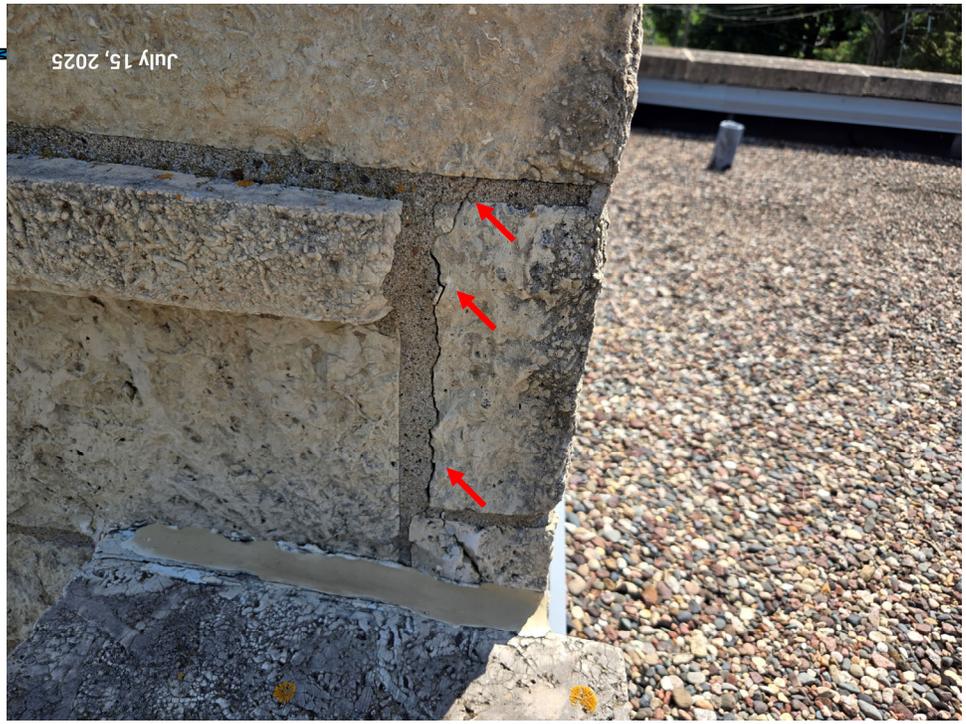
Photo 29:

Description:
Closeup of lower crack.

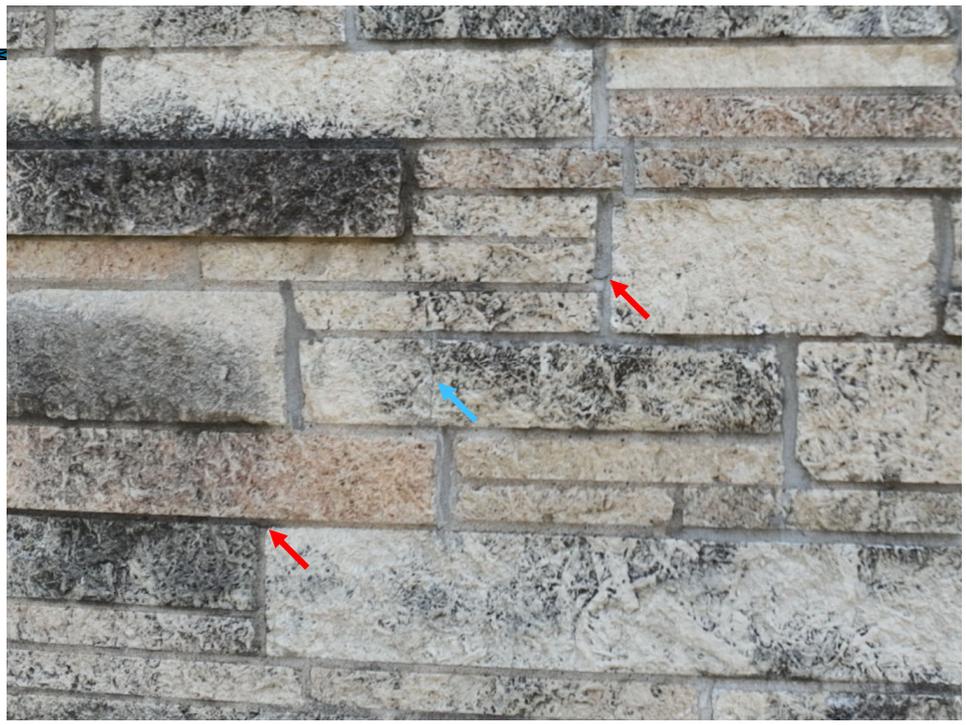
Photo 30:

Description:
Examples of failed mortar joints and cracked stone.

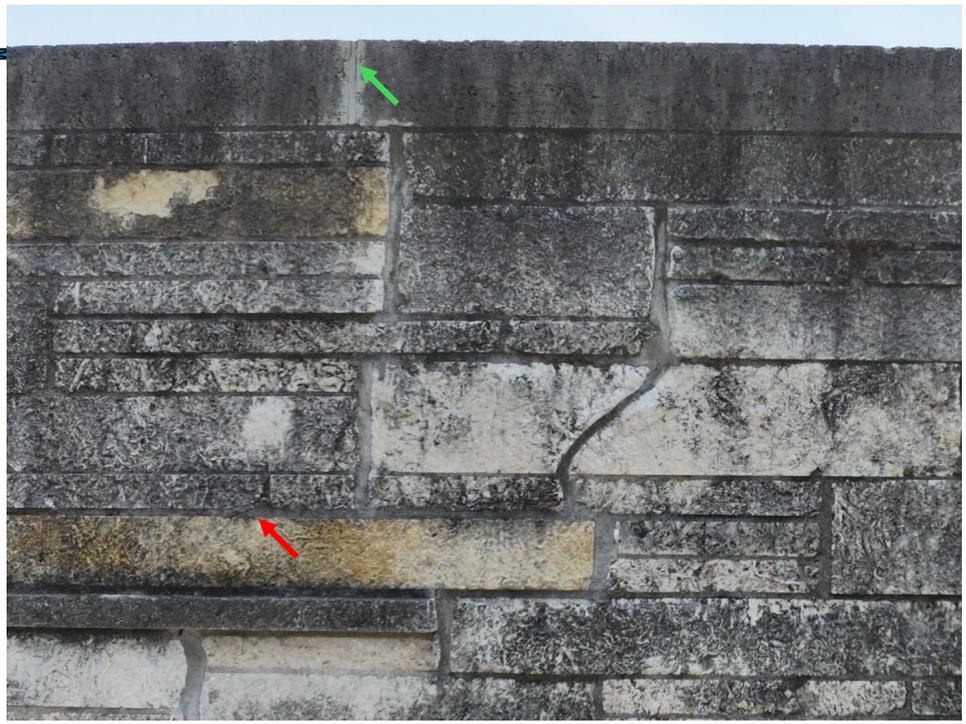
Photo 31:

Additional example of failed mortar joint as well as an example of failed sealant.

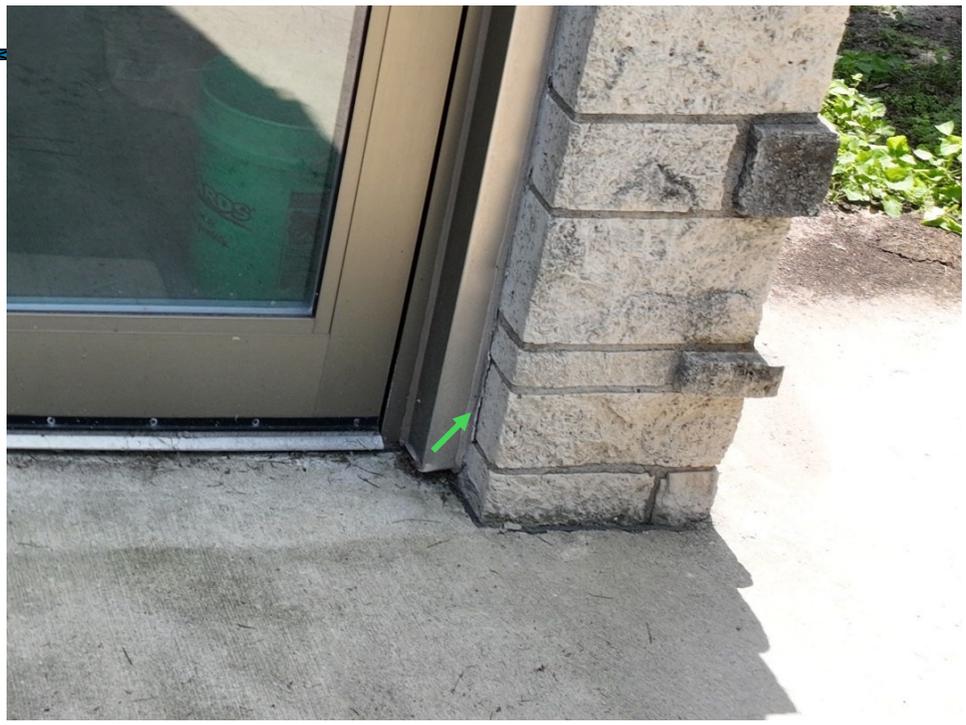
Photo 32:

Additional example of failed sealant.

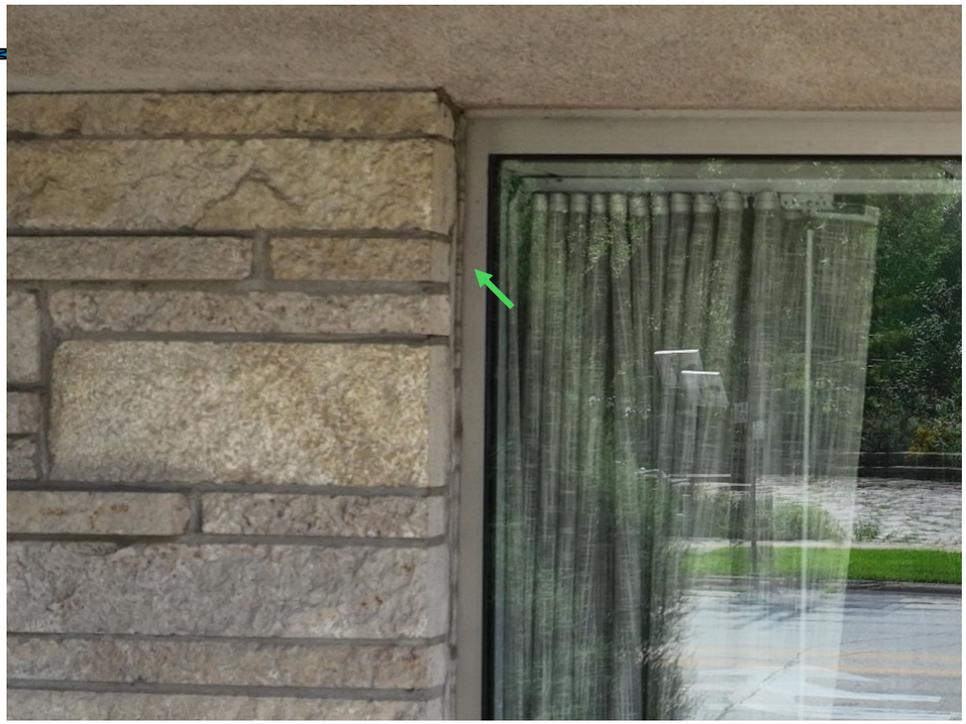
Photo 35:

Description:
Example of failed sealant.

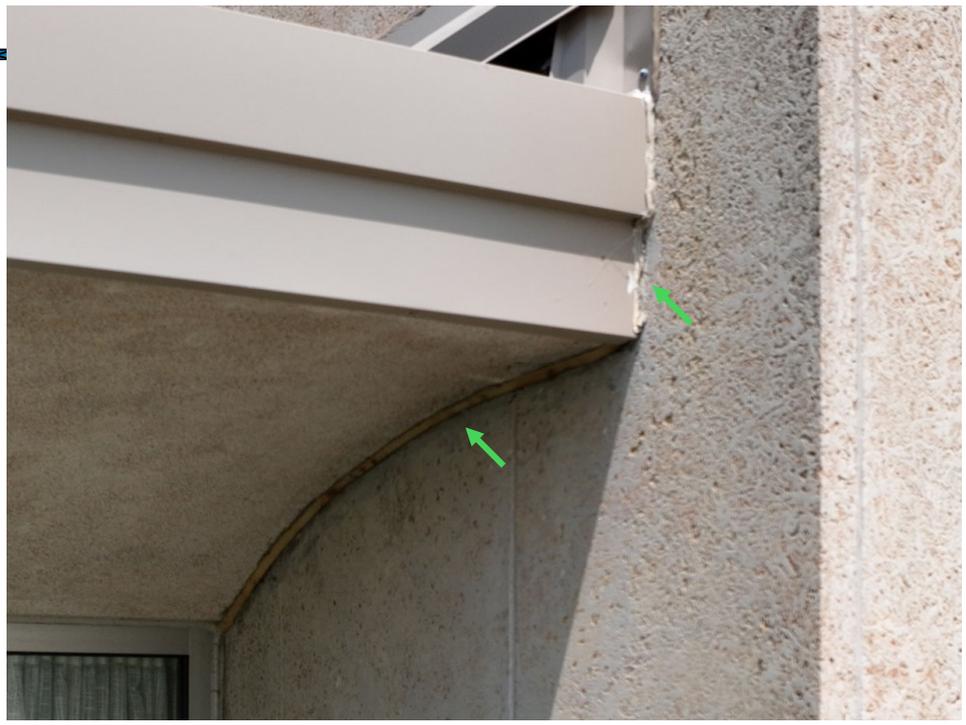
Photo 36:

Description:
Additional examples of failed sealant.

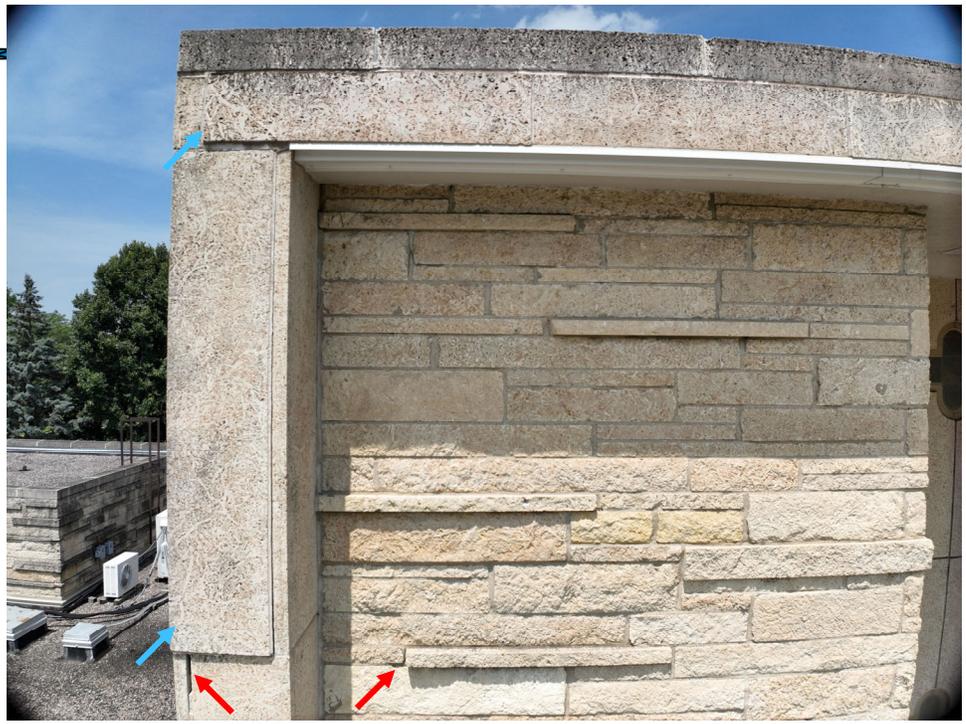
Photo 37:

Examples of out of plane panels and failed mortar joints.

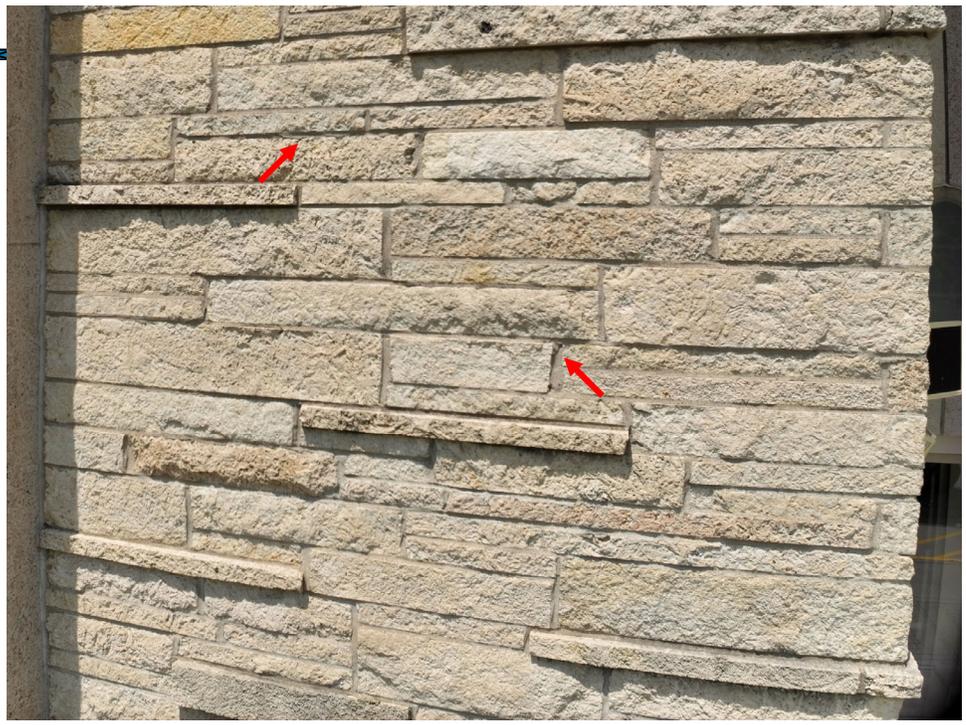
Photo 38:

Examples of failed mortar joints.

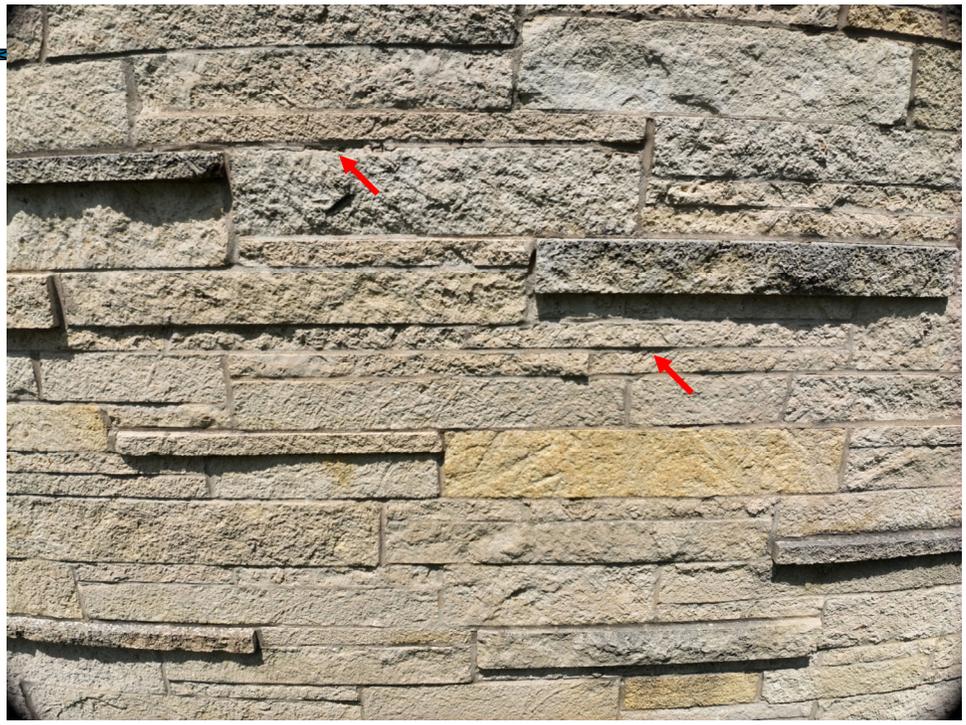
Photo 42:

Example of failed mortar joints.
