BECTEST

Property Condition Assessment For:

First Congregational Church of Christ

RE: Property Condition Assessment (PCA) For:
2503 Main Street, La Crosse, WI 54601

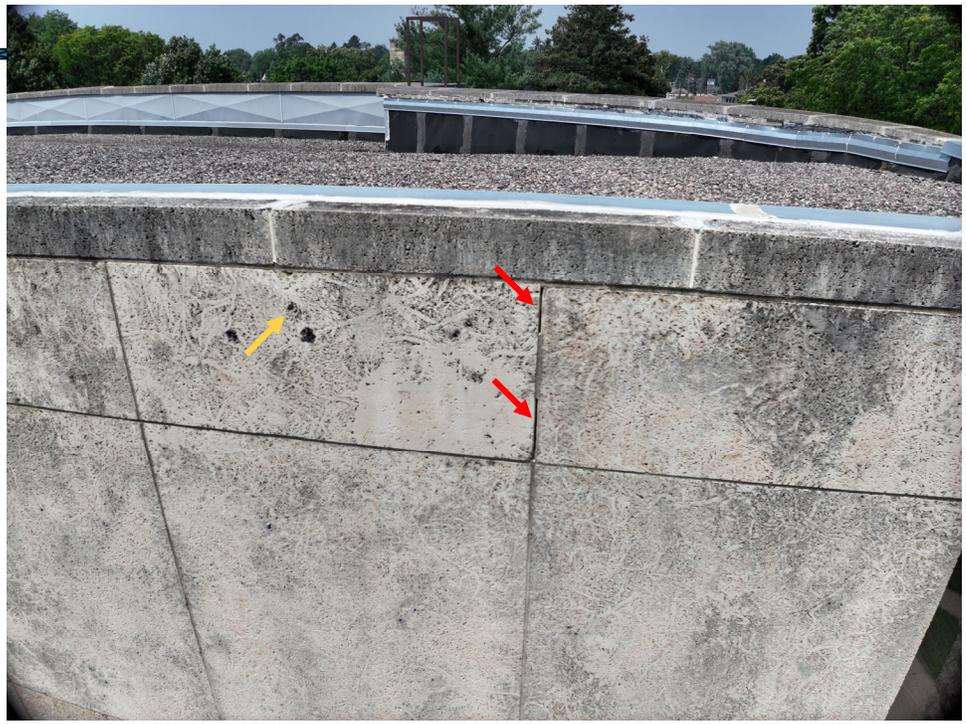
Photo 43:

Additional examples of spalled panel and failed mortar joints.

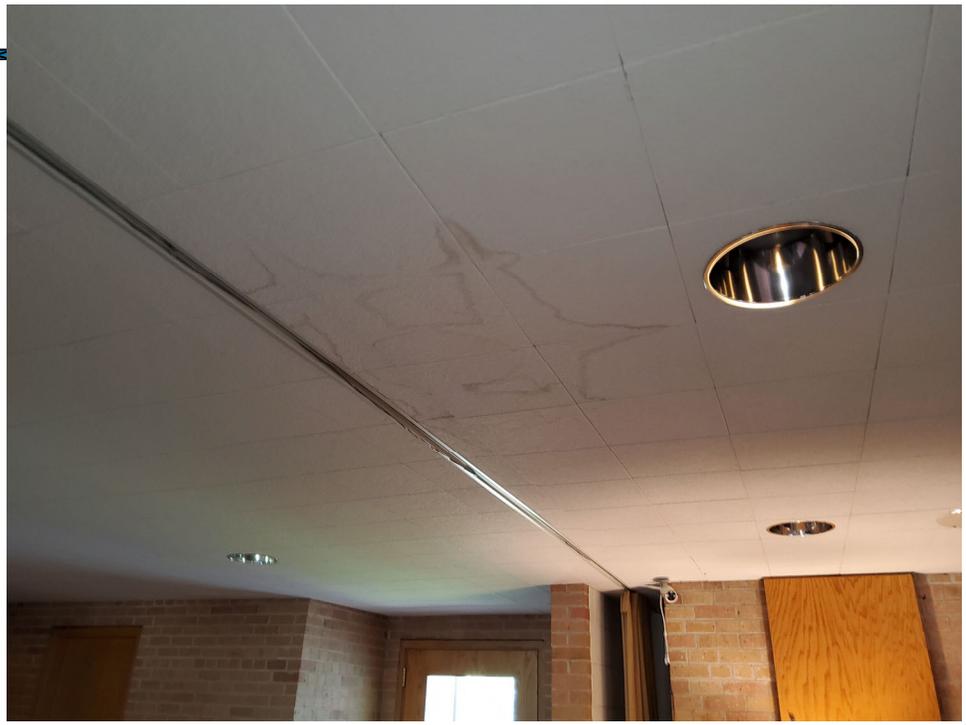
Photo 6:

Description:
Ceiling above west end
of sitting area
Note: Water stains.

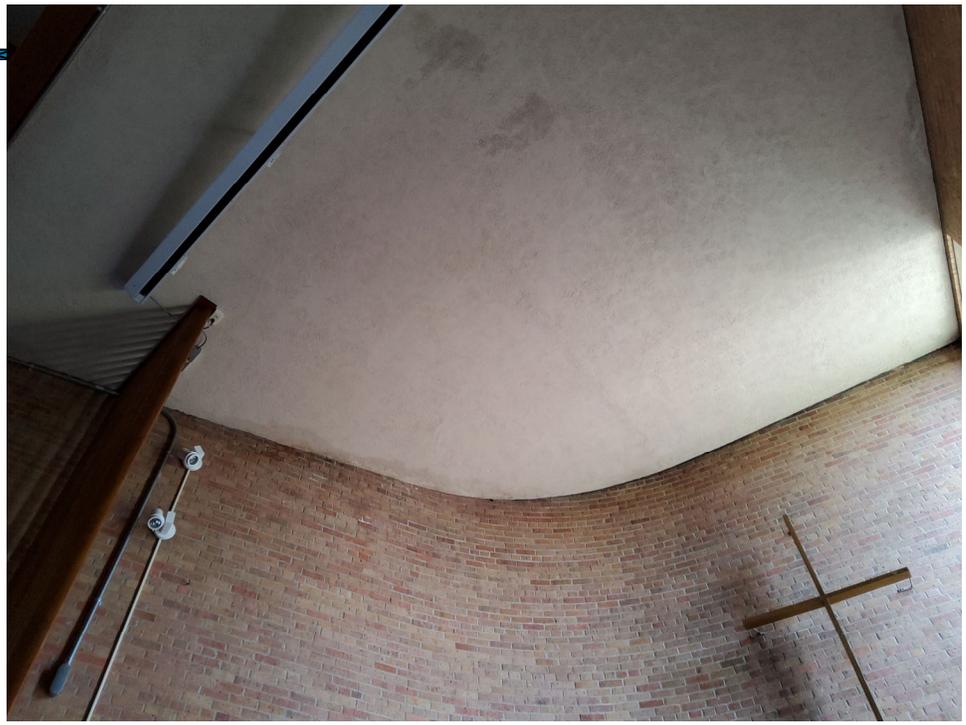
Photo 10:

Description:
Ceiling above altar
Note: Water stains.
