BECTEST

Property Condition Assessment For:

First Congregational Church of Christ

RE: Property Condition Assessment (PCA) For:
2503 Main Street, La Crosse, WI 54601

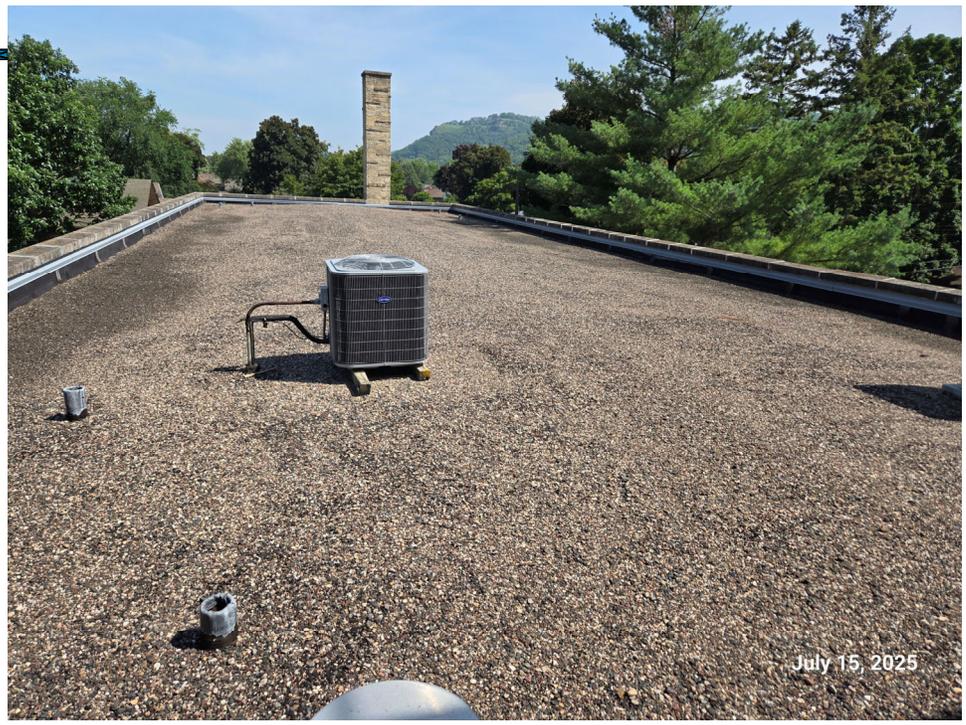
Photo 3:

Location:
North Roof Section
West Wall

Description:
Typical condition of
parapet wall.

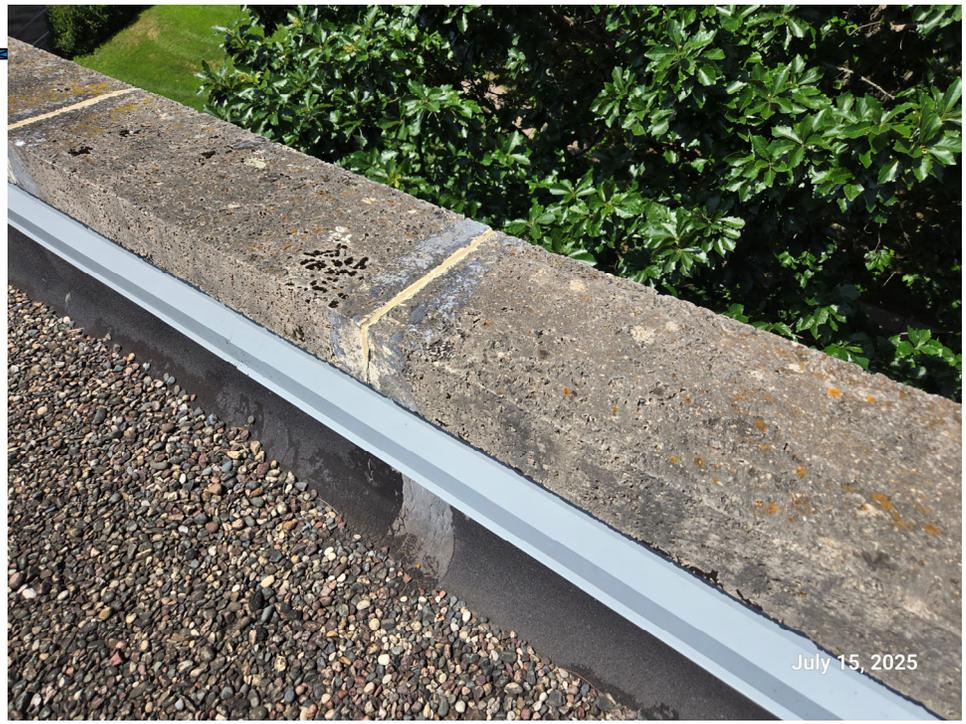
Photo 4:

Description:
Closeup of sealant in
previous photo.

Note: Cracks and
fissures in parapet
flashing sheets.

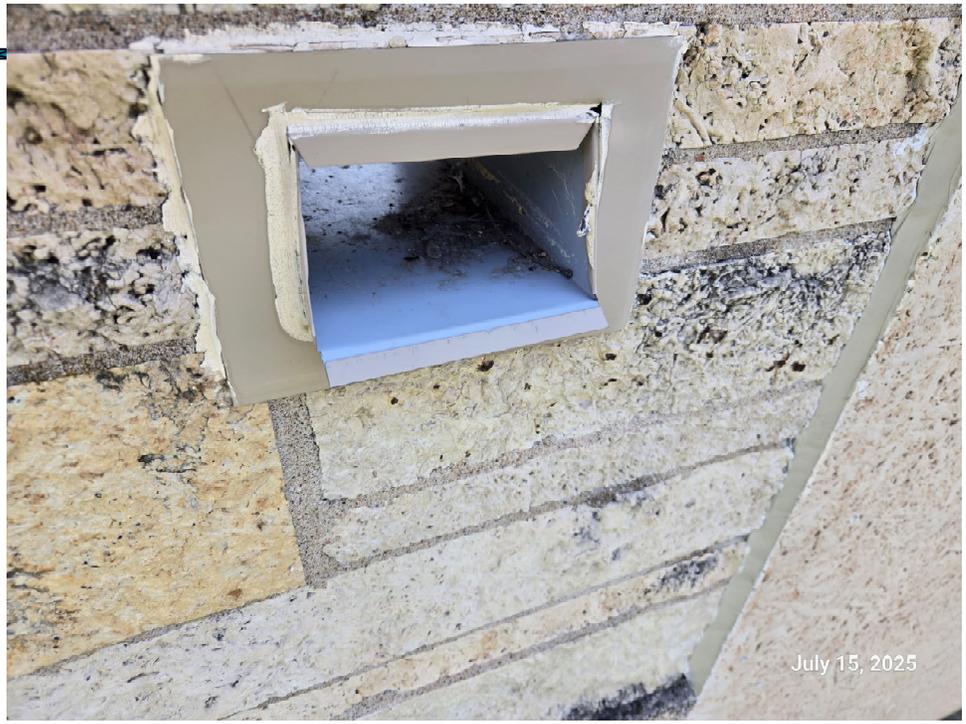
Photo 6:

Description:
Southwest internal drain.

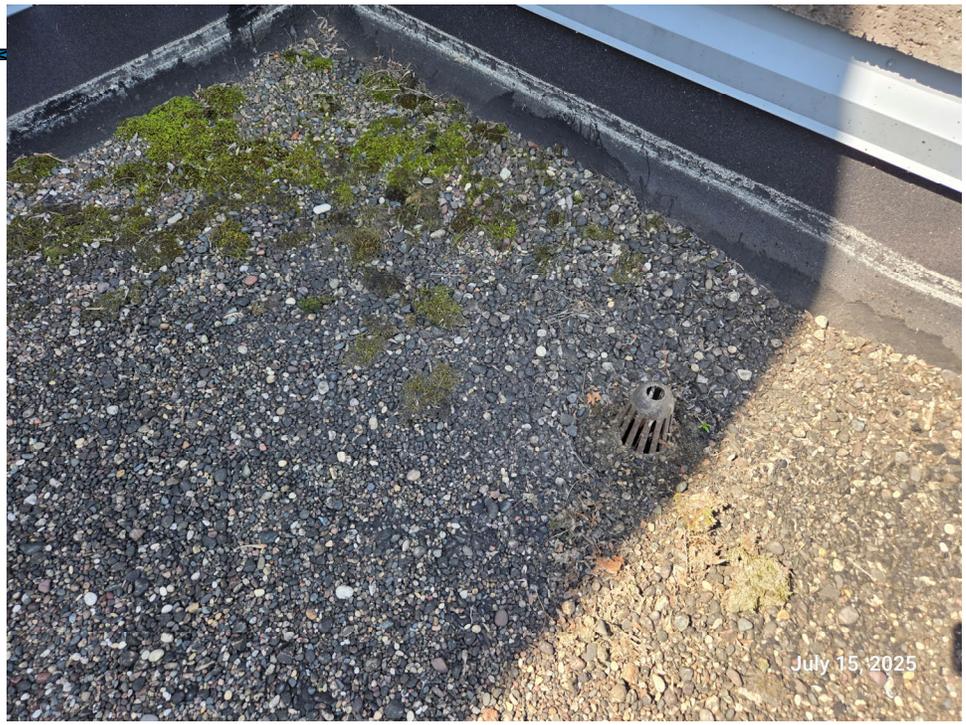
Photo 7:

Description:
Southwest corner
parapet wall end joint
interface.

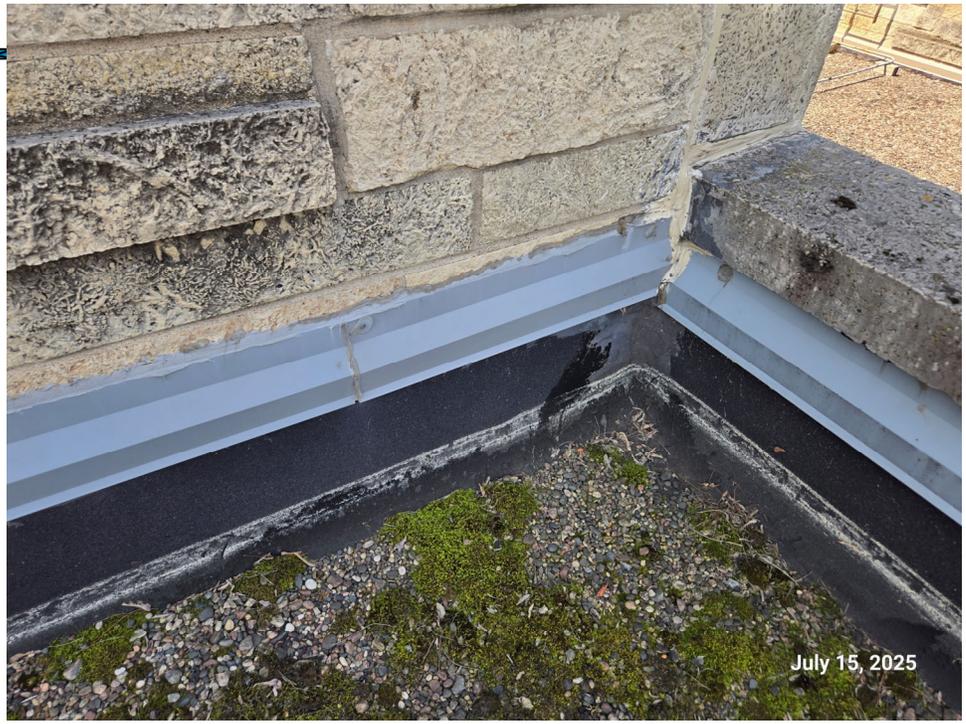
Photo 8:

Location:
North Roof Section
South Wall

Description:
Typical condition of roof-
wall interface.

Note: Fissures in parapet
sheets.

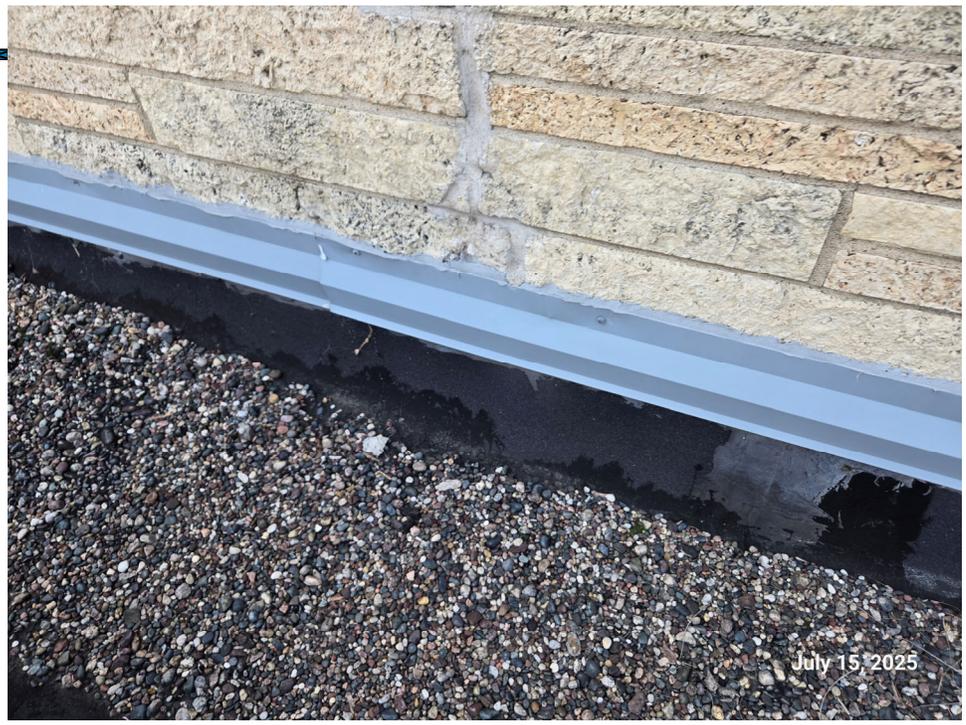
Photo 9:

Failed coping sealant was visible at the wall transition in the southeast corner (photo 9) and at the east edge of the chimney on the north wall (photo 19). Spalling was visible on some coping stones (photo 13). The southeast overflow drain sealant had failed revealing a gap within the sealant (photo 16).

Description:
Southwest corner
parapet wall end joint
interface.

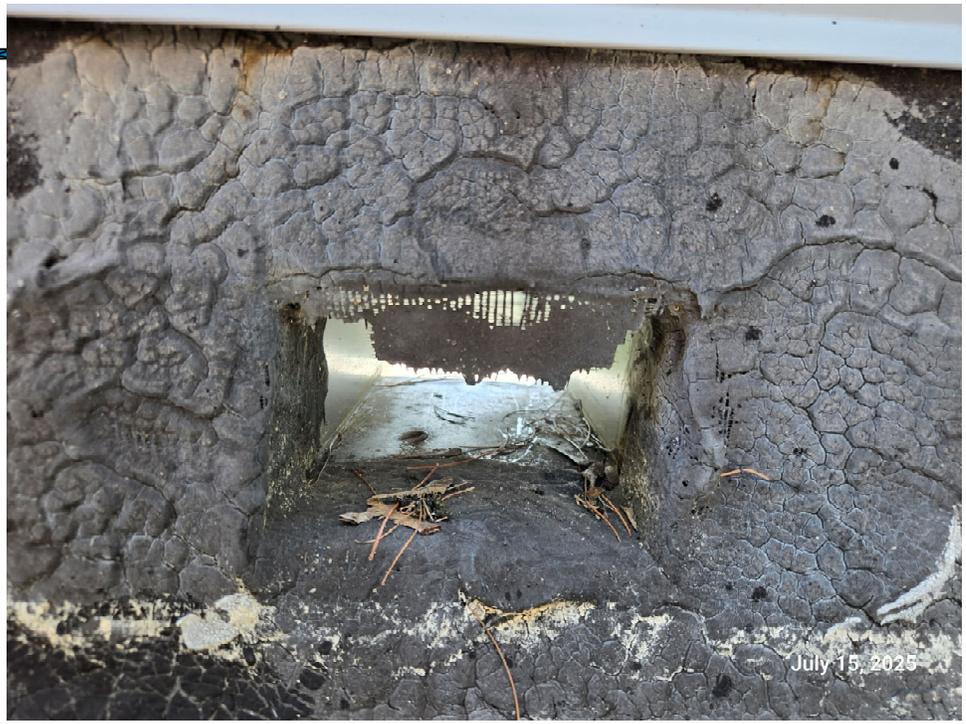
Photo 16:

Failed sealant south of drain.

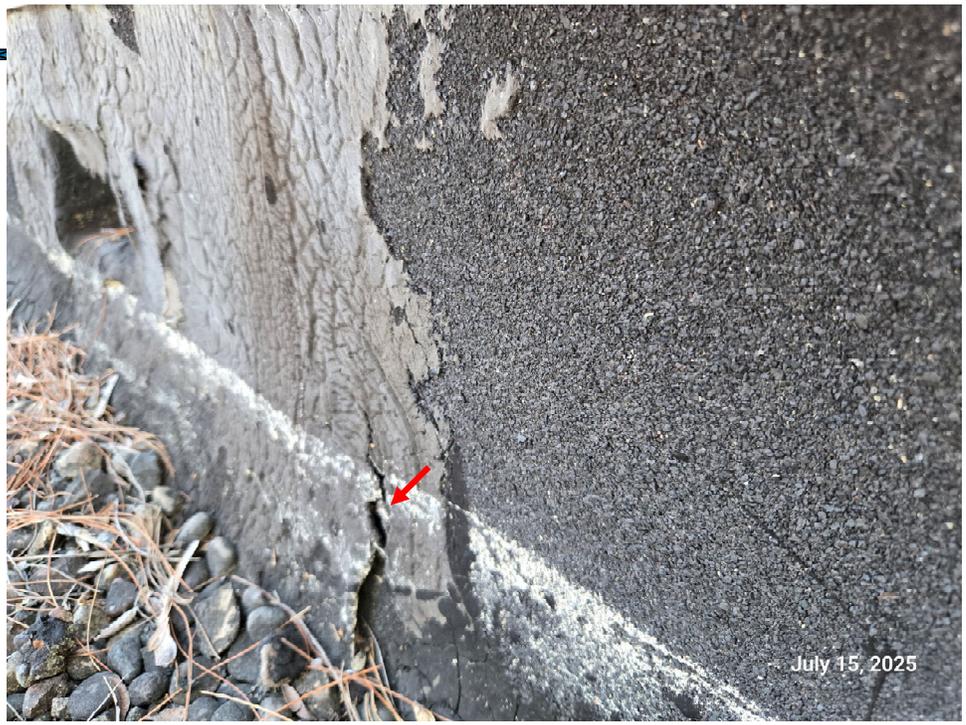
Photo 17:

Description:
Typical condition of
parapet wall.

Note: Cracks and
fissures in parapet
flashing sheets and
sealant.

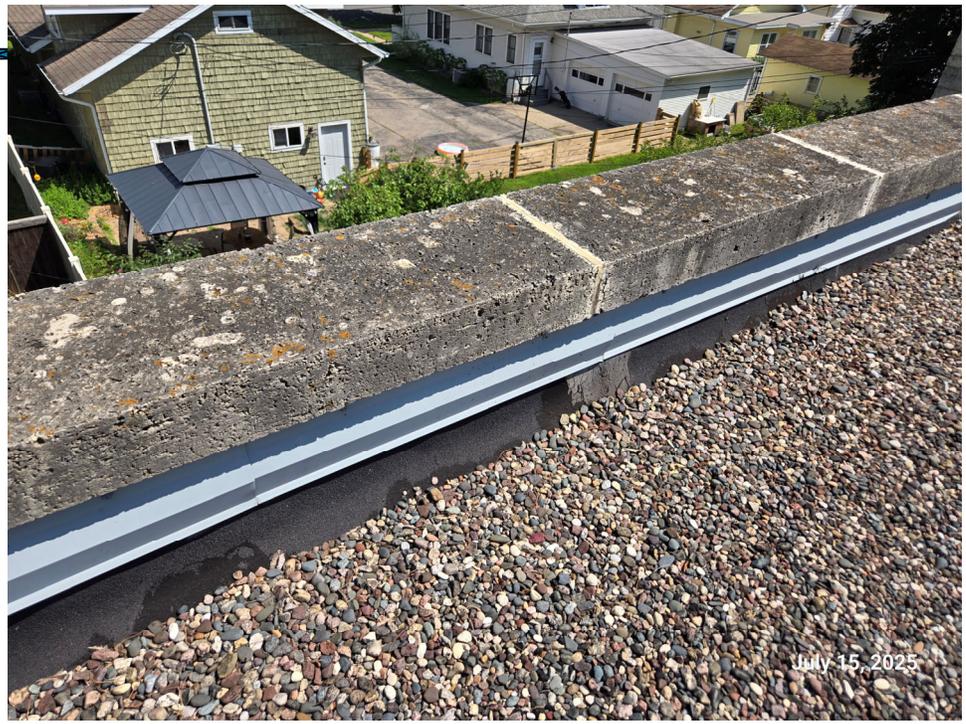
Photo 18:

Description:
Backed out roof flashing
fastener.

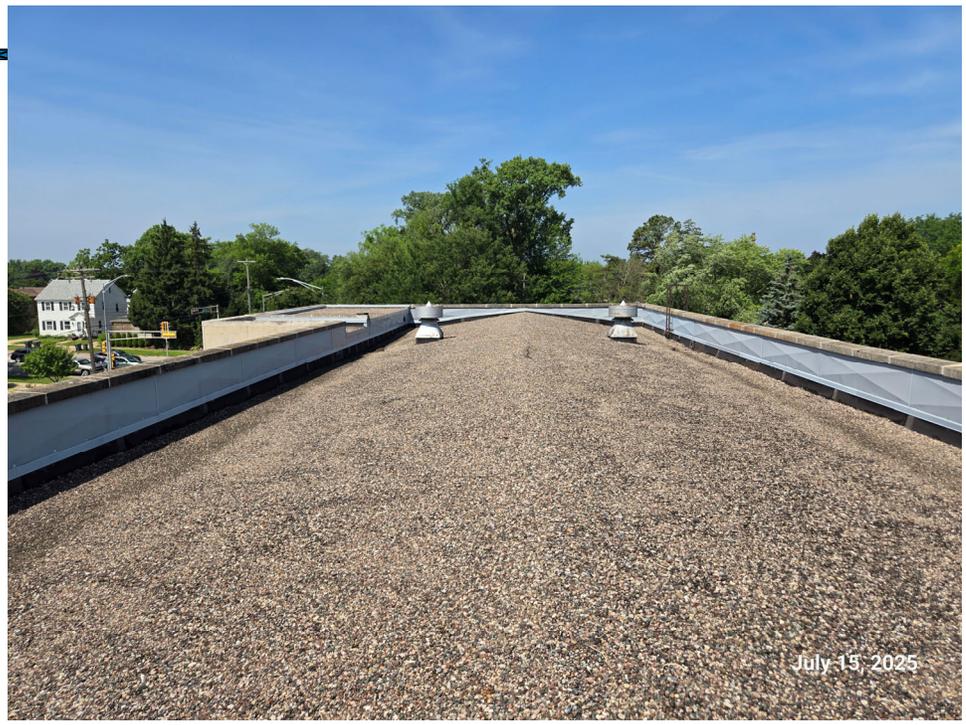
Photo 23:

The roof area had a ridge in the center and spans east-west. Gaps where stone was displaced revealed the BUR at the ridge had cracks and fissures as well as exposed reinforcement mesh (photo 47). Some coping stones were out of plane on the north and south parapet walls (photo 28 and façade report section photo 41). Metal flashing sealant was aged or failed (photos 23, 25).

Location:
Main Roof Section
Northwest Corner

Description:
Failed flashing and cap stone sealants.

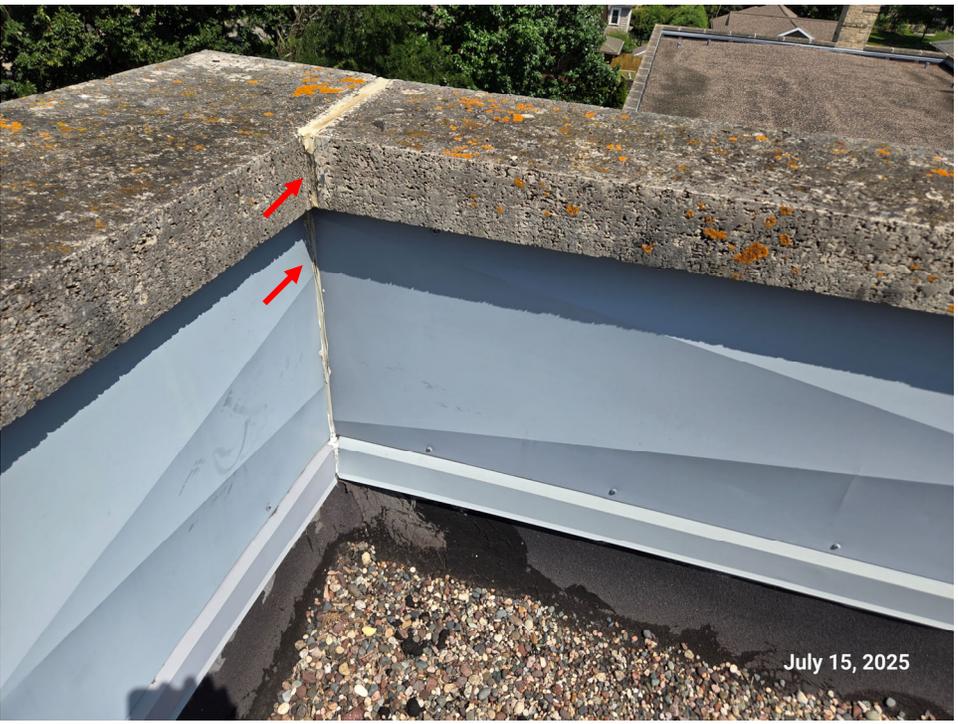
Photo 24:

Location:
Main Roof Section
North Wall

Description:
Typical condition of parapet wall.

Note:
Cracks and fissures in parapet flashing sheets and sealant.
Crack in cap stone.
Aged cap stone sealant.

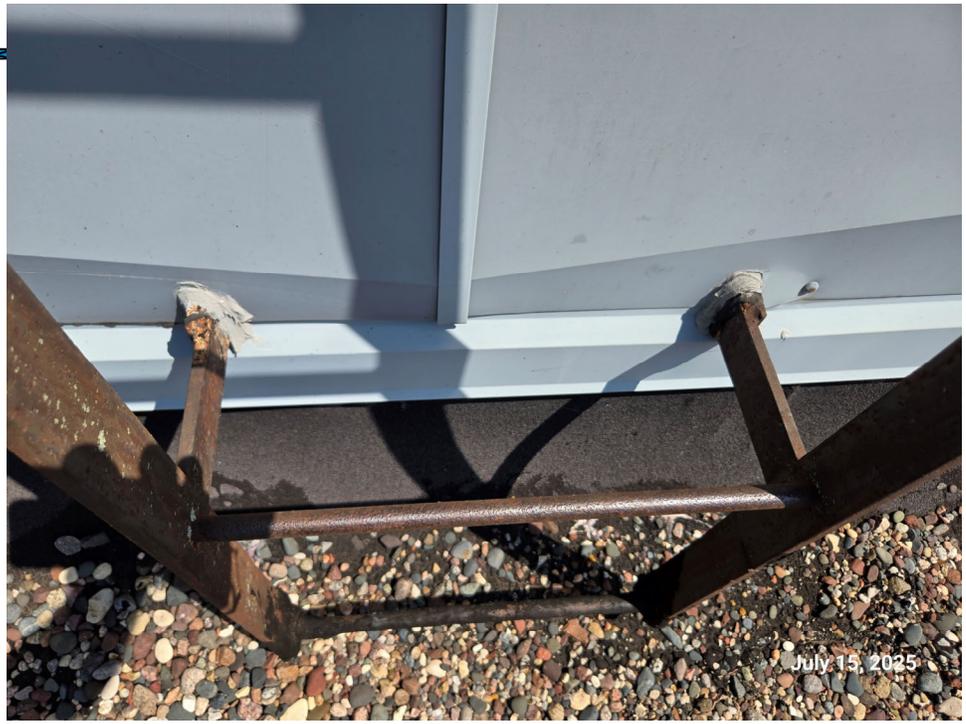
Photo 26:

Typical condition of parapet roof drain.

Note: Cracks and fissures in sealant around drain.

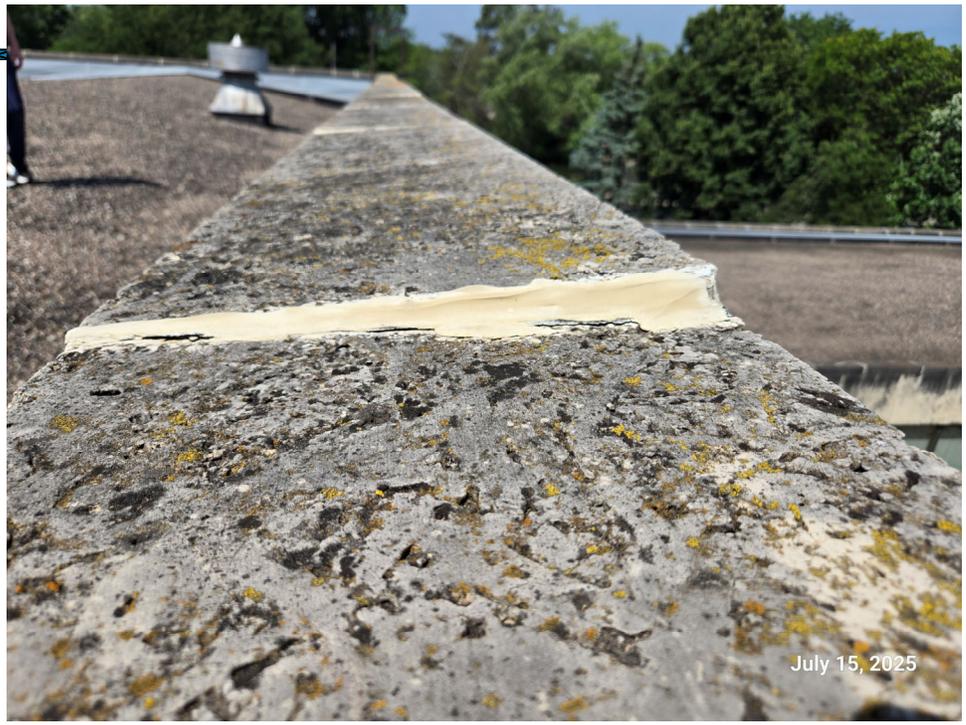
Photo 29:

Outside angle of cap stone out of plane in previous photo.

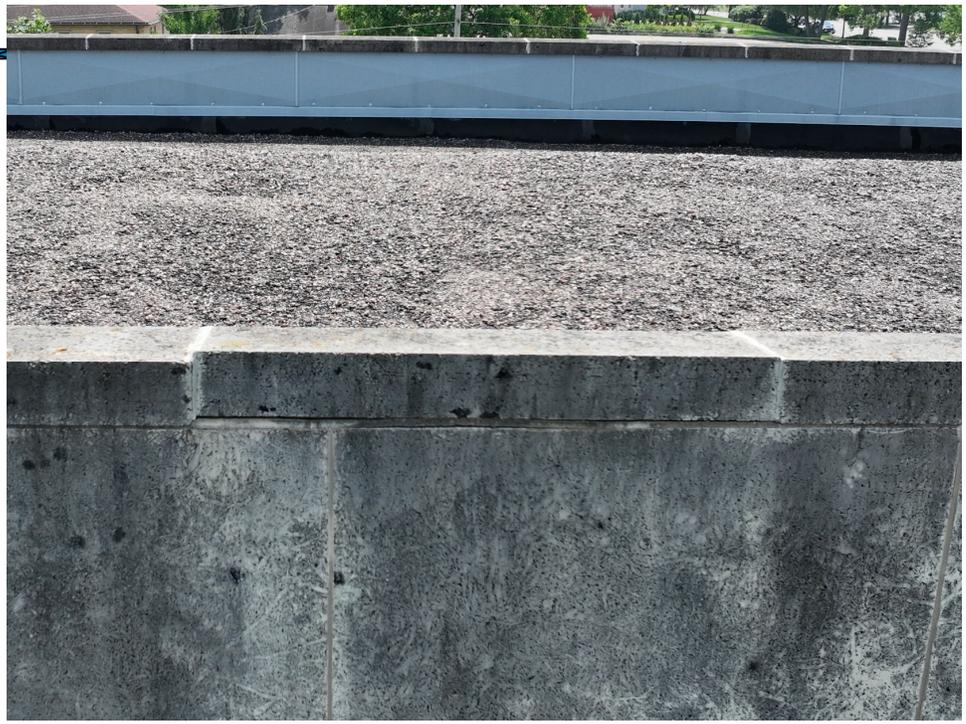
Photo 30:

Failed cap stone and flashing sealant.

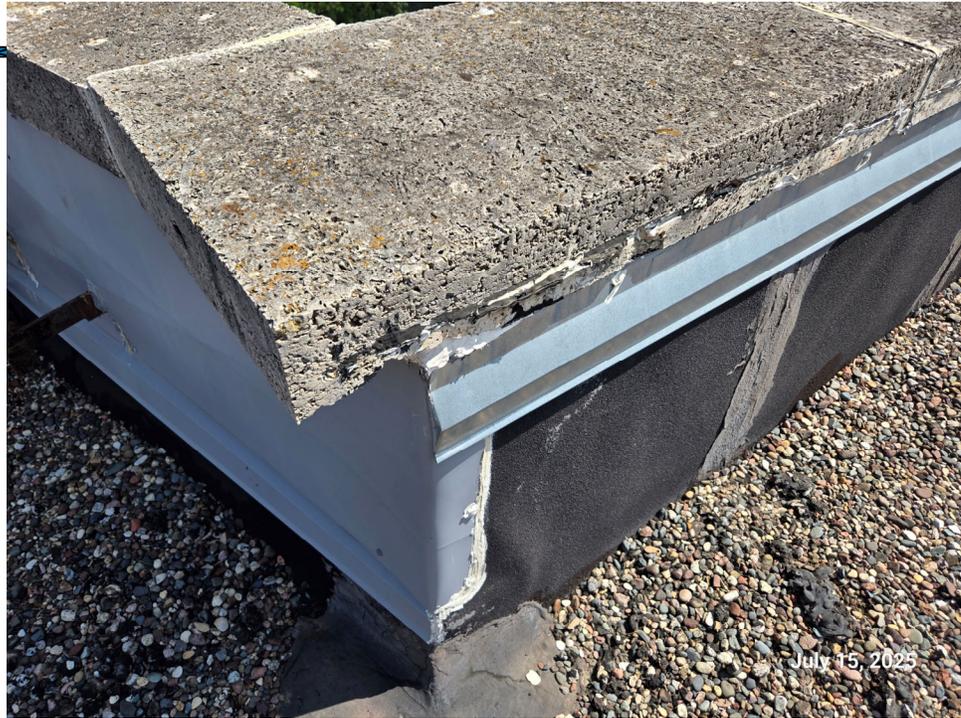
Photo 32:

Eroded cap stone.

Cracks and fissures in parapet flashing sheet sealant.

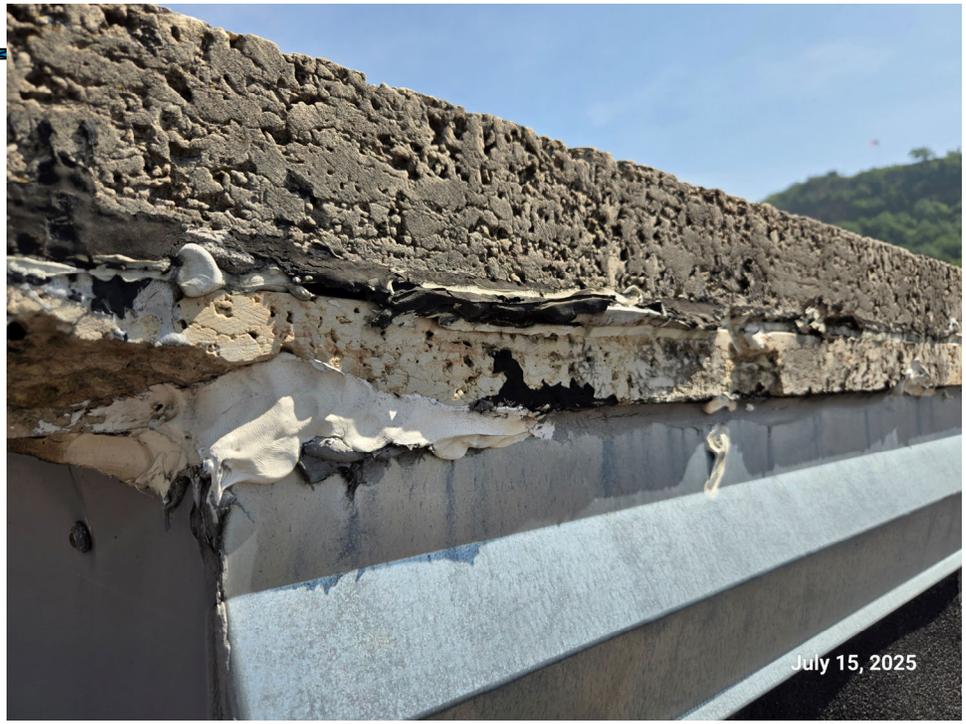
Photo 34:

Another example of failed sealant.

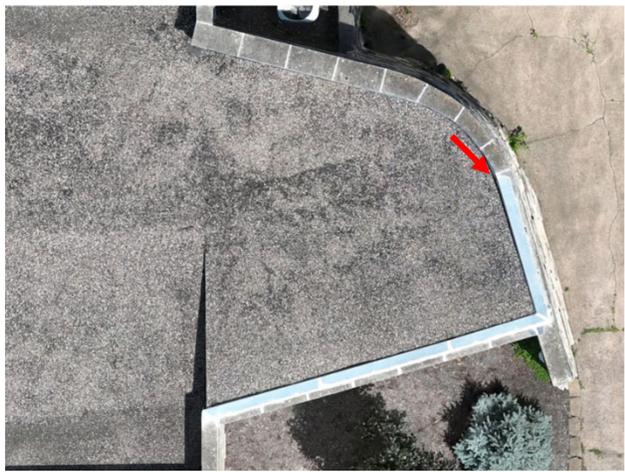
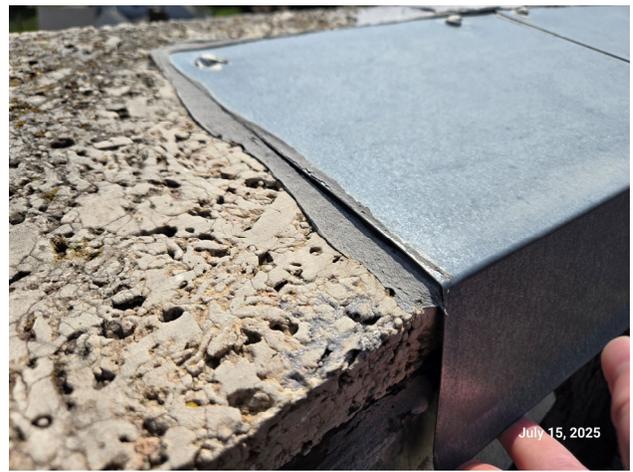
Photo 35:

Location: Main Roof Section – East End
Description: Flashing installed over cap stone.
Note: Failed sealant.

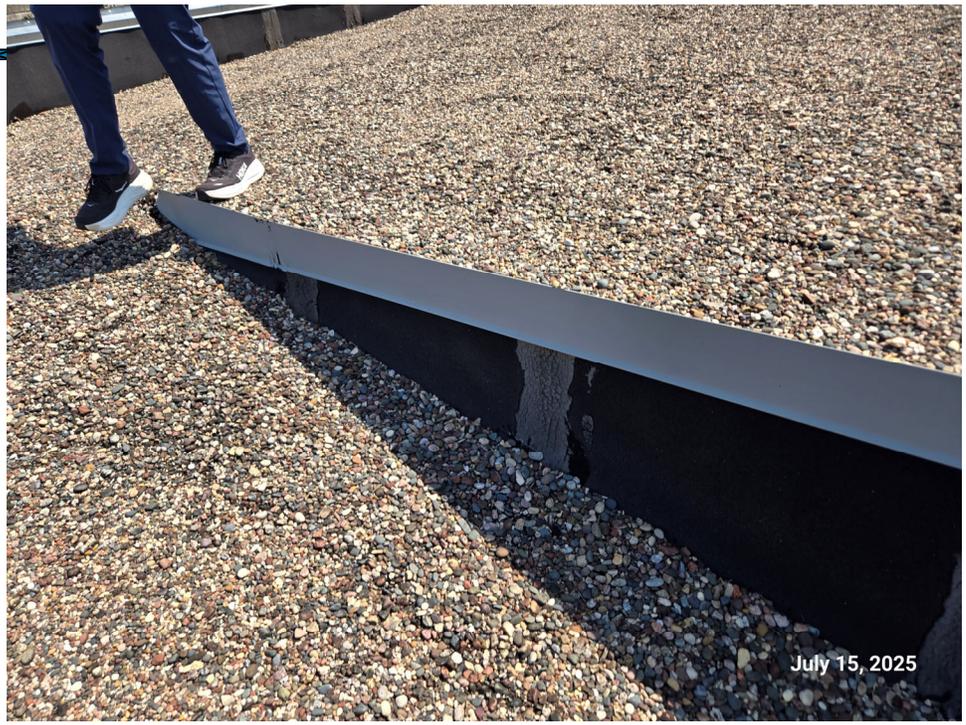
Photo 39:

According to Mark, the roof was about twenty years old. Two leaks were reported near the west end of the main section from the exterior, or near the center of the welcome/lounge area hallway from the interior of the building (façade report section photos 1-2), and at the east end of the main section above the altar from the interior (photos 39-41).

Overview of chapel below main roof section facing east.

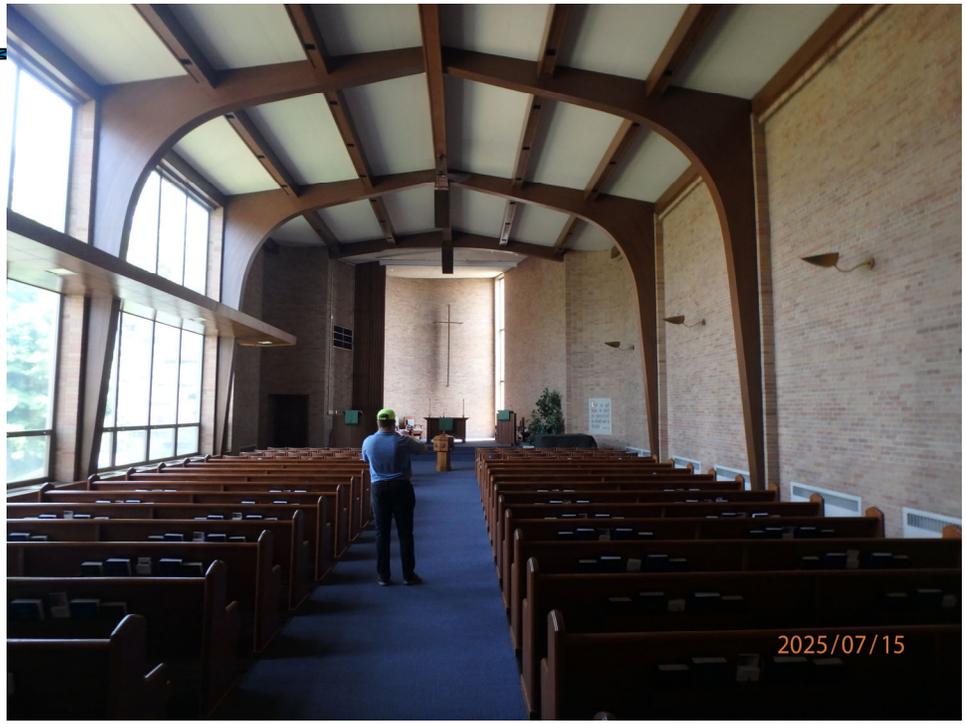
Photo 40:

Stains on east end of chapel ceiling.

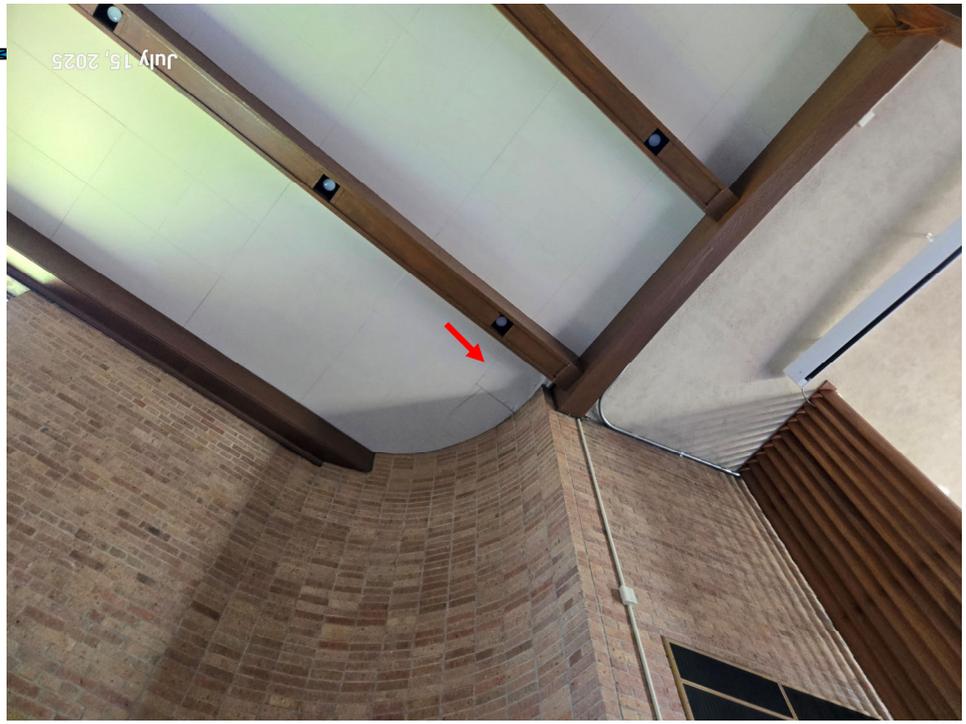
Photo 41:

Description:
Warped ceiling tile.

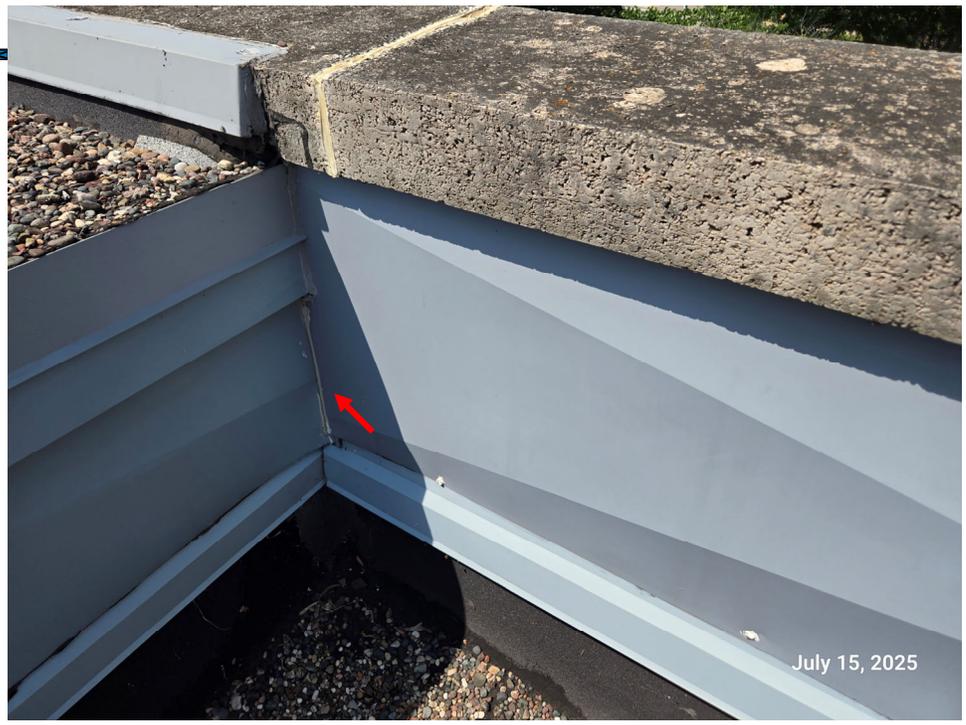
Photo 42:

Location:
Main Roof Section
Southwest Corner

Description:
Deformed flashing and failed flashing sealant.

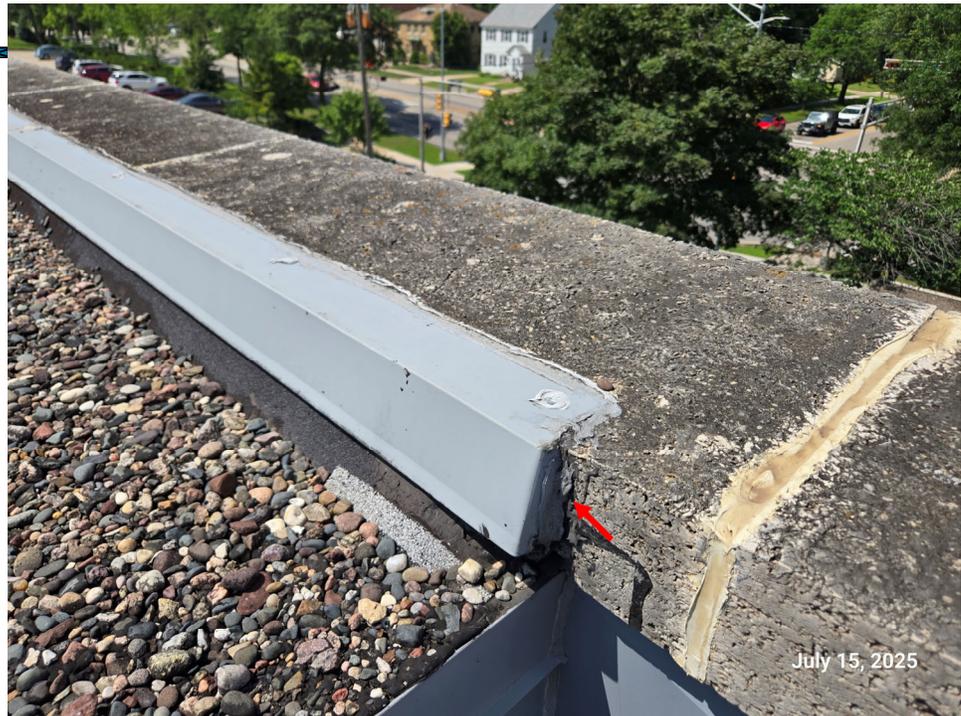
Photo 44:

Flashing detail installed on cap stone.

Note: Aged sealant.

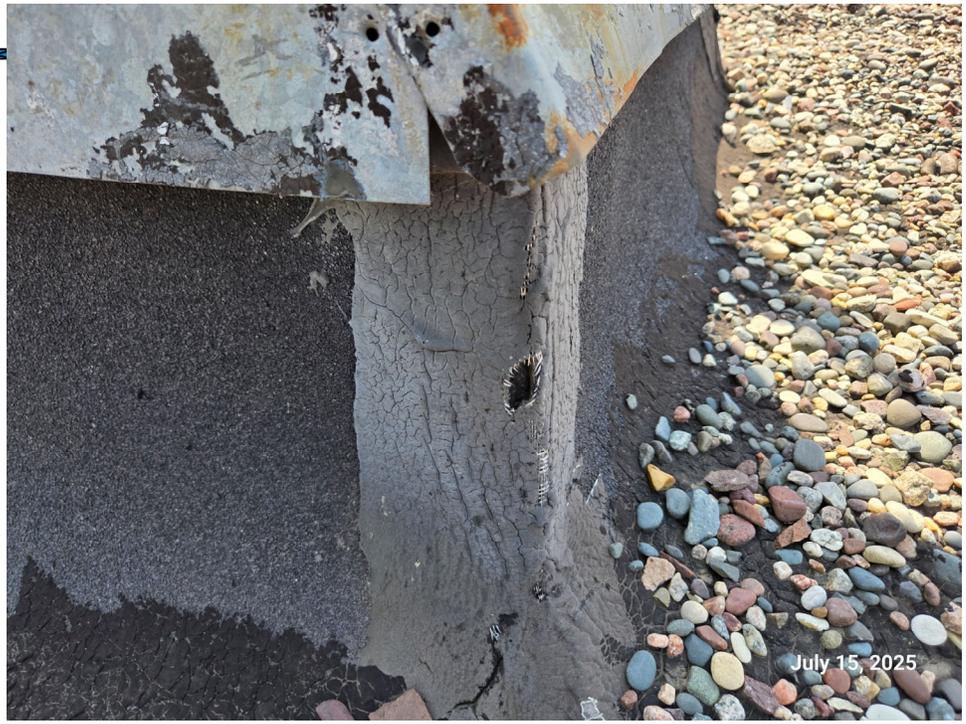
Closeup of area in previous photo.

Note: Fiberglass reinforcement mesh exposed.

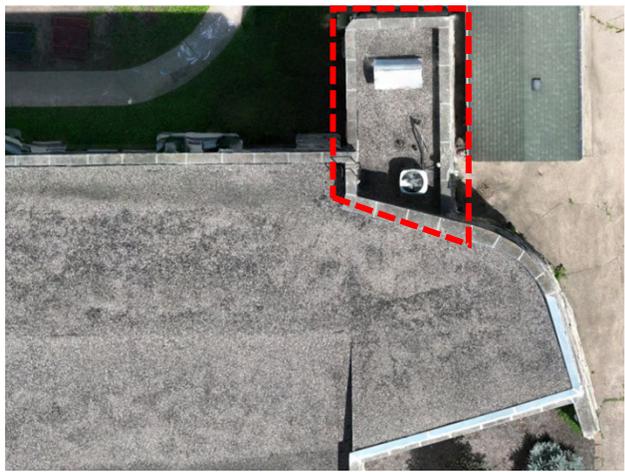
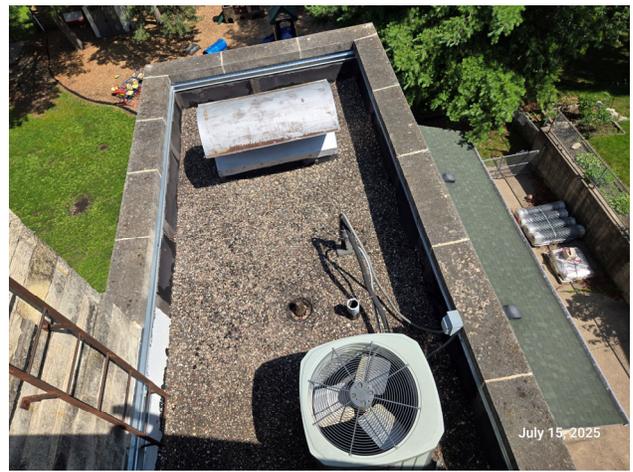
Photo 51:

Location: Lower Area North of East End Main Roof Section

Description: Roof Overview.

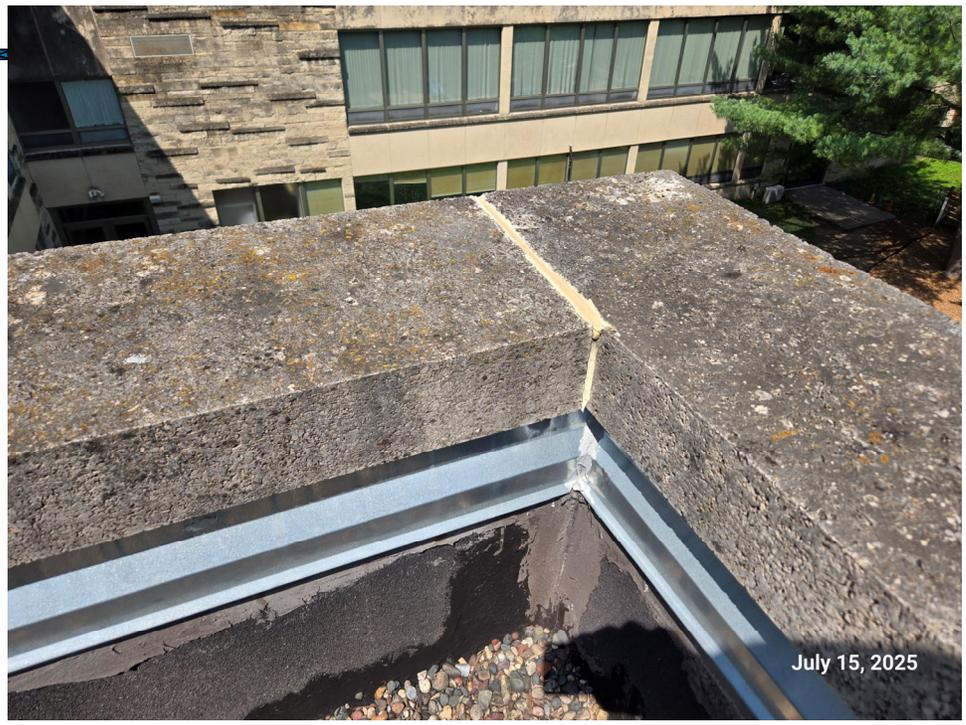
Description:
Typical condition of
parapet wall.

Note: Cracks and
fissures in parapet
flashing sheet sealant
with fiberglass
reinforcement mesh
exposed.

Note: Failed metal
flashing sealant.

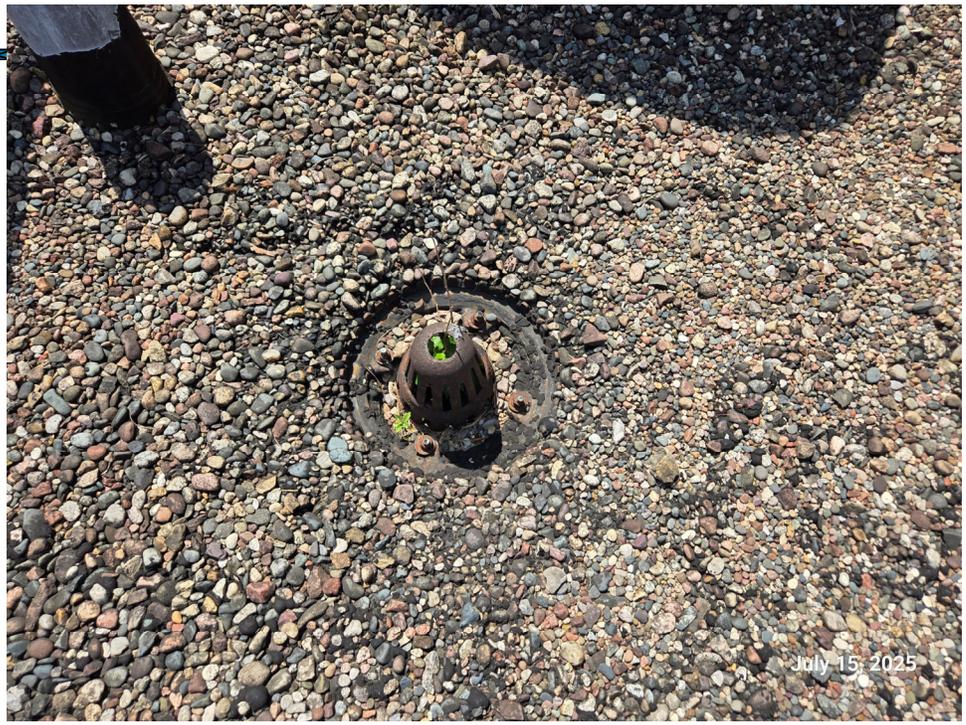
Photo 54:

North of the smaller east end area was a lower area accessible by ship ladder (photo 51). Organic growth was visible growing inside the internal roof drain. All other roof conditions were similar to all other roof sections.

Organic growth within internal drain.

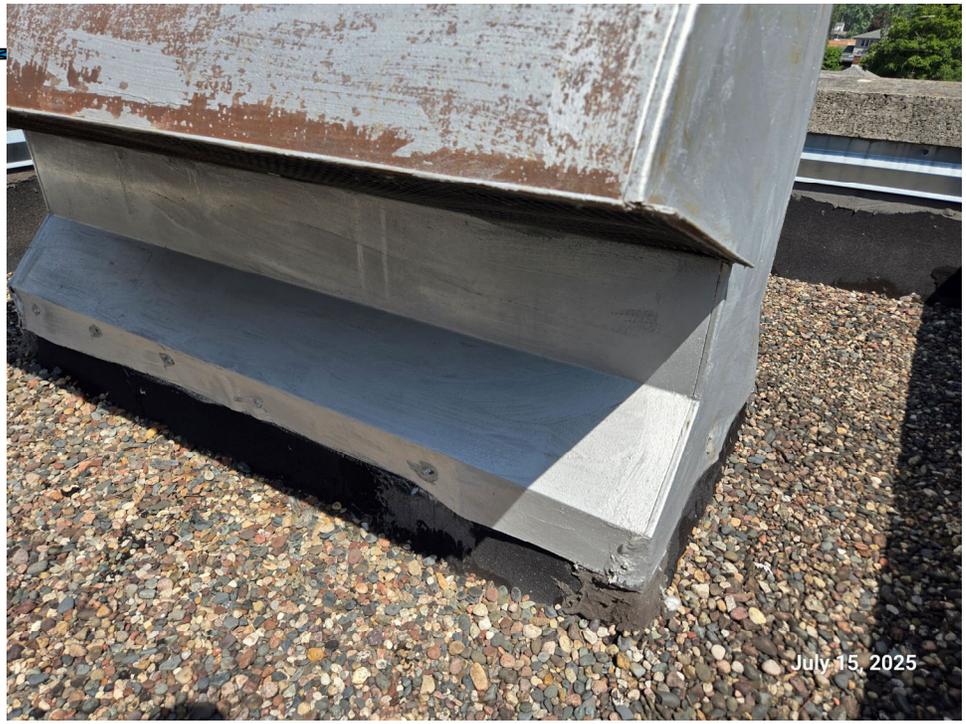
Photo 55:

Typical condition of flashing details for roof penetrations.

Note: Cracks and fissures in flashing sheets and sealant.

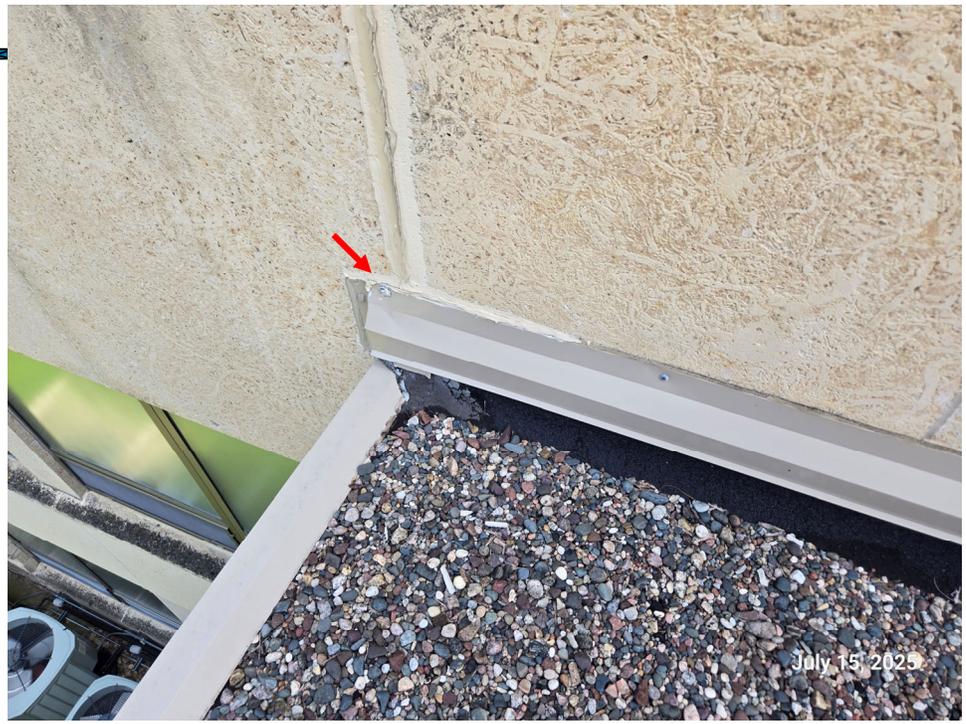
Photo 59:

Description:
Roof-wall transition
detail.

Note: Cracked sealant.

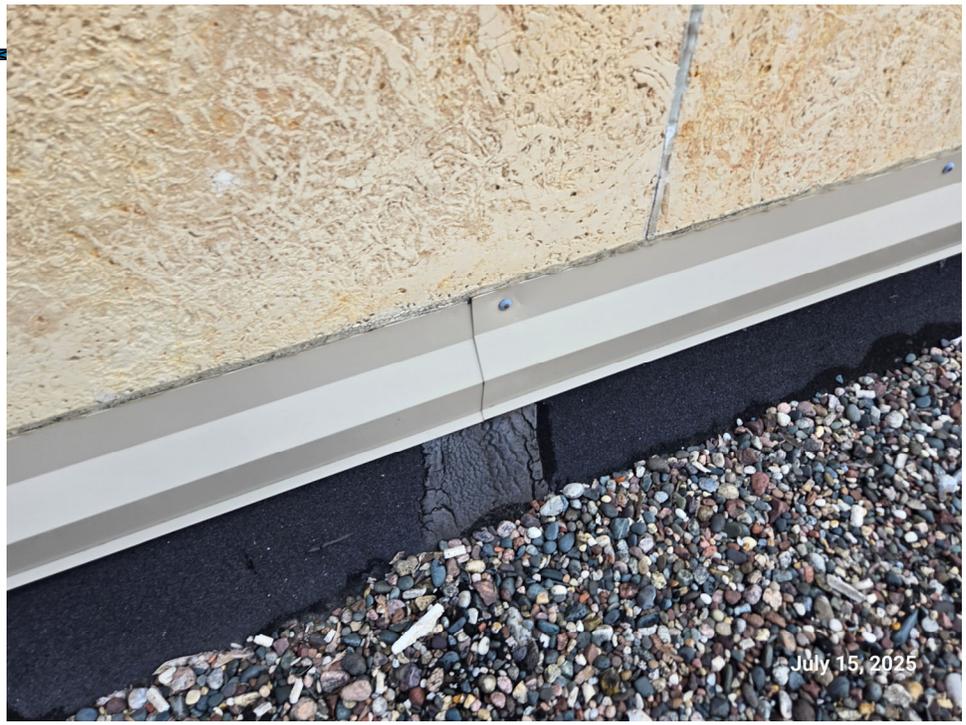
Photo 60:

Description:
Typical condition of roof-
wall transition detail.

Note: Aged flashing
sealant as well as cracks
and fissure in wall
flashing sheet sealant.

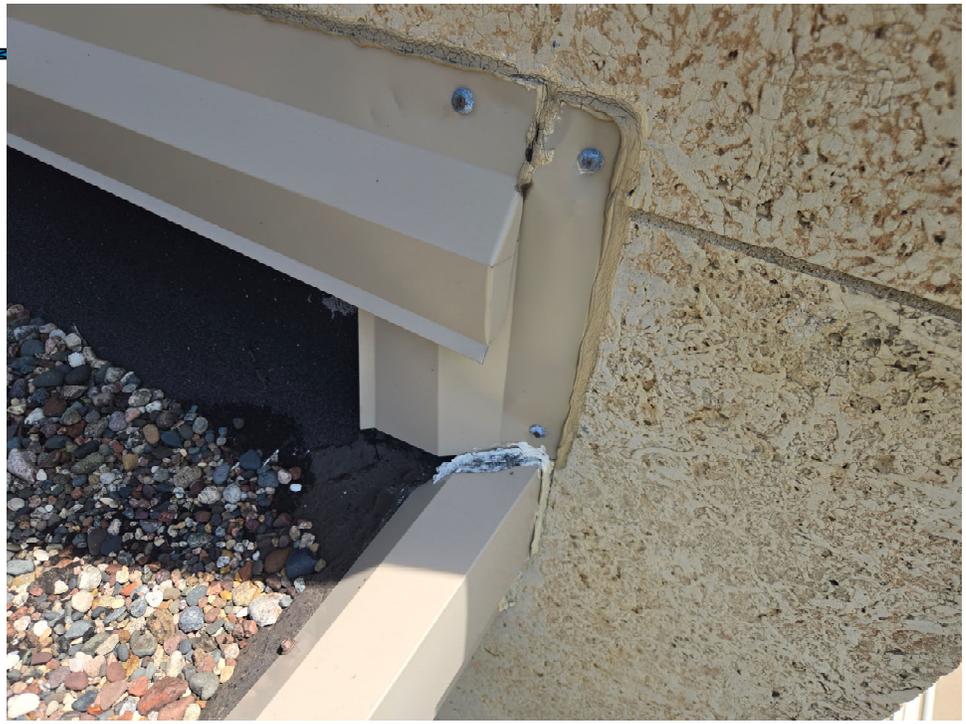
Photo 61:

Southeast corner flashing detail.

Note: Aged sealant.

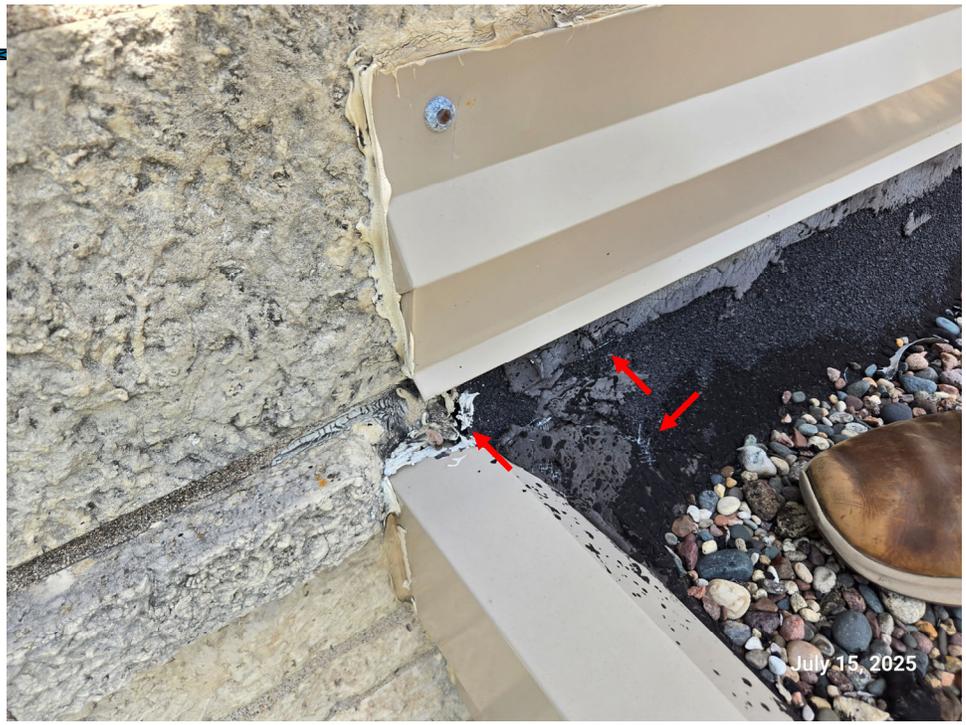
Photo 62:

An extension ladder was required to access the lower-level. The lower-level section did not contain a parapet wall, rather, edge metal was installed around the perimeters. Flashing sheets were sloped up beneath the edge metal and had cracks and fissures in the sheets as well as its sealant as well as exposed reinforcement mesh in some areas (photos 62, 63). Upon request by Mark, BEC removed debris from the internal roof drain (photo 67).

Northwest corner flashing detail.

Note: Fiberglass reinforcement mesh exposed and failed sealant.
