BECTEST

Property Condition Assessment For:

First Congregational Church of Christ

RE: Property Condition Assessment (PCA) For:
2503 Main Street, La Crosse, WI 54601

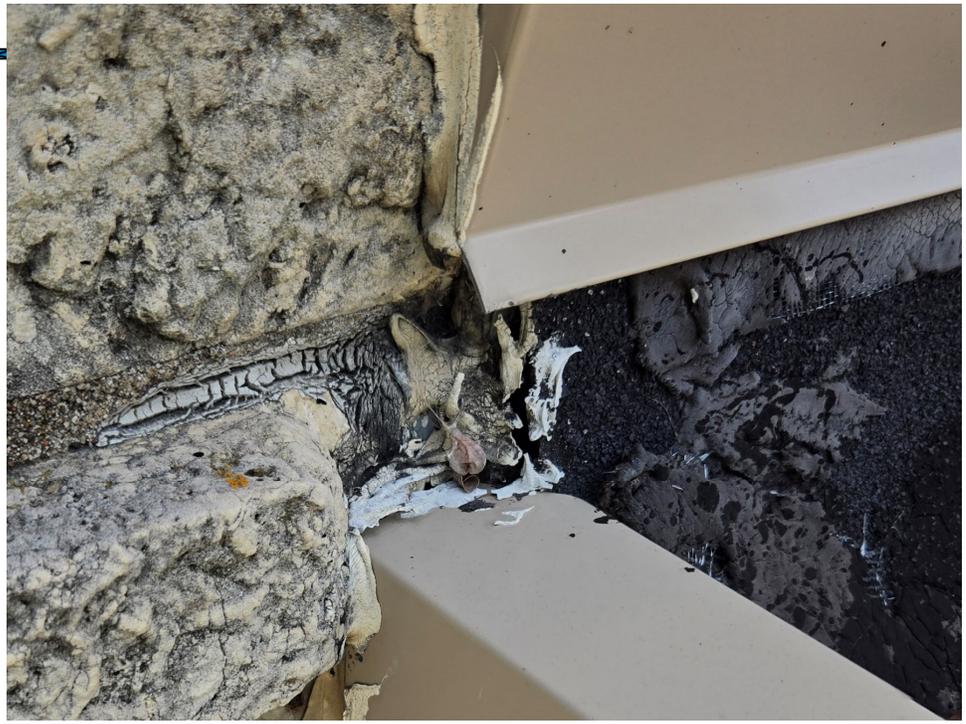
Photo 63:

Closeup of failed sealant in previous photo.

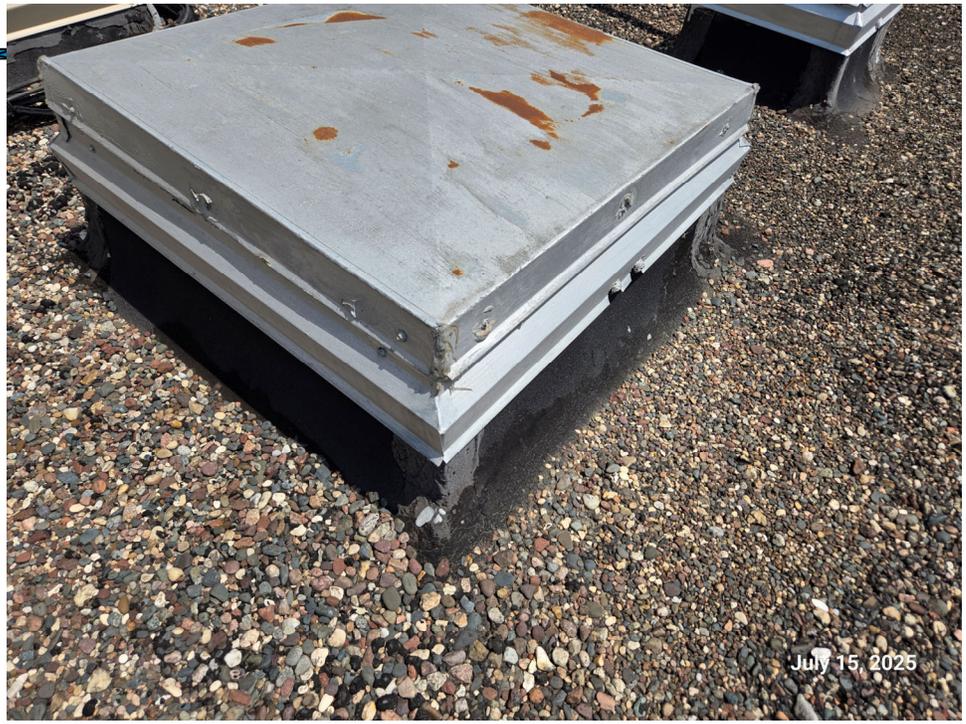
Description:
Typical condition of flashing details for roof penetrations.

Note: Cracks and fissures in flashing sheets and sealant.

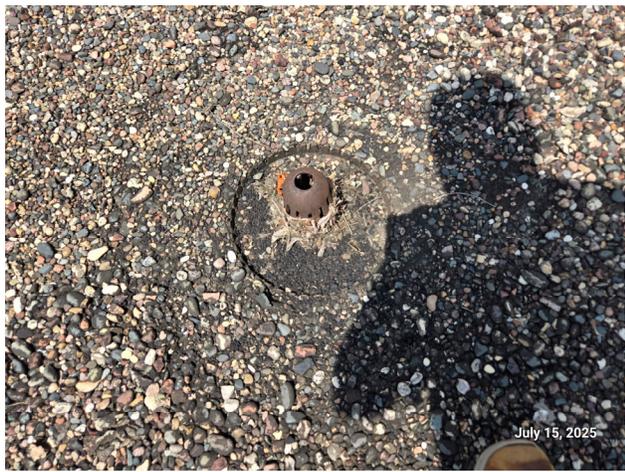
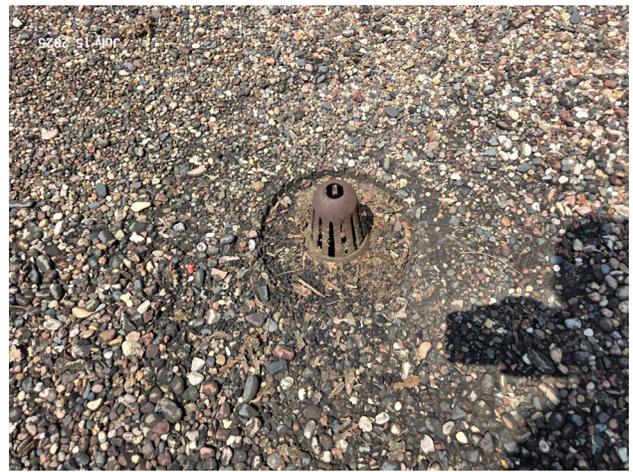
Photo 67:

Location: West Roof Section – Center of Roof

Description: Debris removed from internal drain cover.

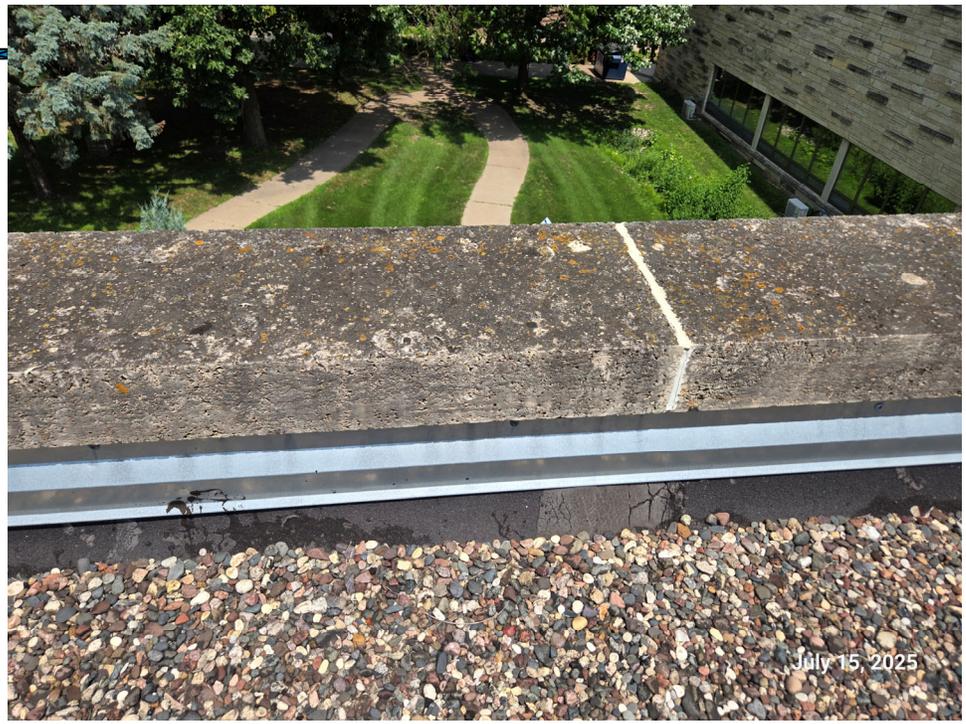
Photo 69:

Description:
Typical condition of
parapet wall.

Note: Cracks and
fissures in parapet
flashing sheet sealant.

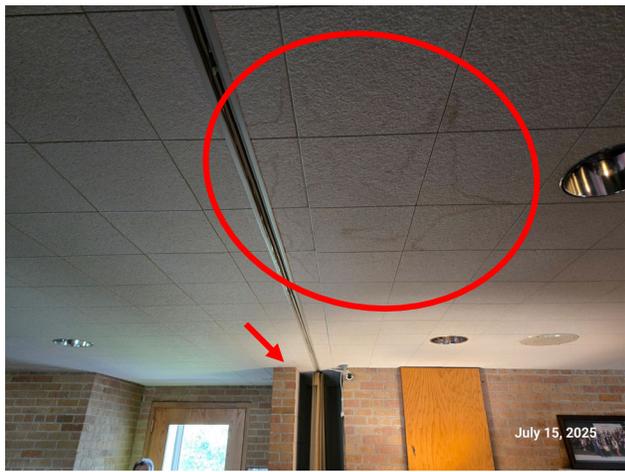
Photo 1:

Location: Main West Wall

Description: Stain on ceiling west of main entrance.

Note: Approximate location of main west wall from interior (arrow). Approximate location of stain from aerial overview (circle).

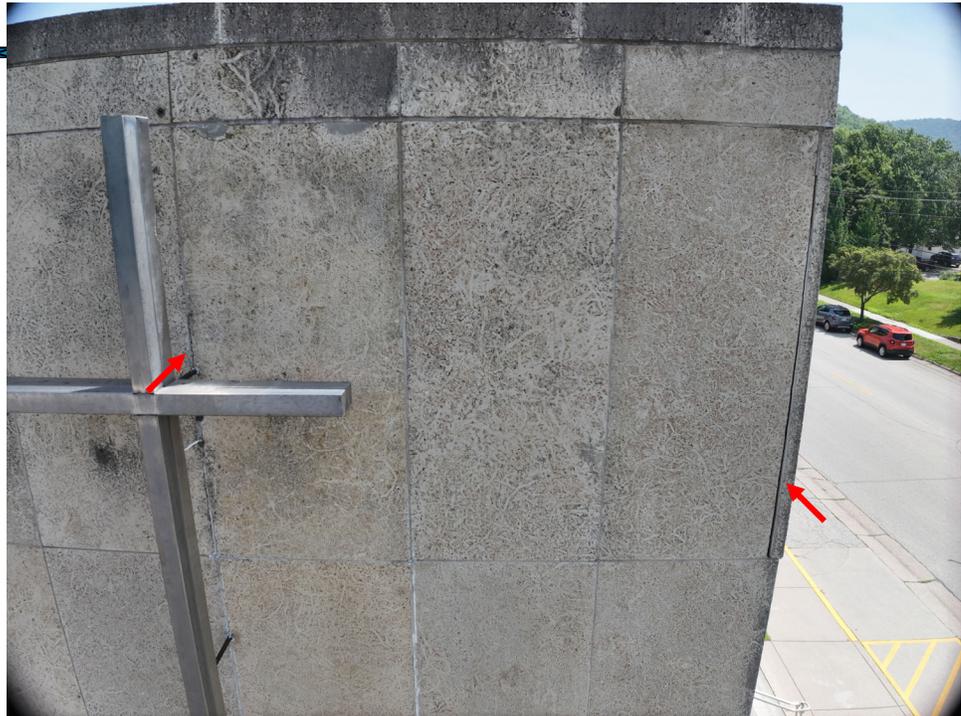
Photo 4:

1. The leak in the welcome/lounge area hallway was due to failed mortar joints in the panels on the west wall above the west section (photos 1-3, 5-7). Although a direct source was not discovered, voids in the failed mortar joints were discovered. The out of plane panel may have contributed to the water ingress as well.
2. Spalled stones and panels do not pose an immediate threat of water intrusion, but erosion or additional spalling will continue over its lifetime.
3. Spray foam penetrations can be a cause for future unwanted water entry as prolonged exposure to UV rays and moisture causes degradation over time.

Examples of failed mortar joints.

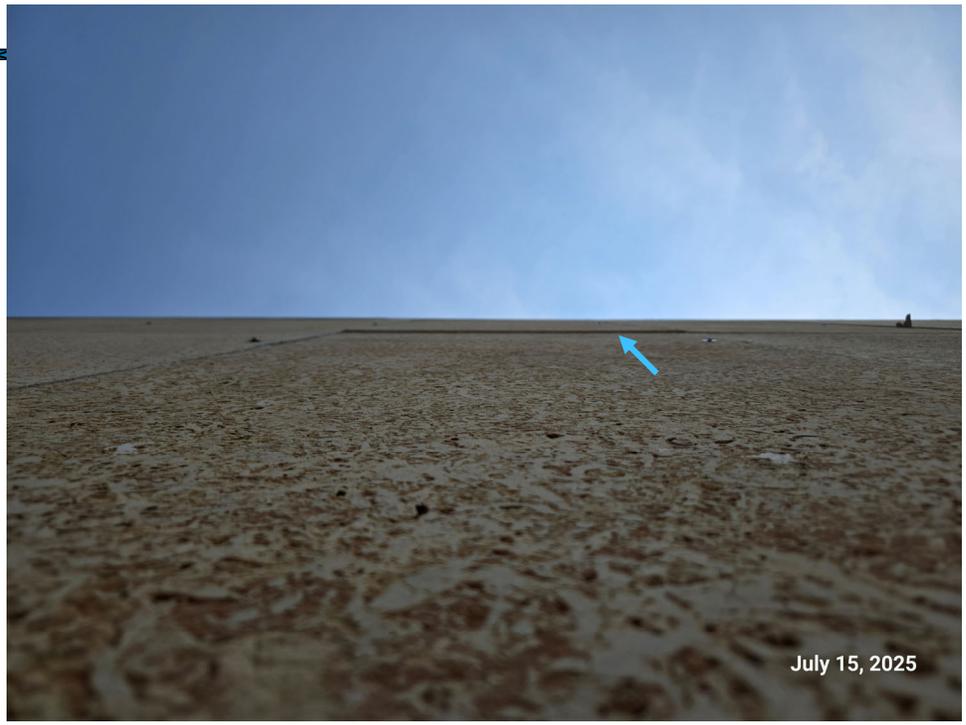
Photo 6:

Description:
Upper panel out of plane.

1. Remove and replace failed sealant around windows, metal flashing details and between coping stones. Work should be completed by a qualified professional.
2. Reposition and secure the four panels that were discovered out of plane. Work should be completed by a qualified professional. Ensure no materials behind the panels are compromised from moisture before repositioning and securement.
3. Fill spalling in the stones and panels to minimize risk of water intrusion or monitor to ensure spalling does not worsen. Work should be completed by a qualified professional.
4. Spray foam areas should be replaced with more permanent repairs such as mortar or sealant with a backer. Work should be completed by a qualified professional.
5. Wall cladding on all elevations should be tuck pointed on and around the indicated areas in the following photo report by a qualified contractor.

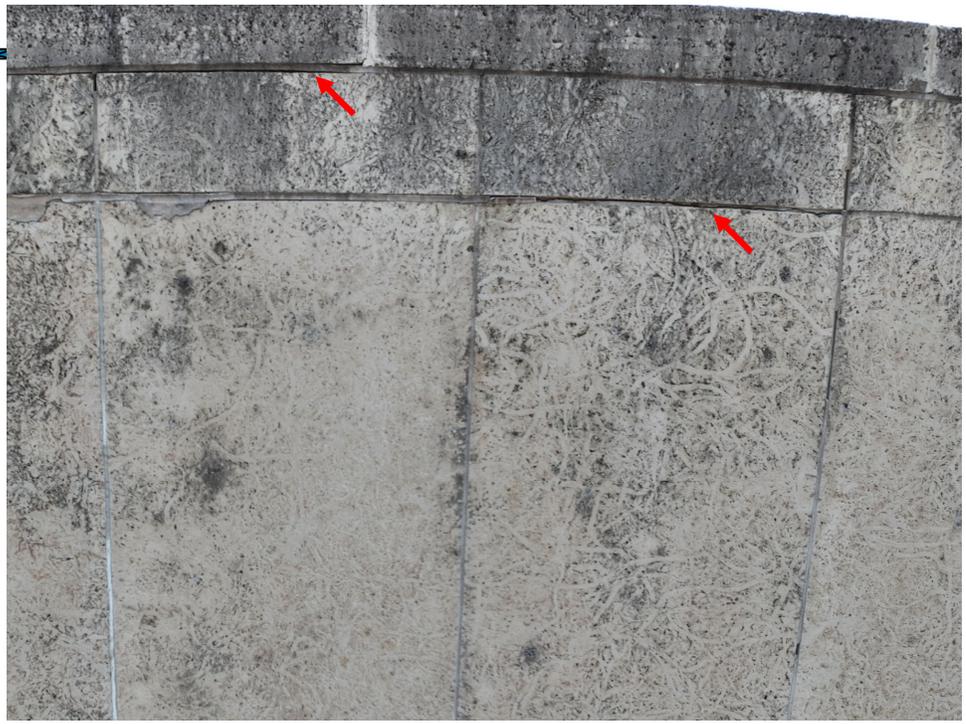
Photo 7:

Closeup of other failed mortar joint examples.

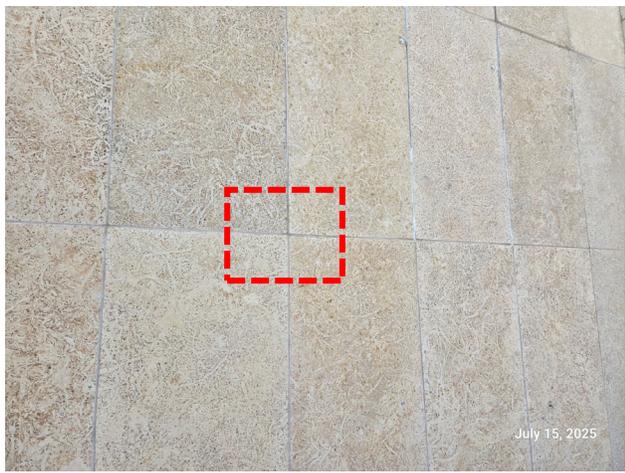
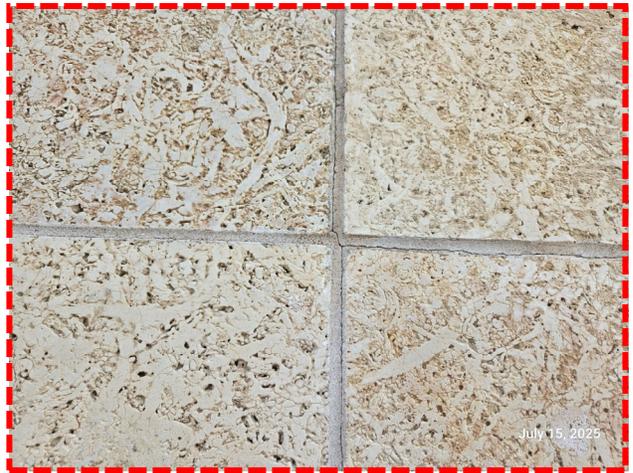
Photo 8:

Location: West Elevation – Above West Roof Section

Description: Additional example of failed mortar joints.

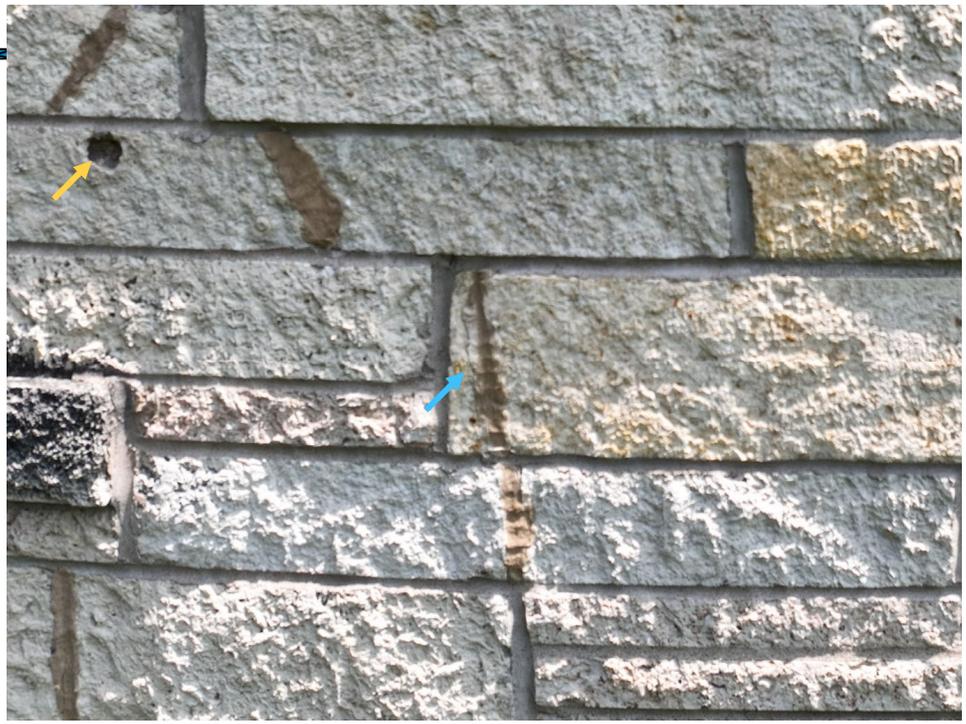
Photo 16:

Closeup of failed mortar joint in prior photo.

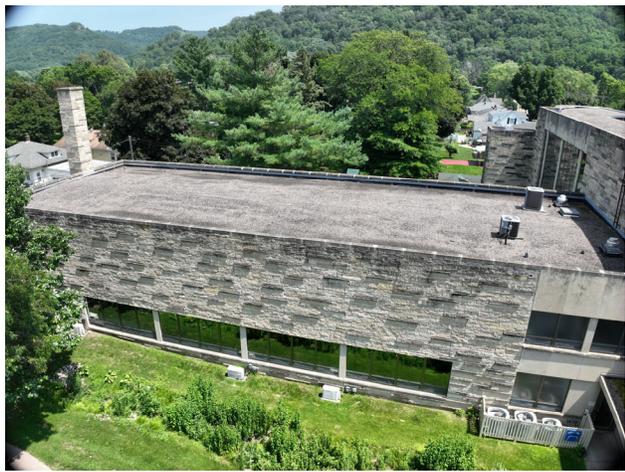
Photo 17:

Location: North Section – West Elevation

Description: Additional example of fractured mortar.

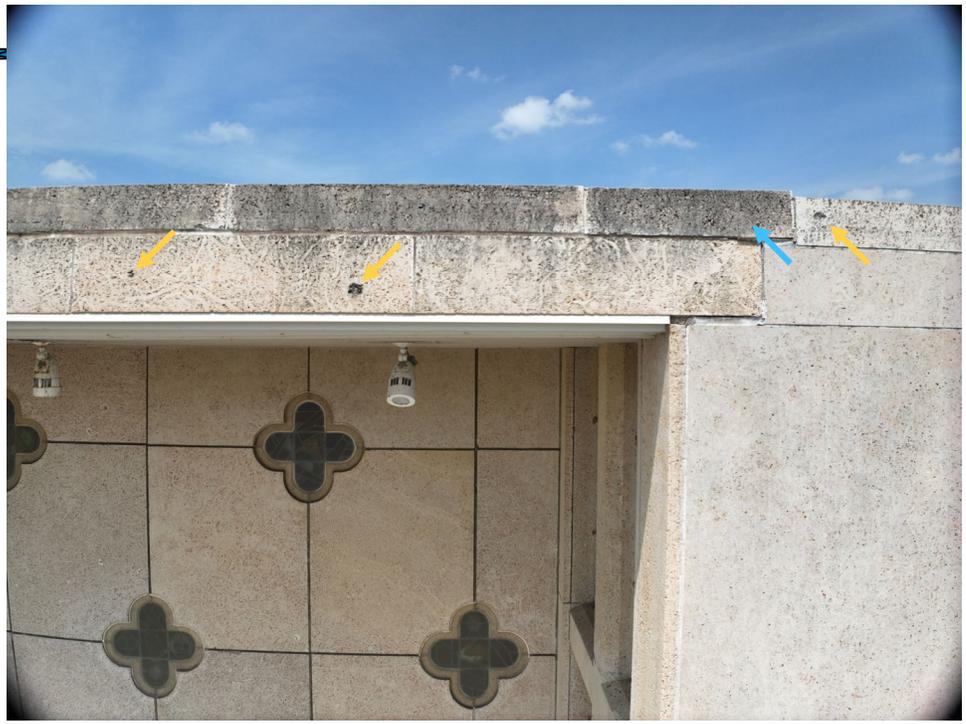
Photo 42:

Description:

Example of failed mortar joints.

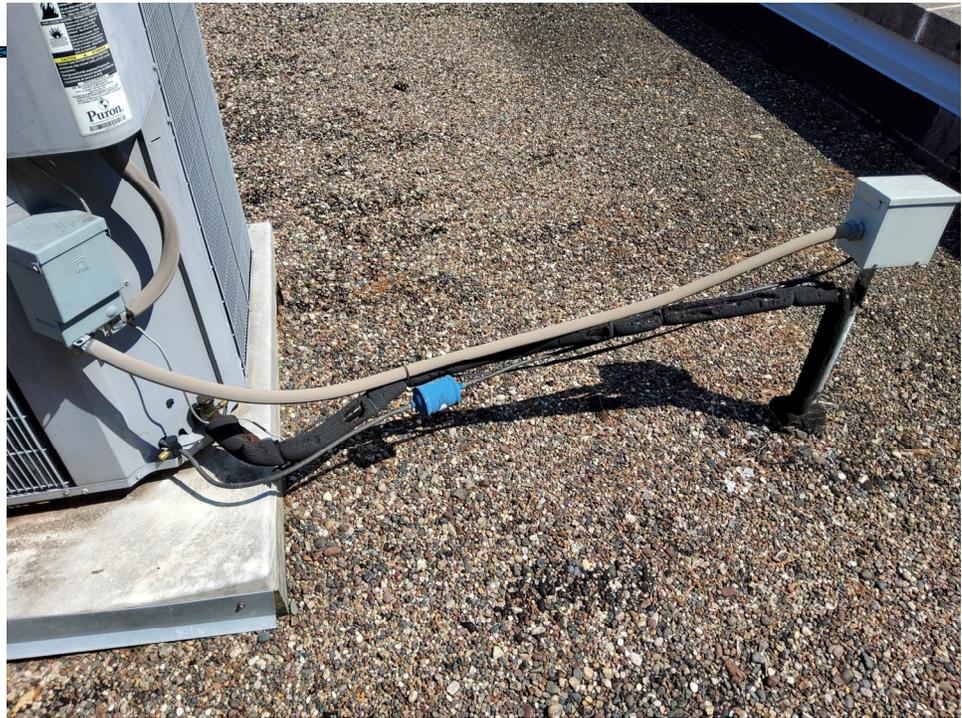
Condition of piping and conduit.

Note: Deteriorated pipe insulation.

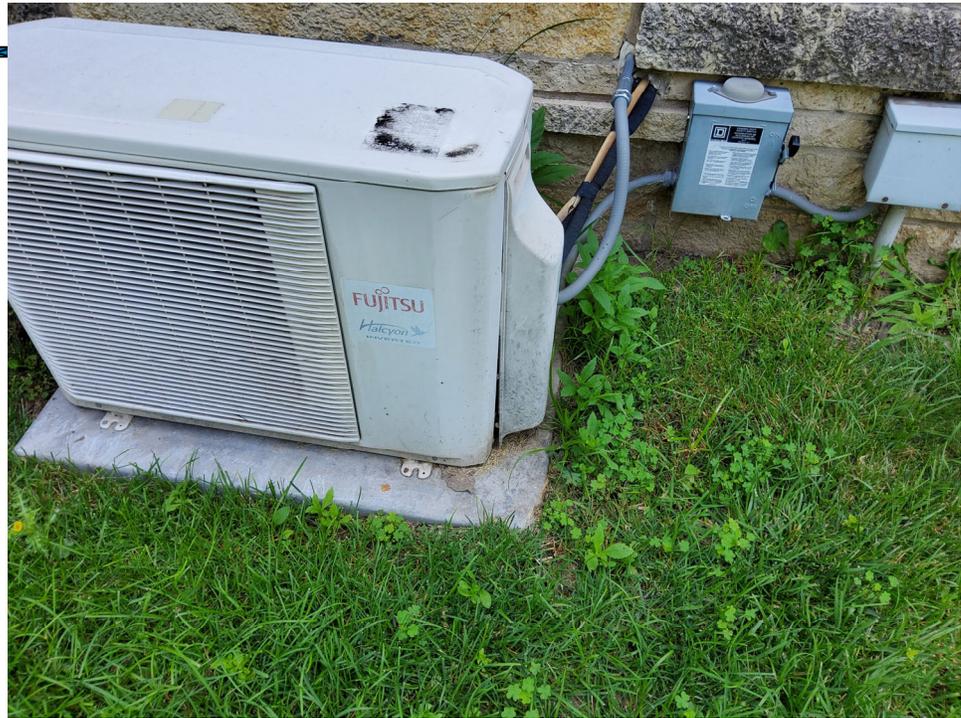
Fujitsu split system A/C condenser, model AOU9CQ, estimated age 19 years.

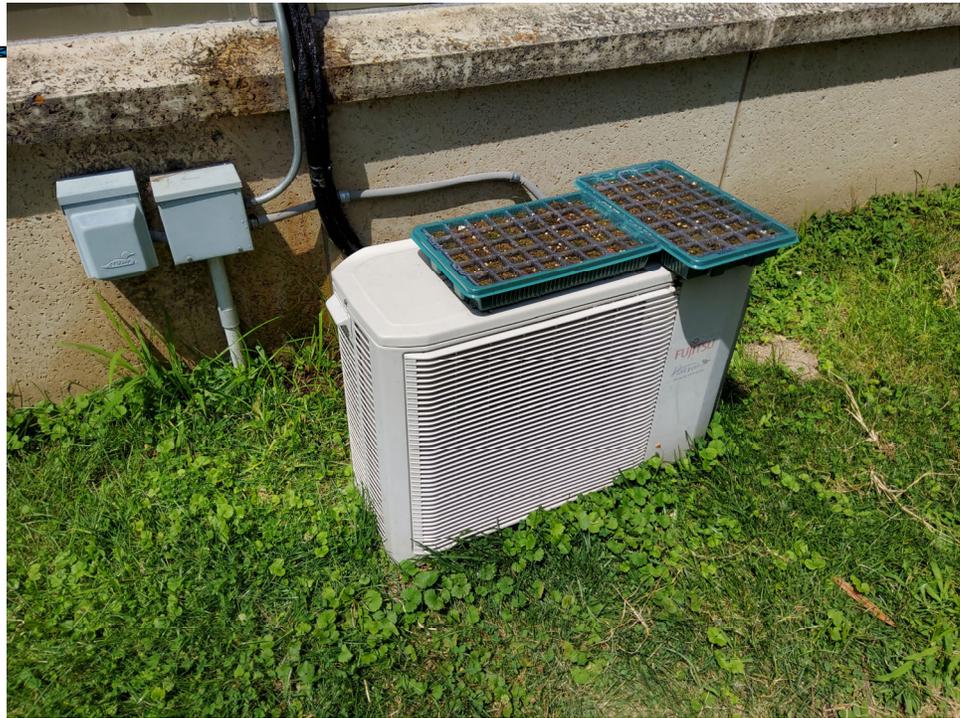
Fujitsu split system A/C condenser, model AOU240L, estimated age 19 years.

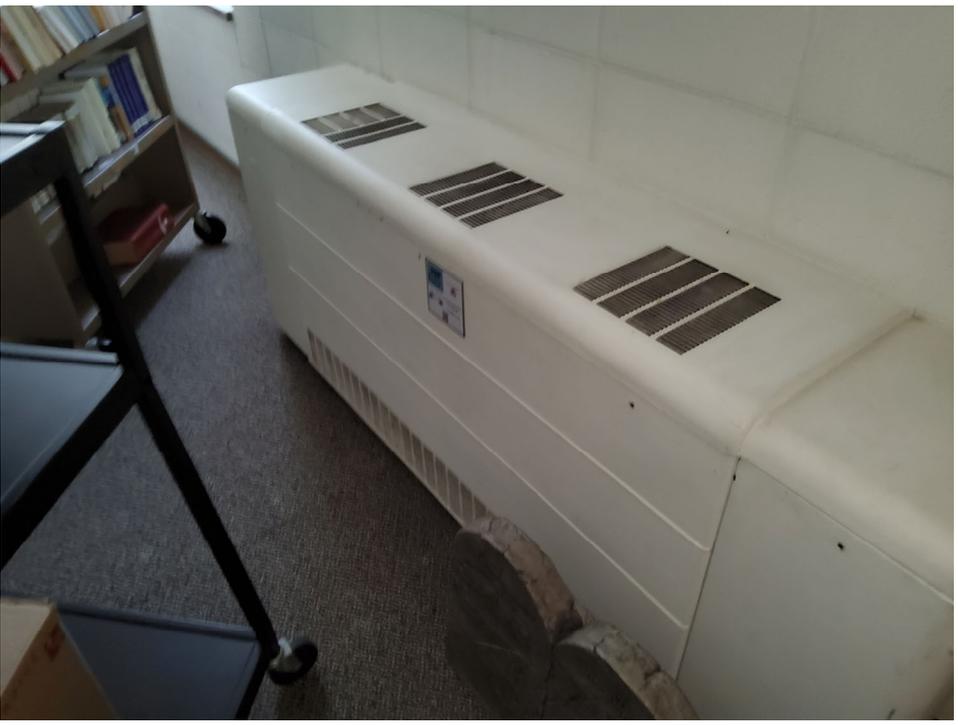
Photo 49:

Another HVAC terminal unit.

Note: Exposed wiring.

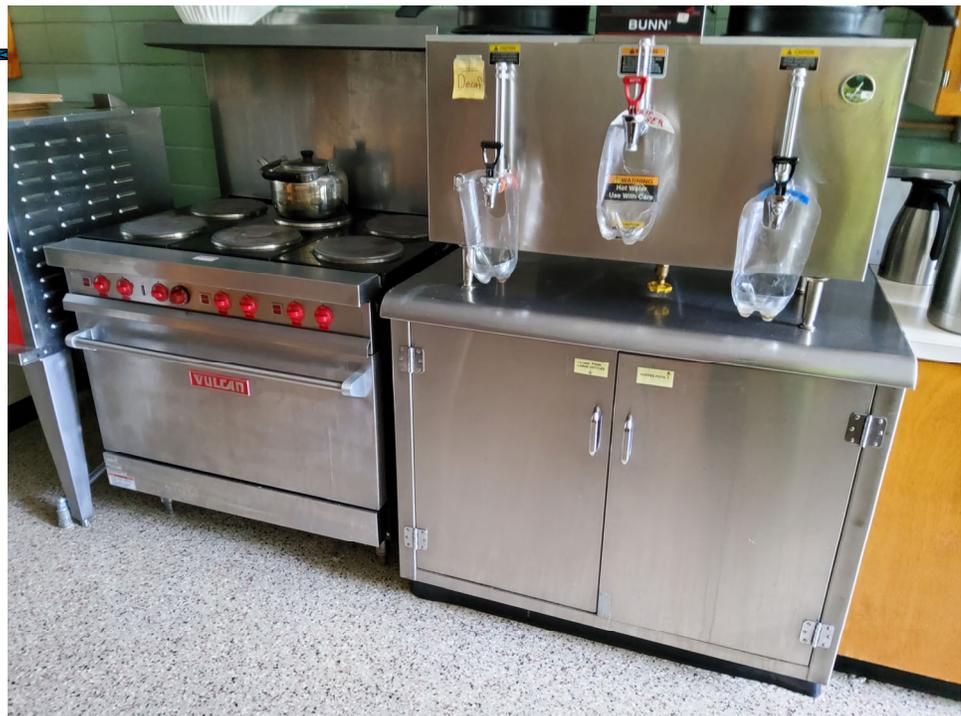
Vulcan electric range and Bunn beverage unit.

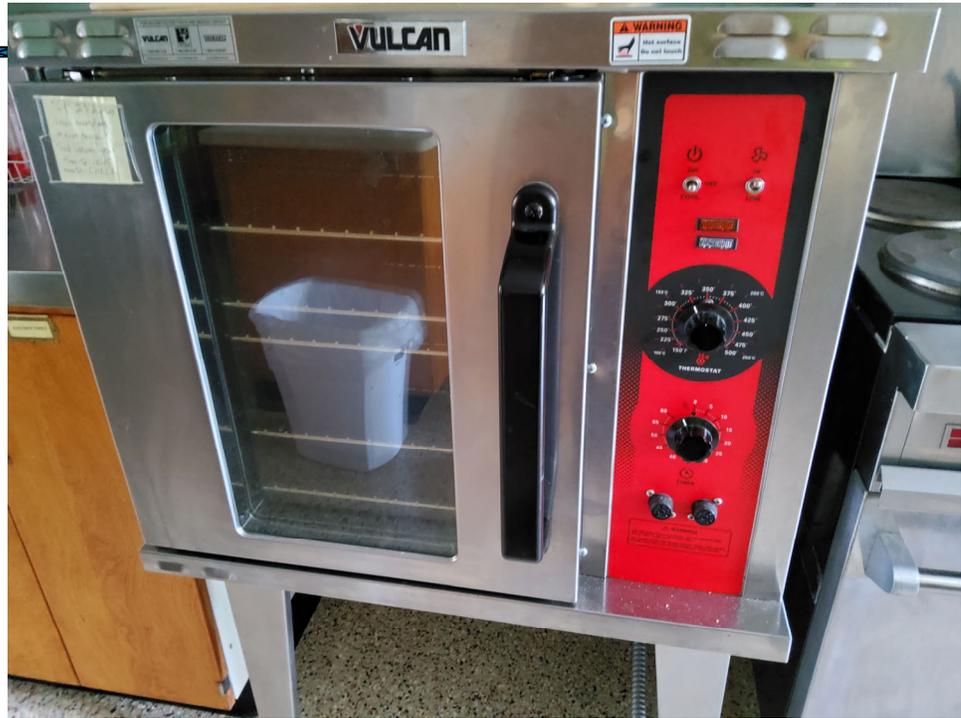
Photo 63:

Description:
Vulcan electric
convection oven.

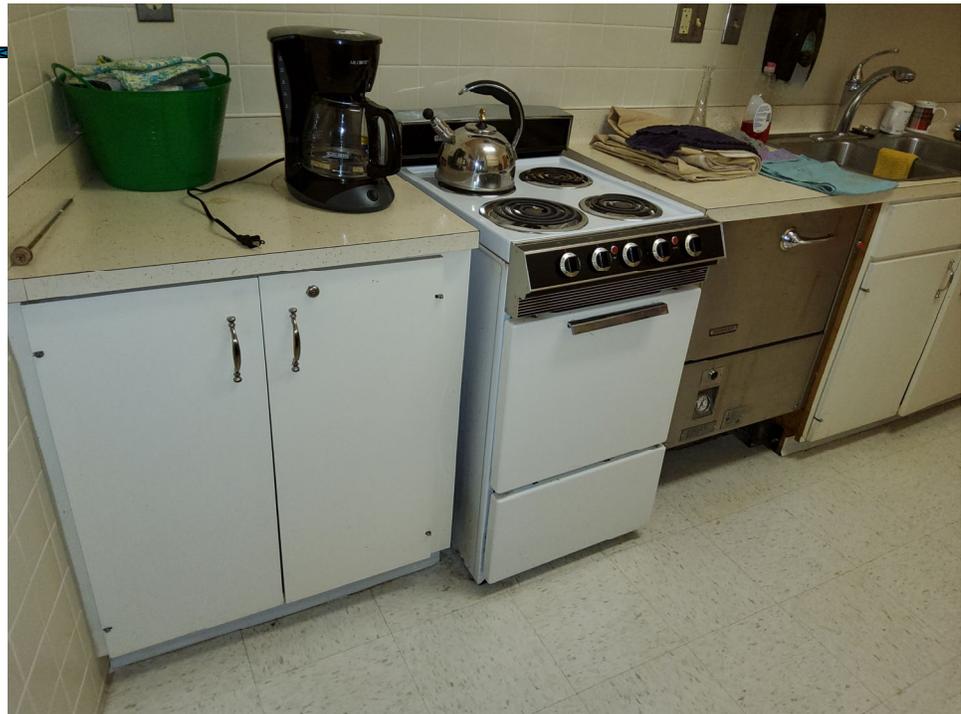
Photo 64:

Description:
Electric range and
Hobart dishwasher.

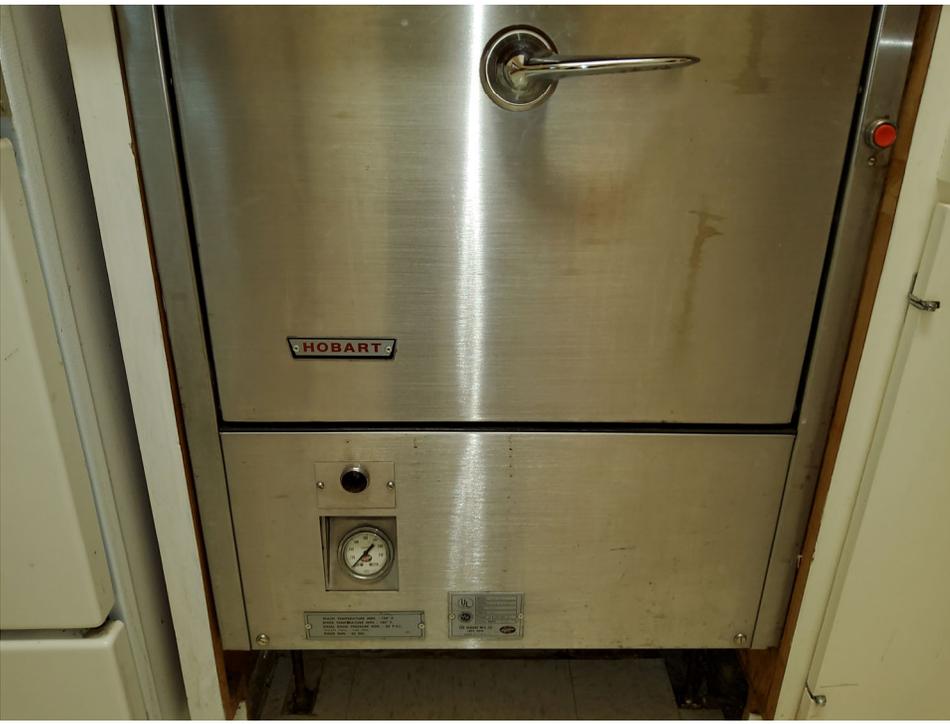
Photo 65:

Hobart dishwasher, model UM-4D, label indicated age 41 years.

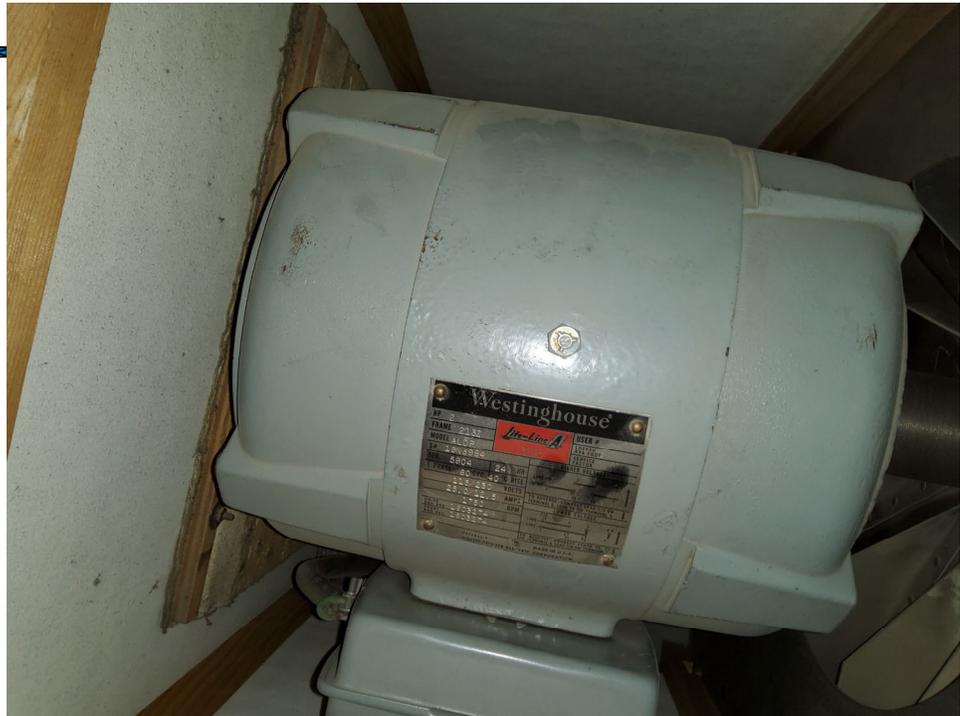
Photo 67:

Westinghouse blower motor for pipe organ, model ALDP, estimated age 70 years.

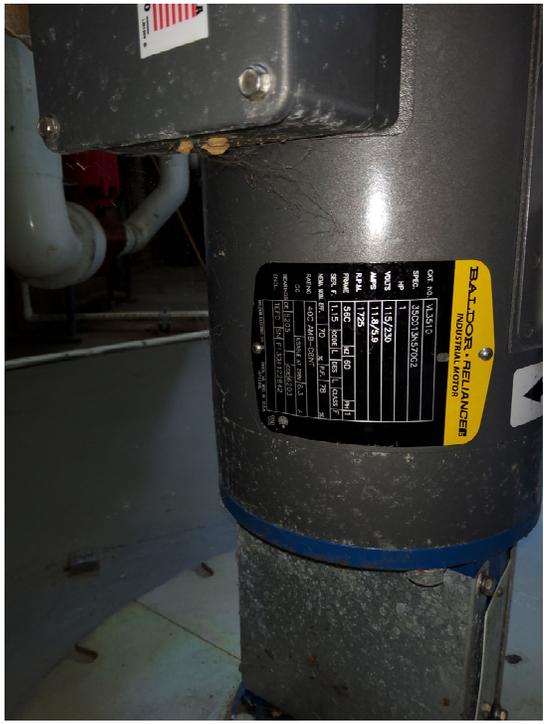
Photo 69:

Description:
Baldor sump pump motor, model VL3510, late model.

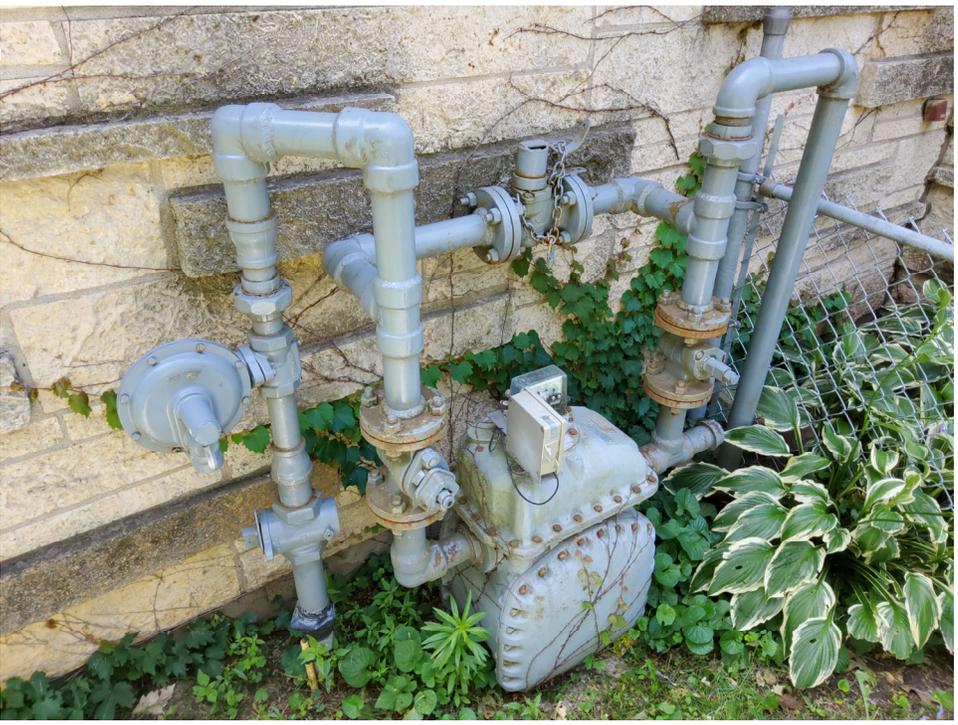
Photo 70:

Description:
Natural gas service entrance.

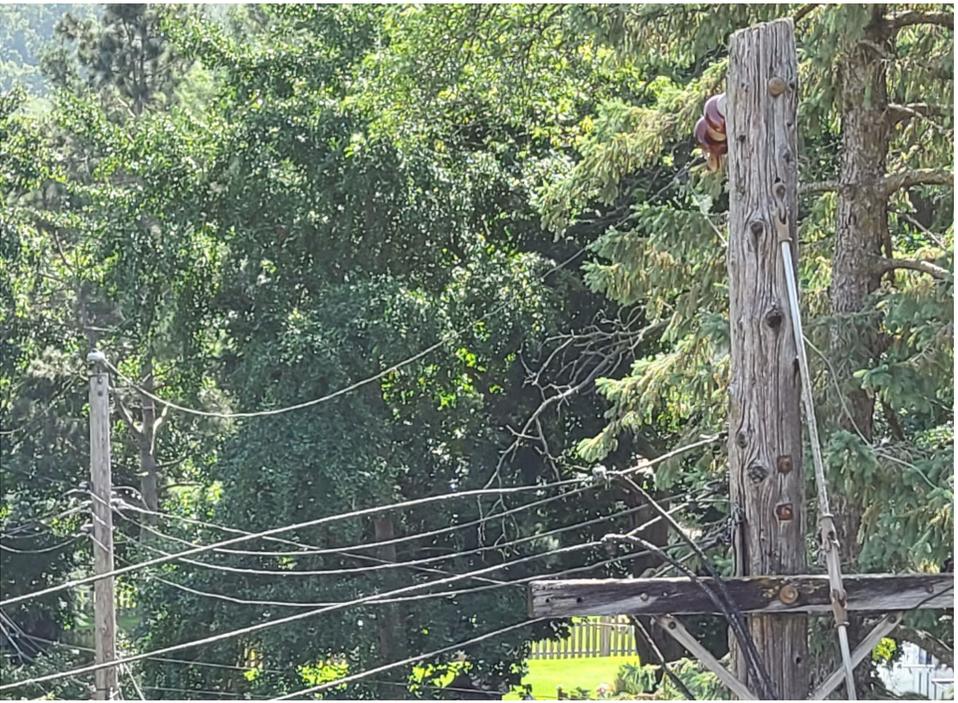
Photo 2:

Description:
Detail of single-phase primary supply wire.
Note: Aged condition of wire and pole, proximity to tree.

1. The tree in close proximity to the utility pole should be trimmed to prevent interference with wires and cables. The utility pole and primary supply wire are due for replacement/upgrade by the utility.
2. While presenting no safety concerns, the fused switch configuration in the upper hallway should be modernized to standard switches fed by a circuit breaker subpanel.
3. The outlet above the sanctuary roof may not comply with the National Electrical Code. Knowledge of the installation or destructive testing would be required for evaluation.

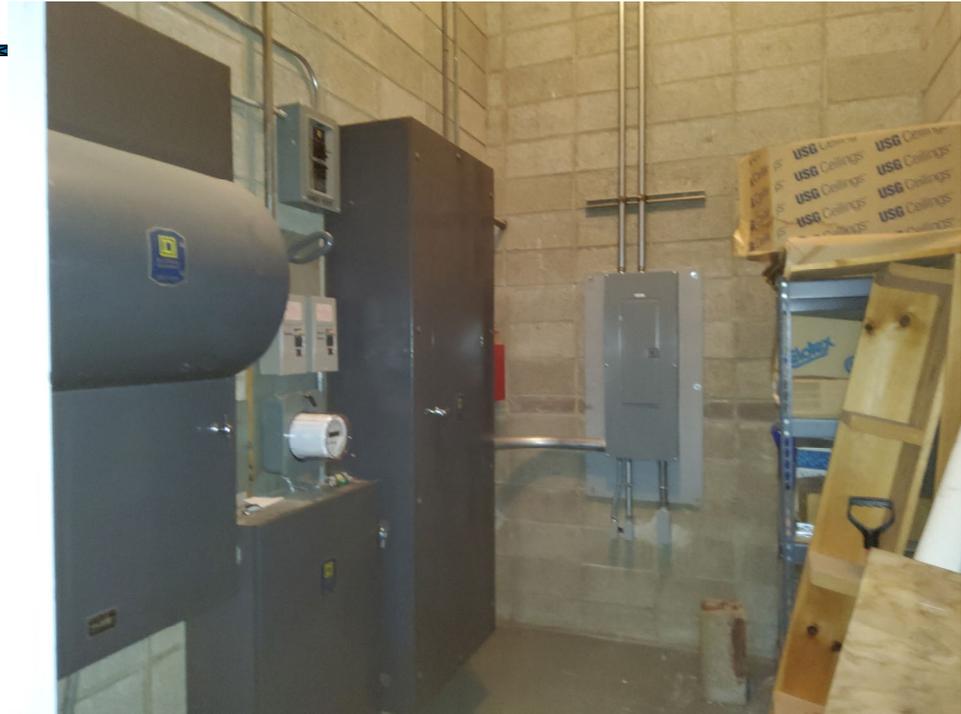
Photo 4:

Overview of main electrical service panels and disconnects.

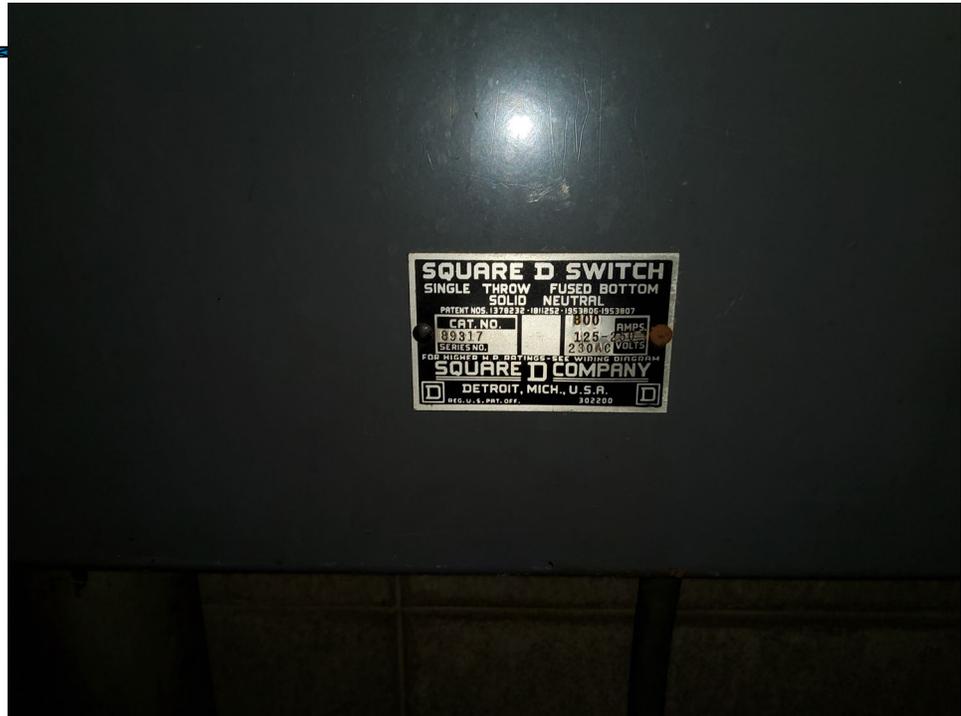
Photo 5:

Square D main disconnect switch, rated 800 Amps, estimated age 65 years.

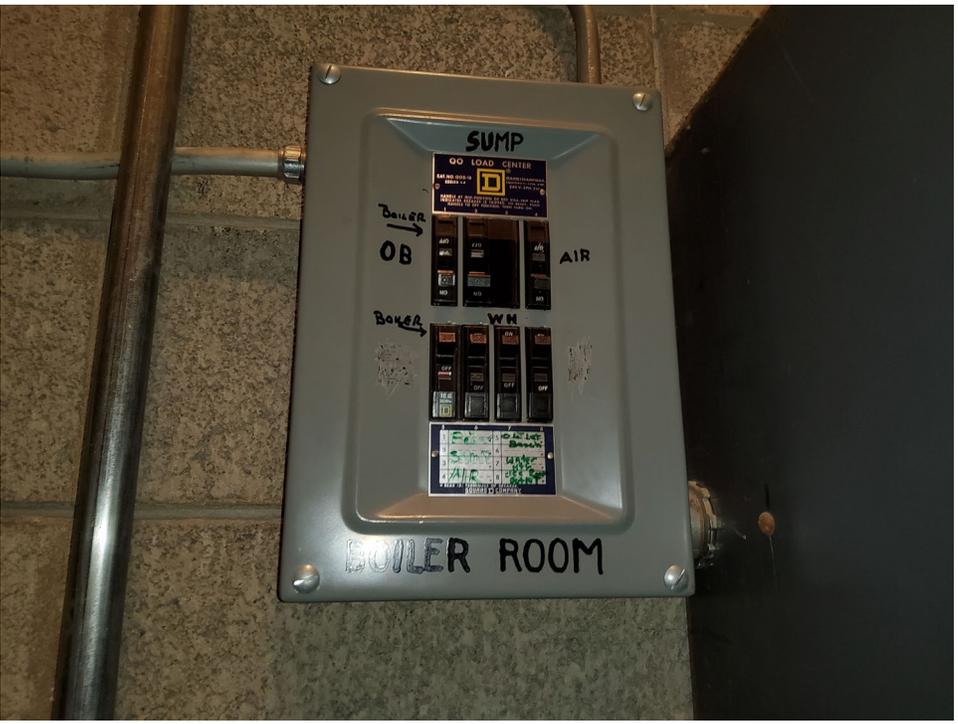
Photo 7:

Description:
Square D QO breaker panel, estimated age 50 years.

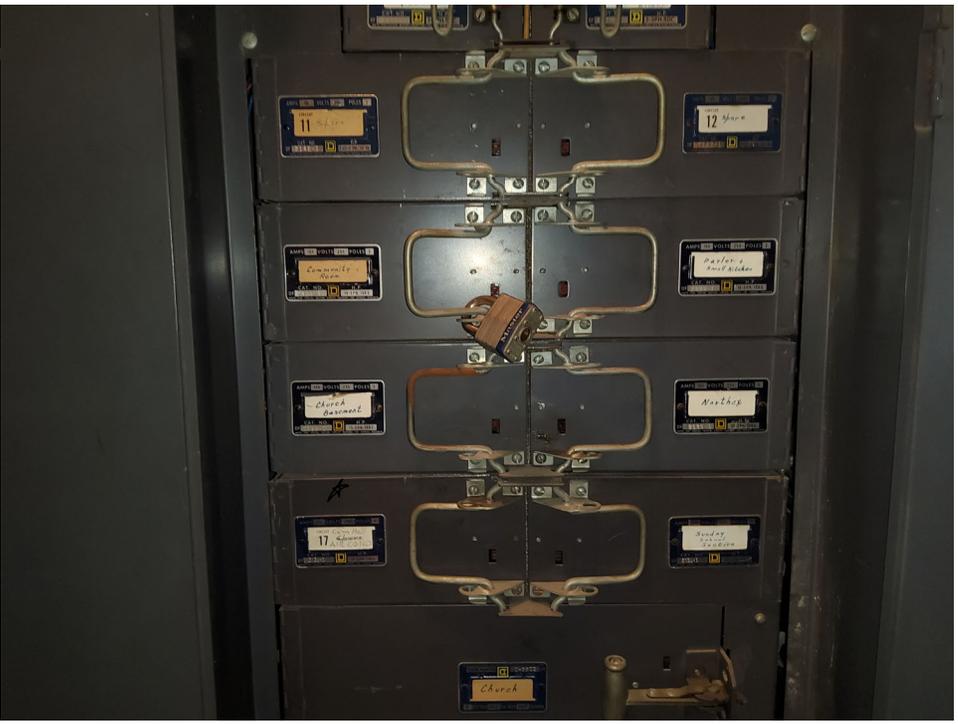
Photo 9:

Description:
Square D main panel board, middle section.

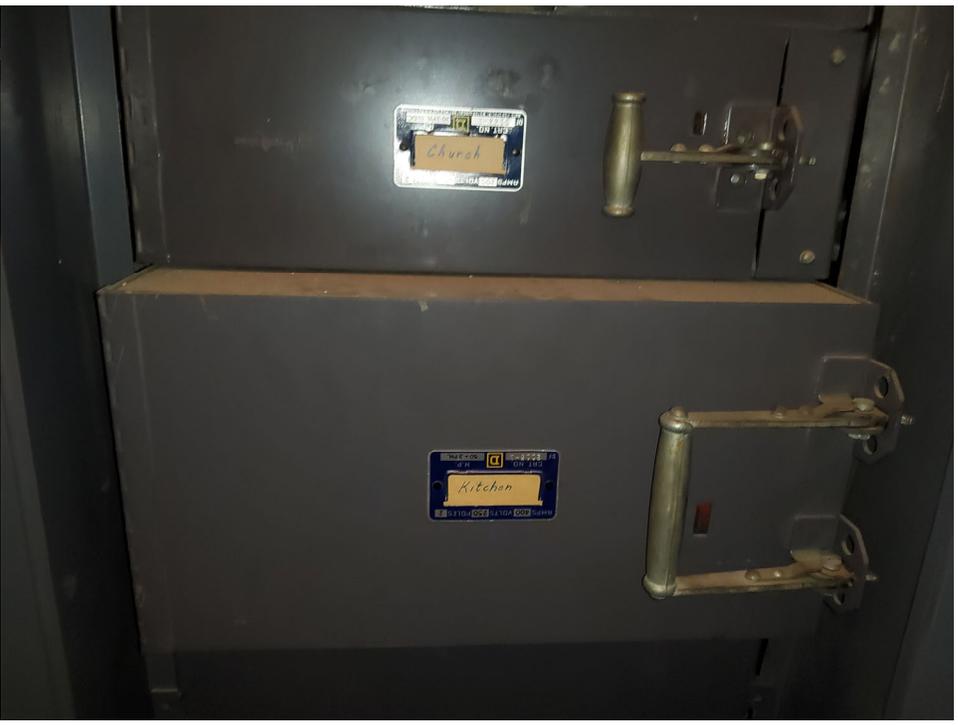
Photo 10:

Description:
Square D main panel board, lower section.

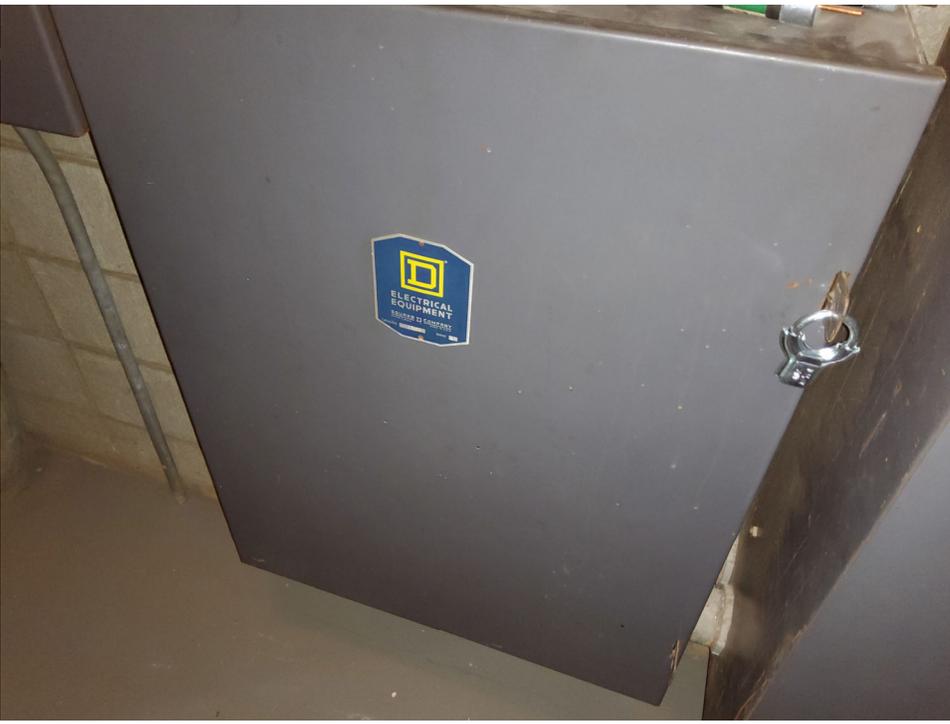
Photo 11:

Description:
 Square D accessory panel.

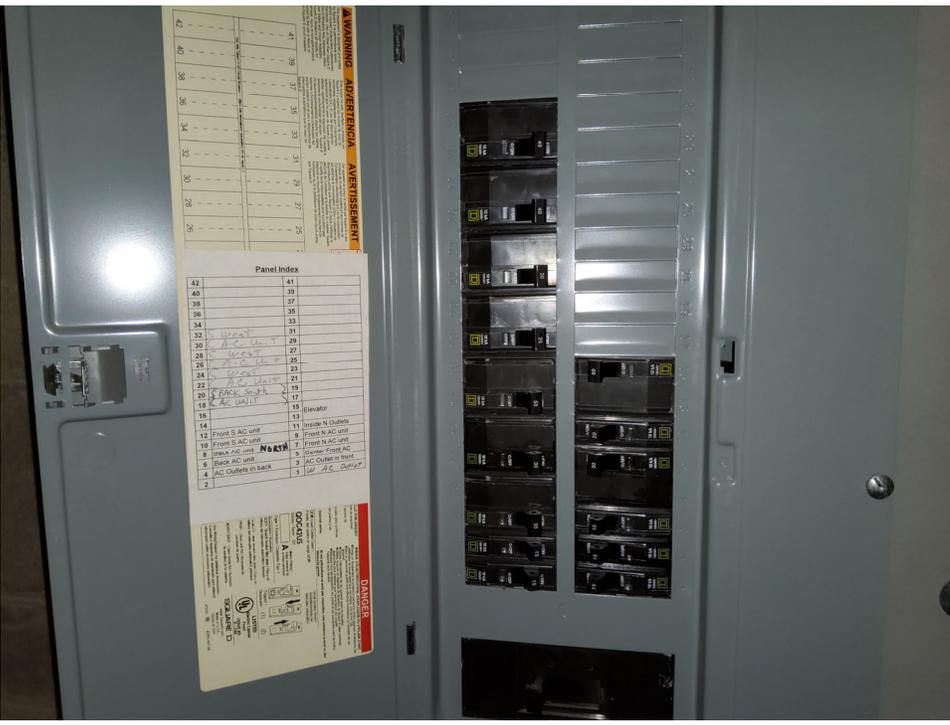
Photo 12:

Description:
 Square D QO breaker panel, late model.

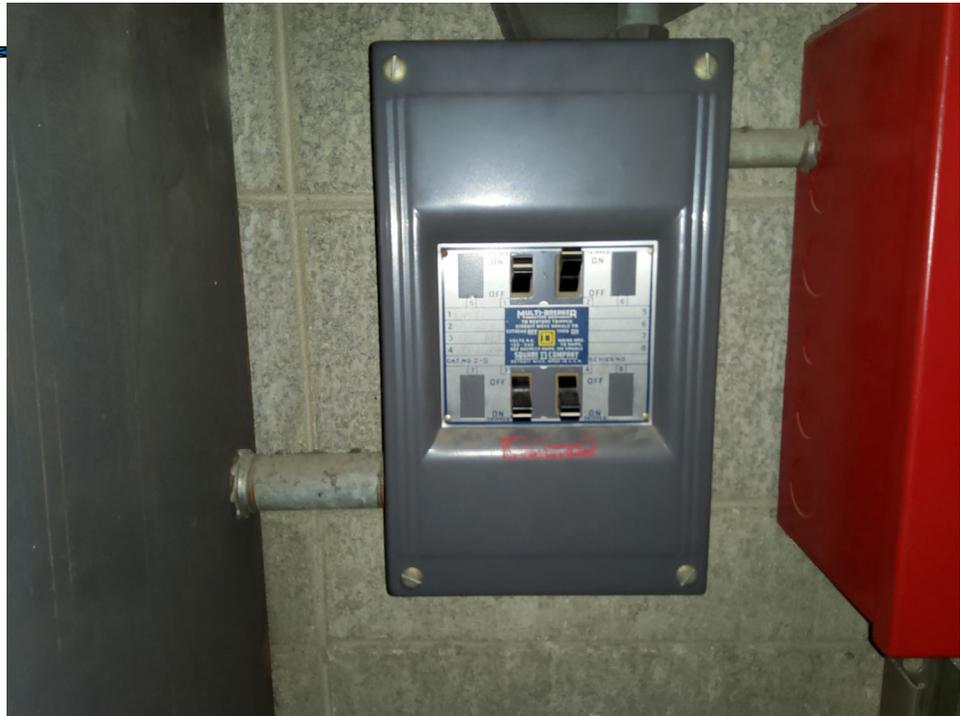
Photo 13:

Square D "Multi-Breaker"
panel, estimated age 65
years.

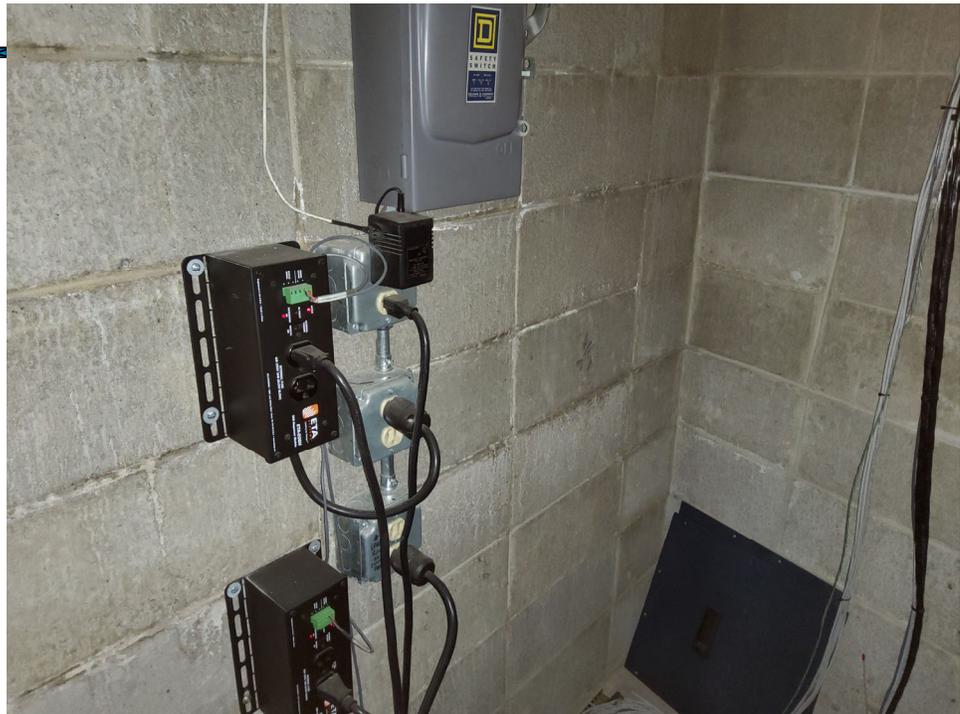
Photo 14:

Disconnect switch and
power conditioners.

Note: ETA Systems
model ETA-20SH, late
model.
