BECTEST

Property Condition Assessment For:

First Congregational Church of Christ

RE: Property Condition Assessment (PCA) For:
2503 Main Street, La Crosse, WI 54601

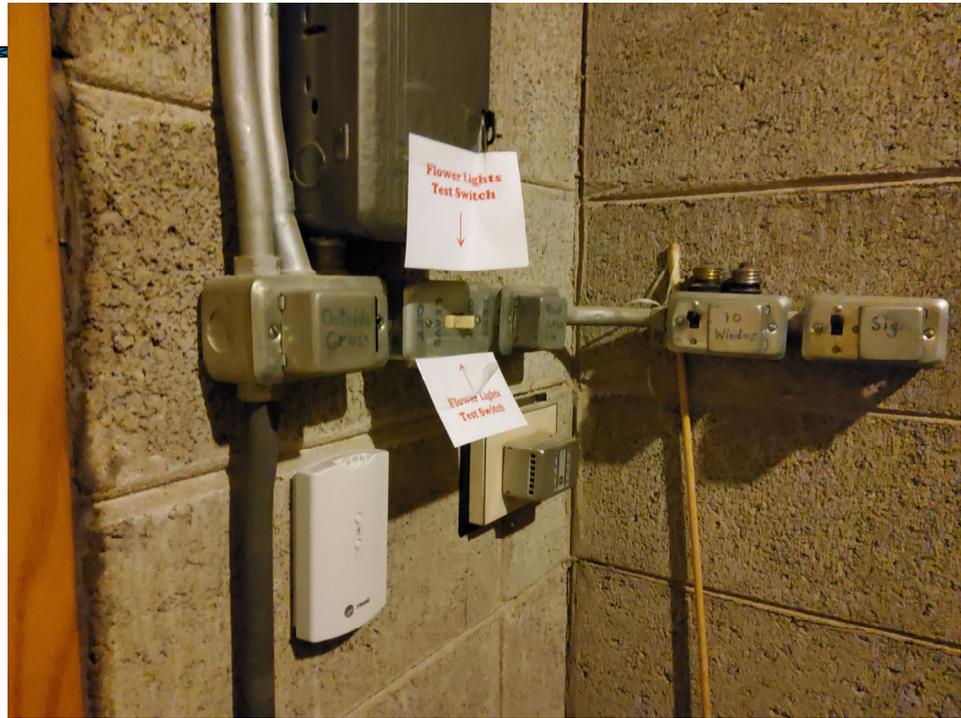
Photo 15:

Fused switches for various lighting.

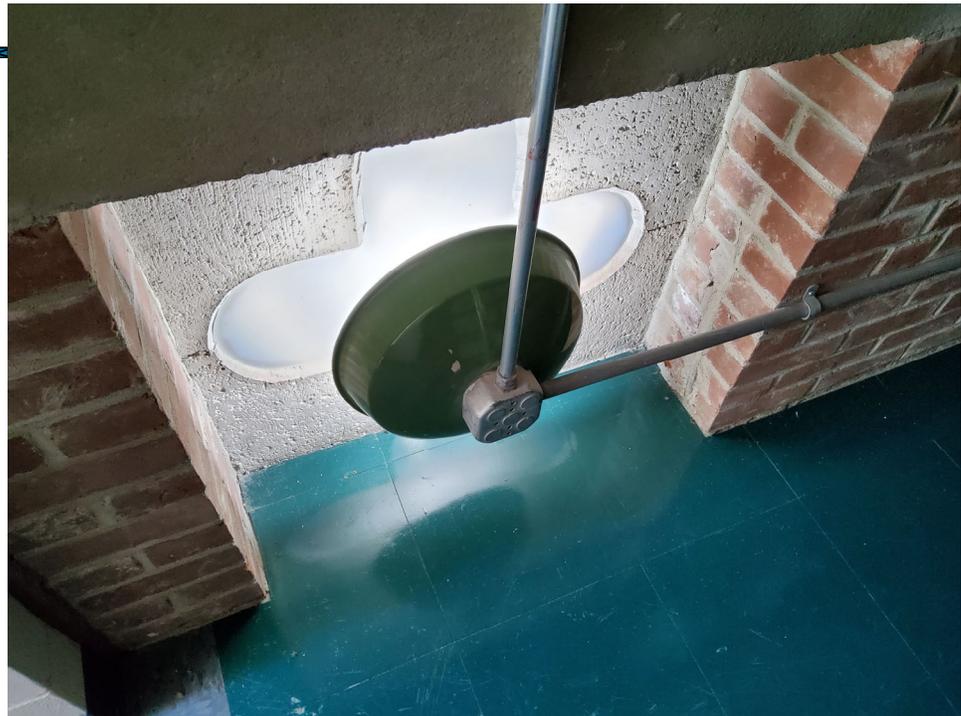
Photo 16:

Typical lighting fixtures.

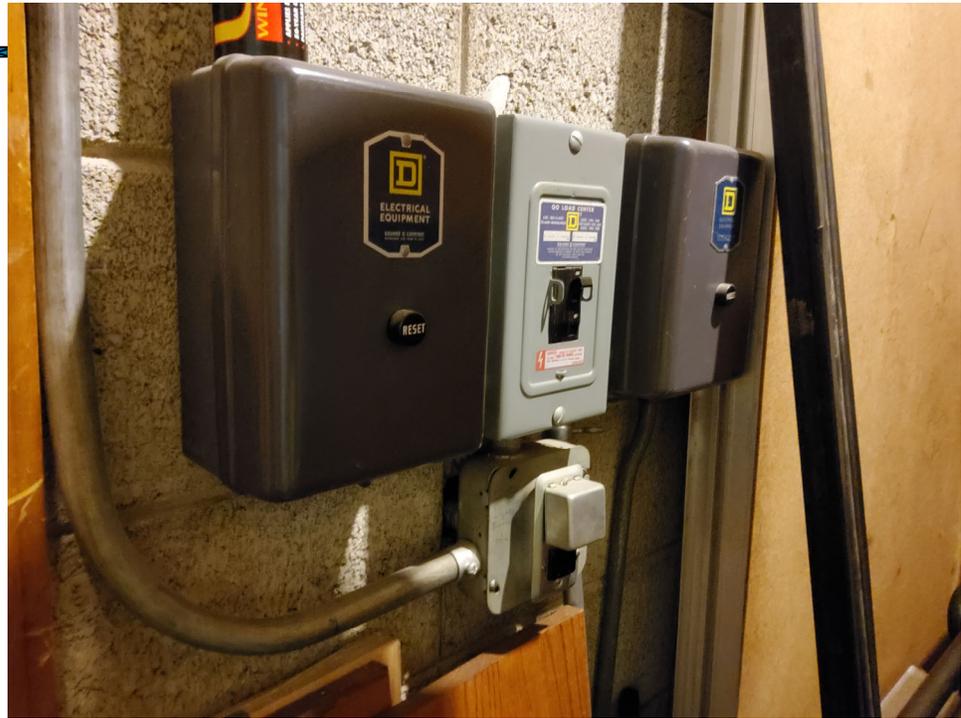
Photo 17:

Square D QO breaker panel, late model.
Square D motor starters, estimated age 60 years.

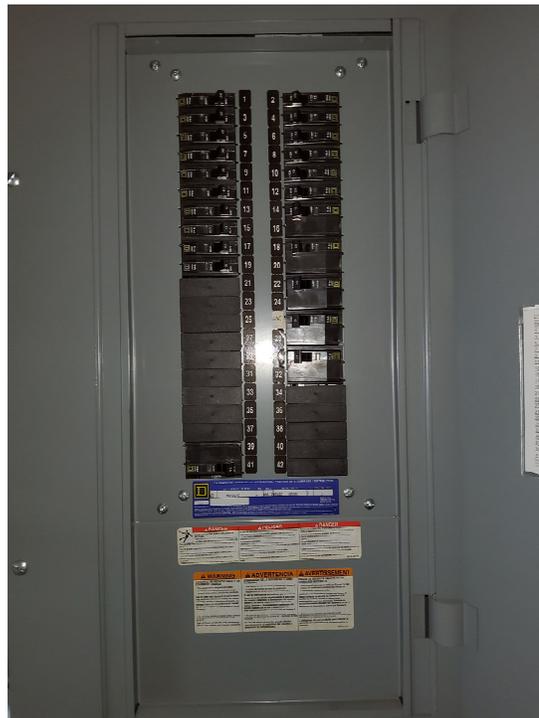
Photo 18:

Square D QO breaker panel, late model.

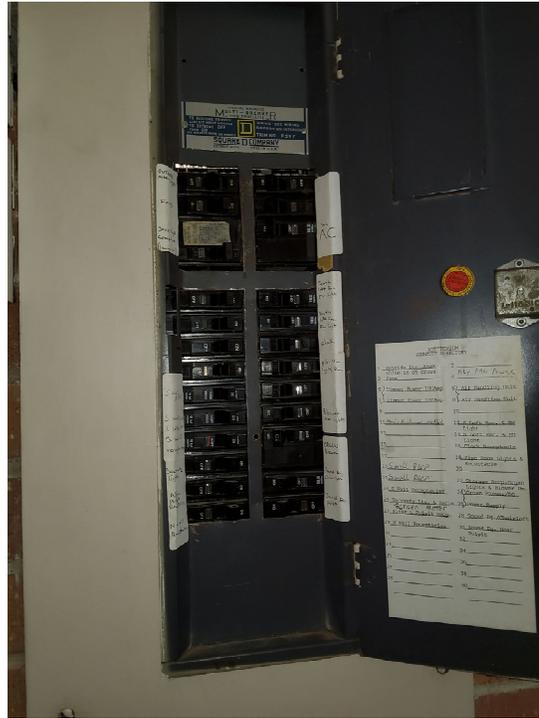
Photo 19:

Square D “Multi-Breaker” panel, estimated age 65 years. Breakers estimated age 50 years.

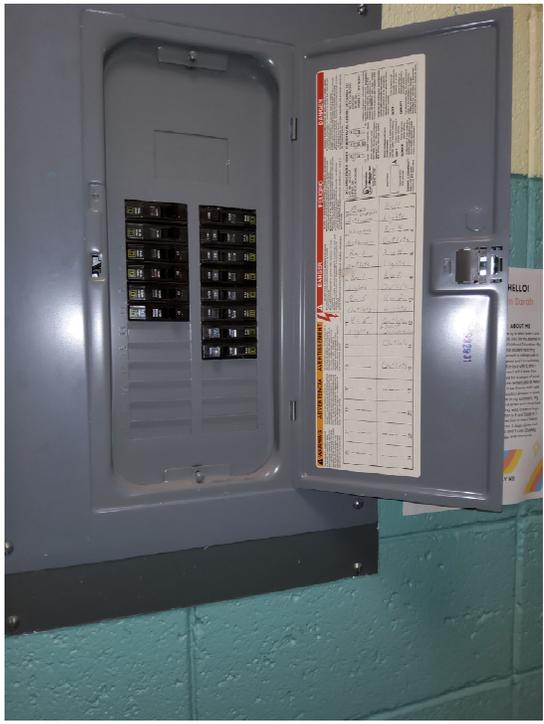
Photo 21:

Square D QO breaker panel, late model.

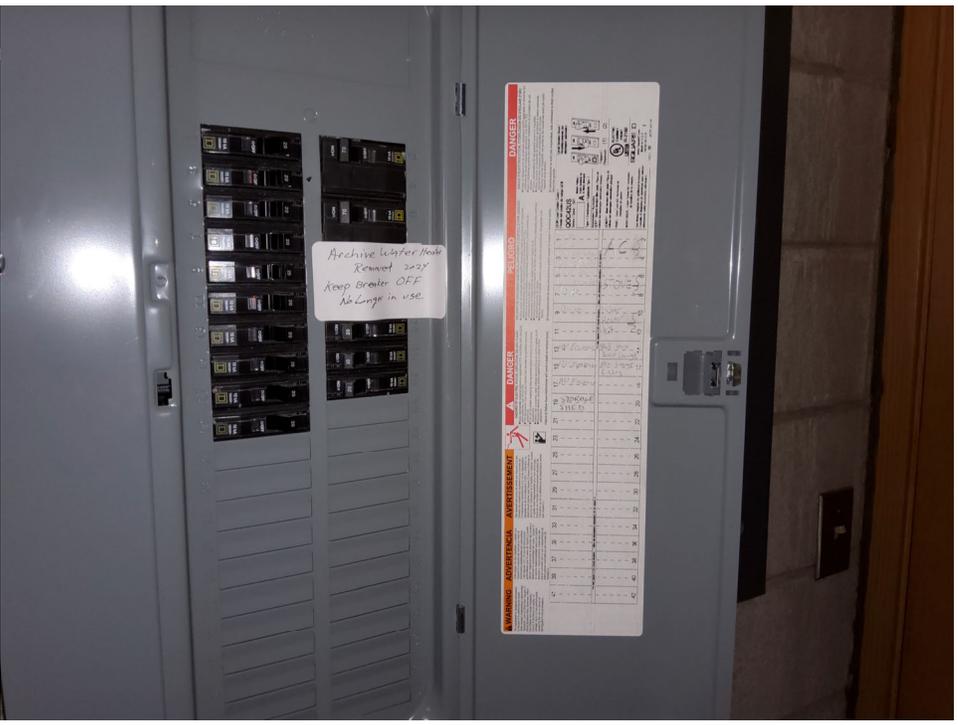
Photo 22:

Square D QO breaker panel, late model.

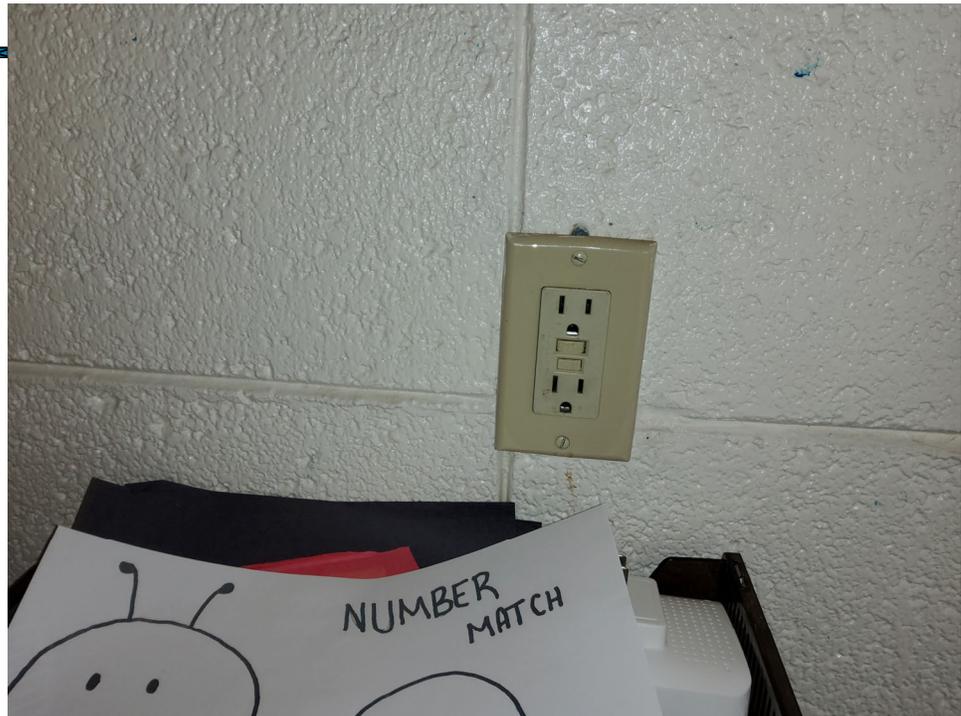
Photo 24:

Typical Ground fault Interrupter (GFI) outlet.

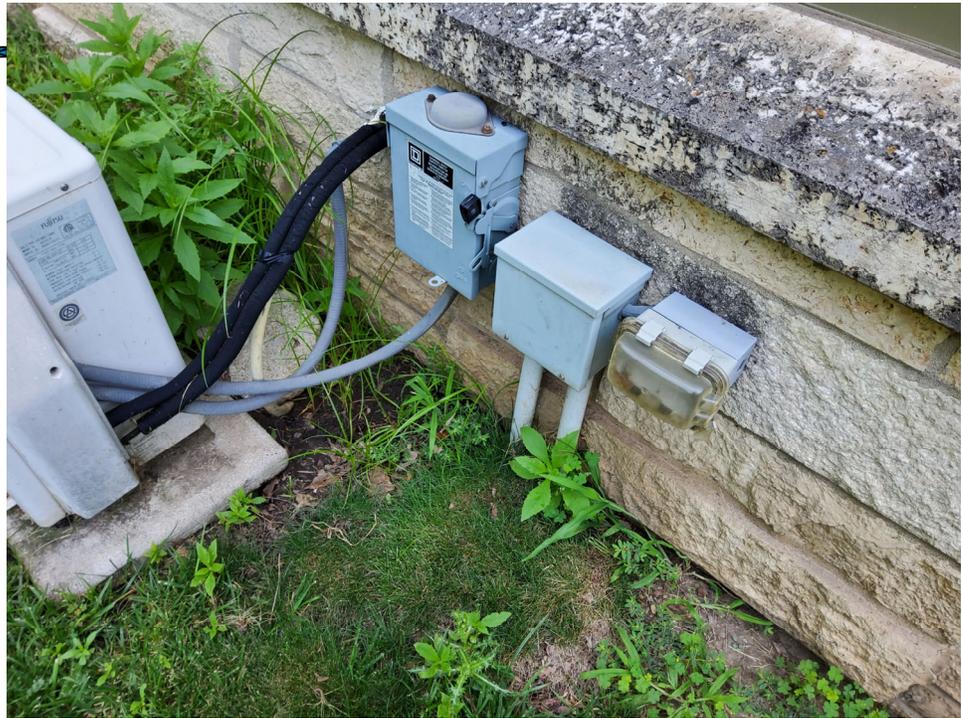
Photo 27:

Description:
A/C disconnect and
weather protected outlet.

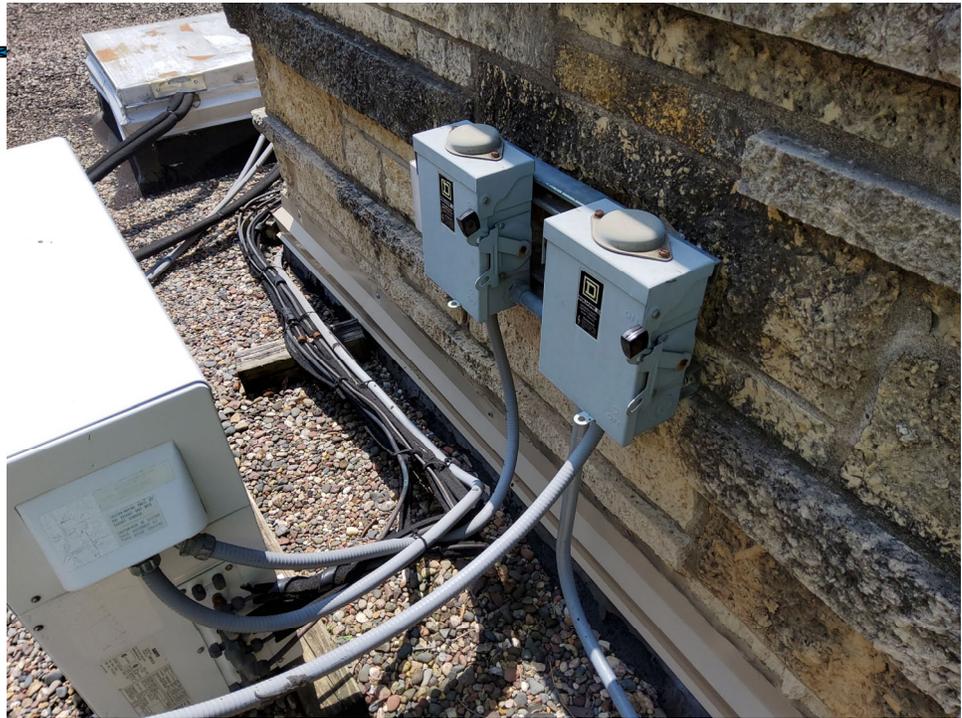
Photo 29:

A/C disconnects.

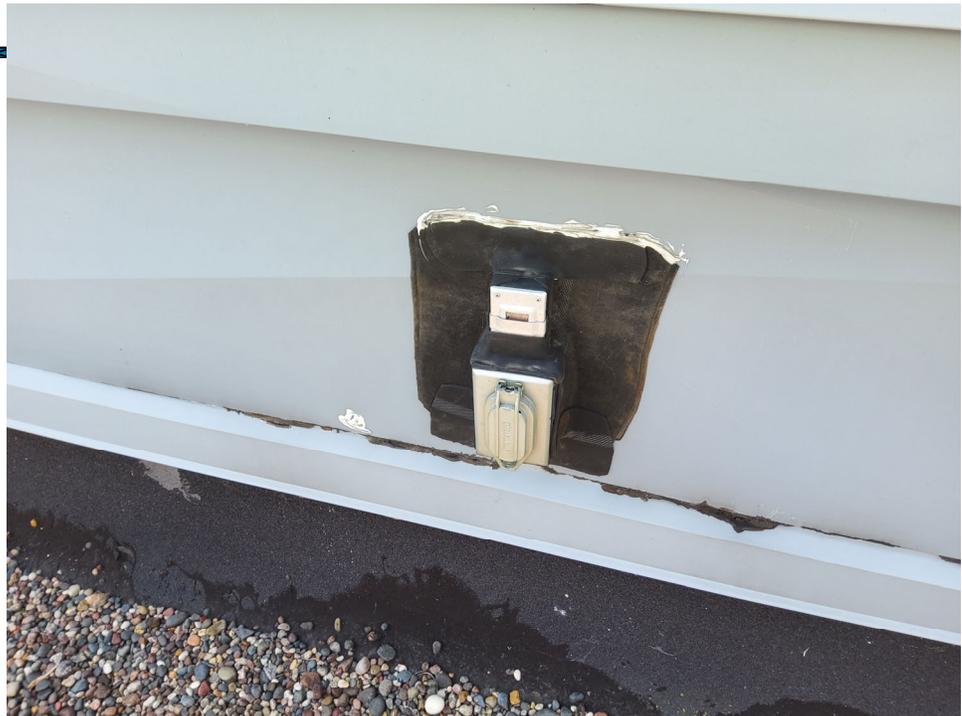
Photo 30:

Exterior outlet appears to have photo sensor integrated.

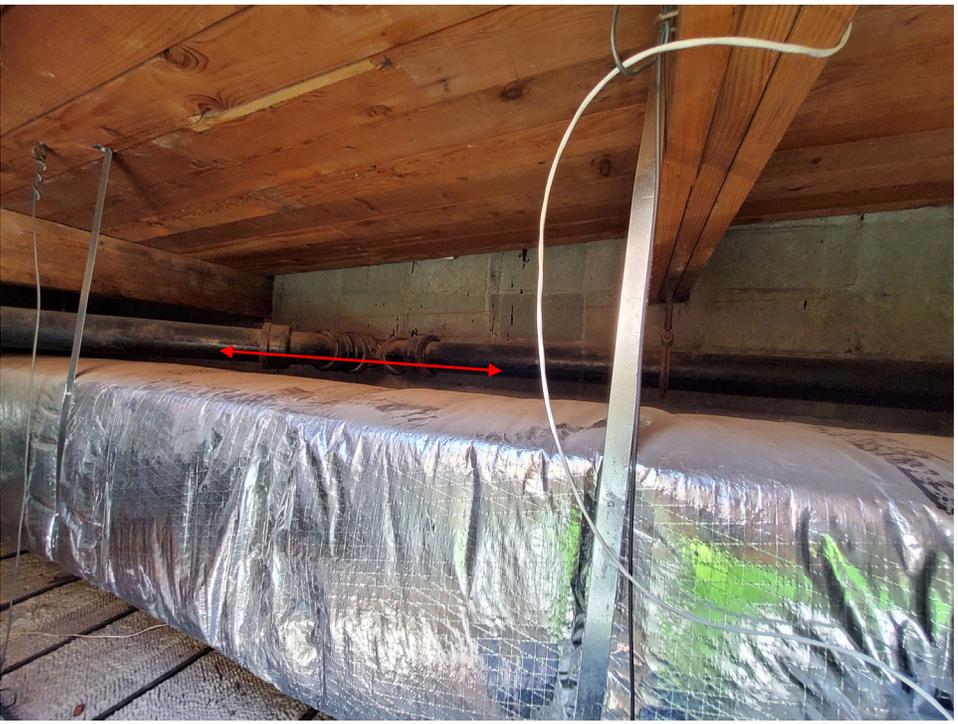
The underside of the roof deck on the south end of the north wing had roof drain piping passing through it. No signs of leakage were observed.

Piping from roof drains.

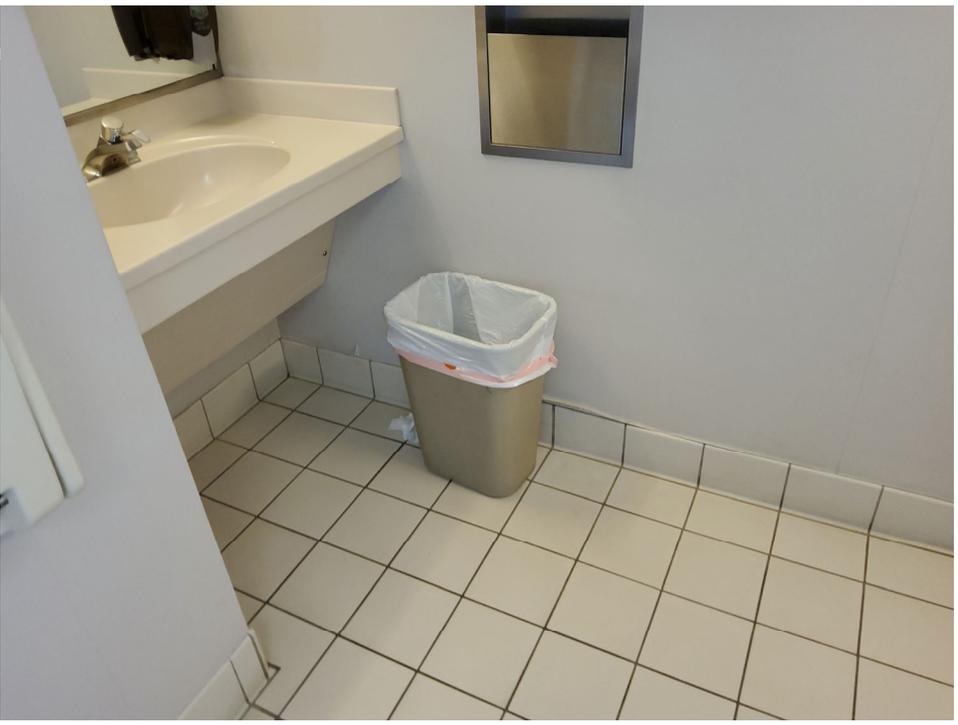
Photo 2:

Lavatory.

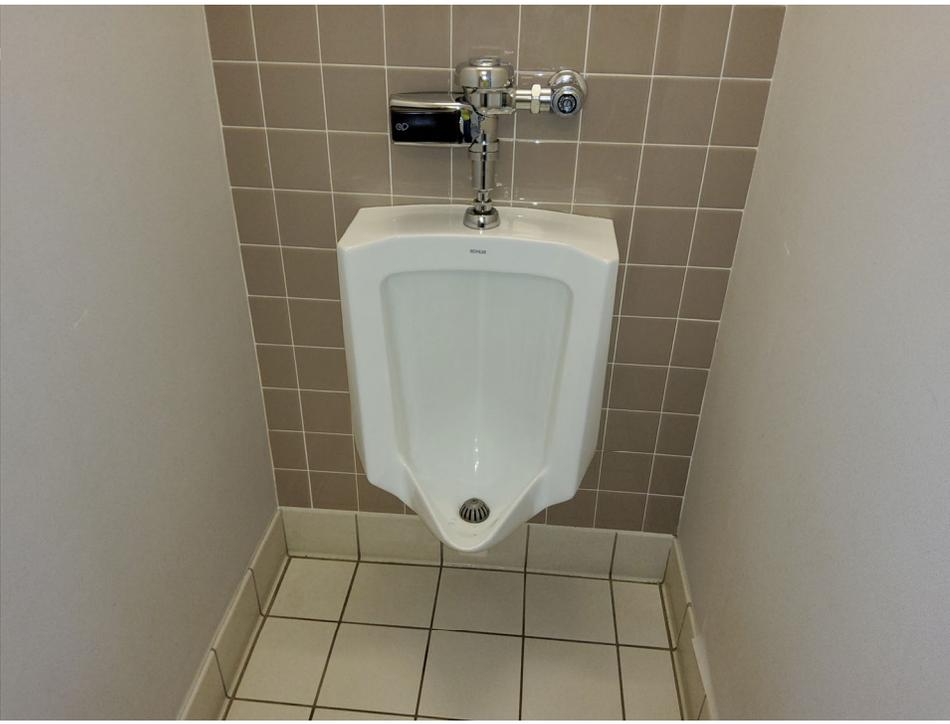
Photo 3:

Location:
Main level men's room

Description:
Urinal with automatic
flush valve.

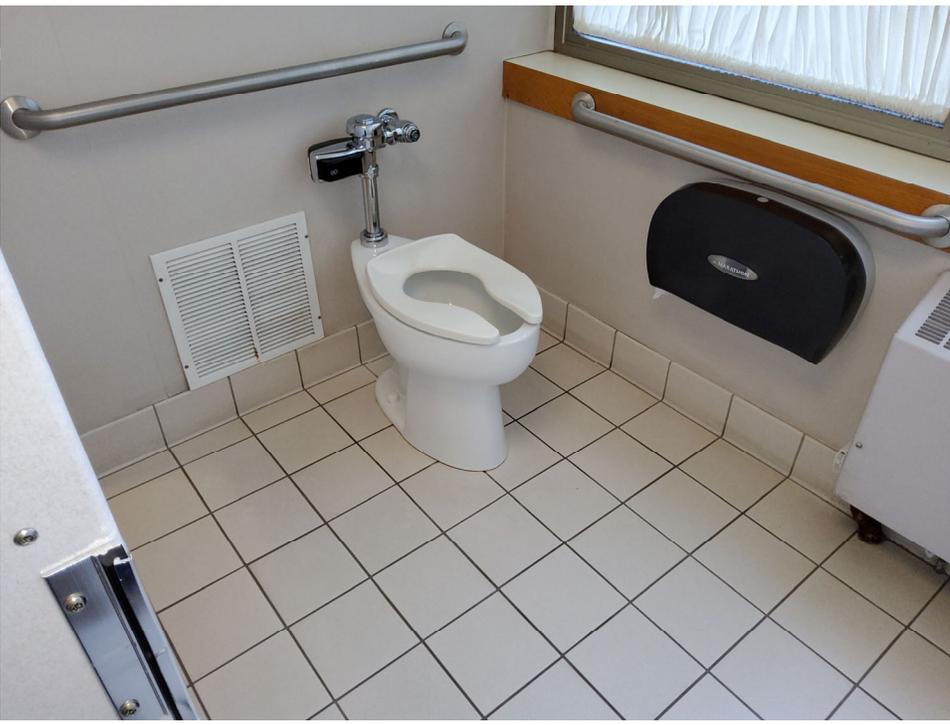
Photo 4:

Location:
Main level men's room

Description:
Toilet with automatic
flush valve.

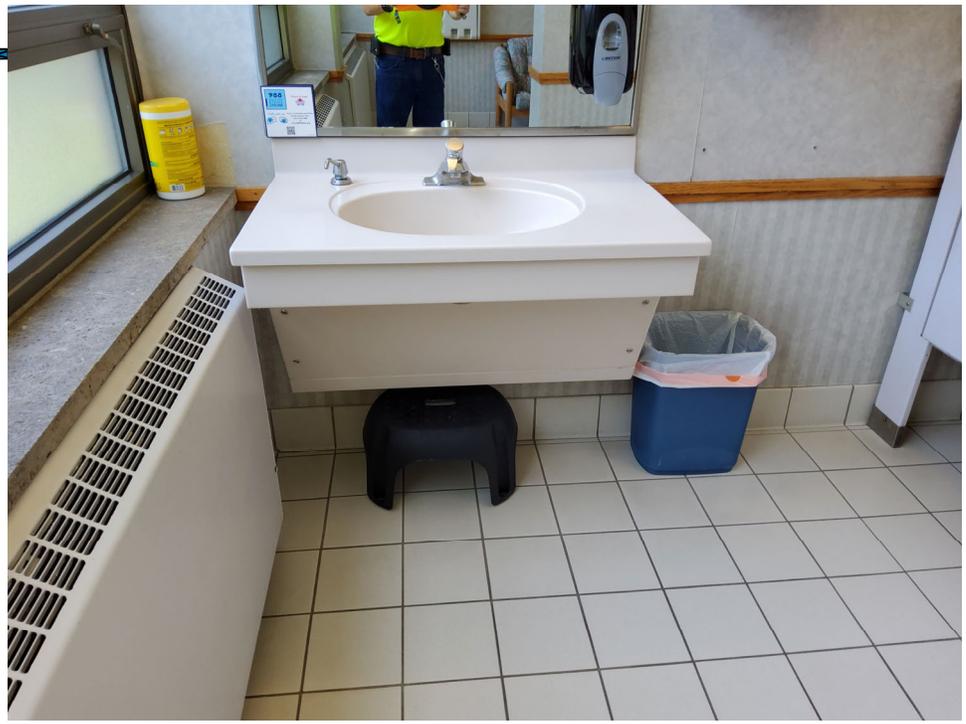
Photo 5:

Location:
Main level women's room

Description:
Lavatory.

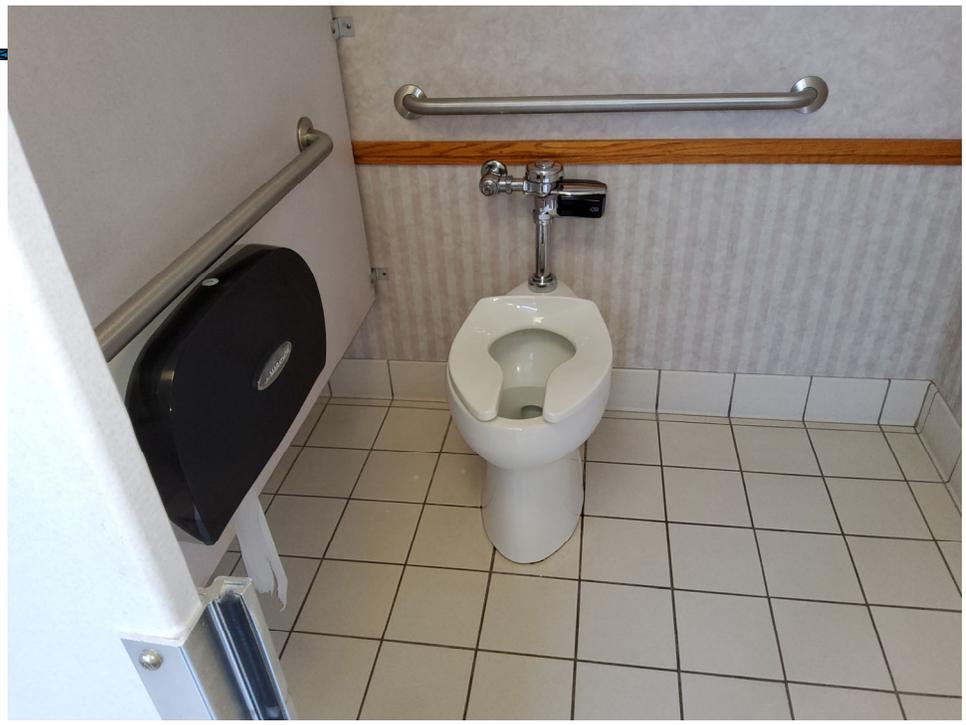
Photo 6:

Location:
Main level women's room

Description:
Toilet with automatic flush valve.

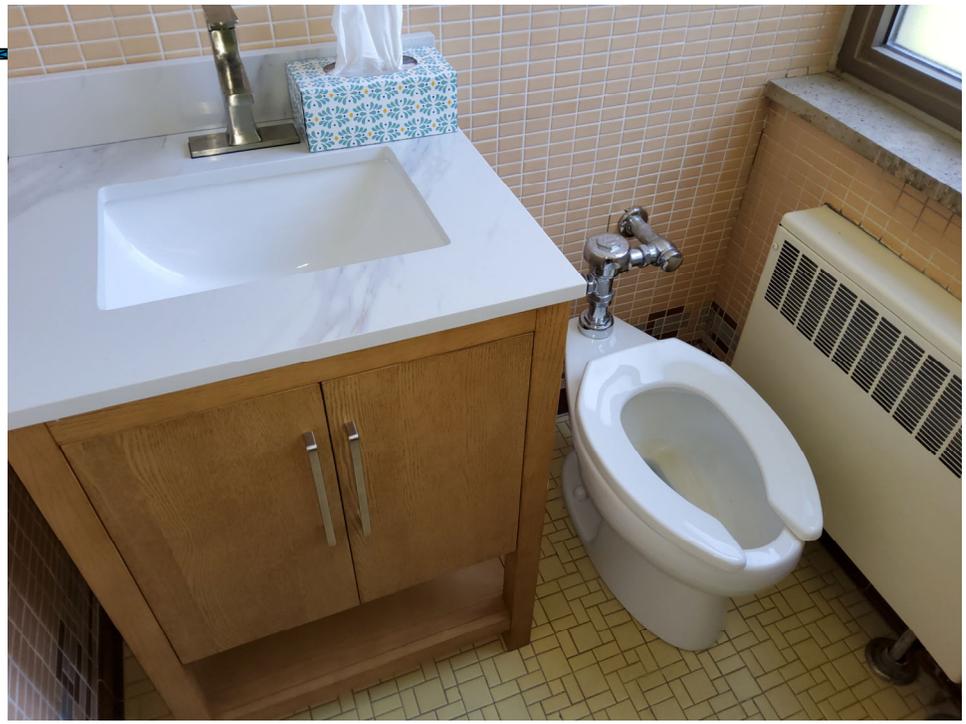
Photo 7:

Lavatory and toilet with manual flush valve.

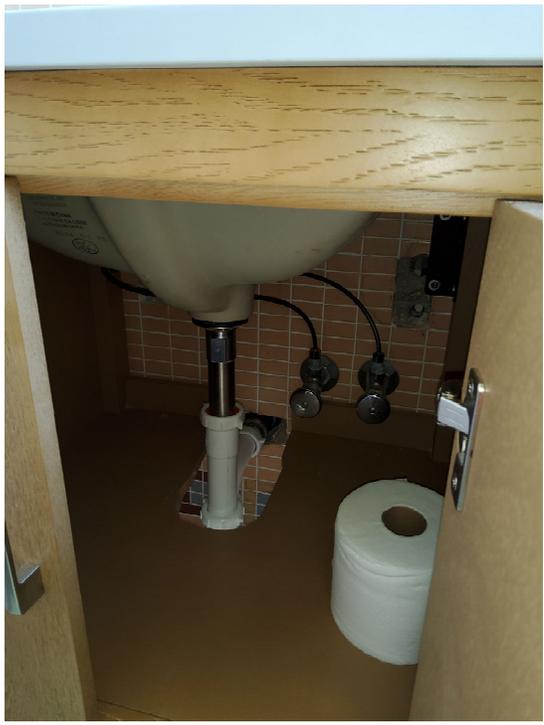
Photo 8:

Supply lines and drain piping.

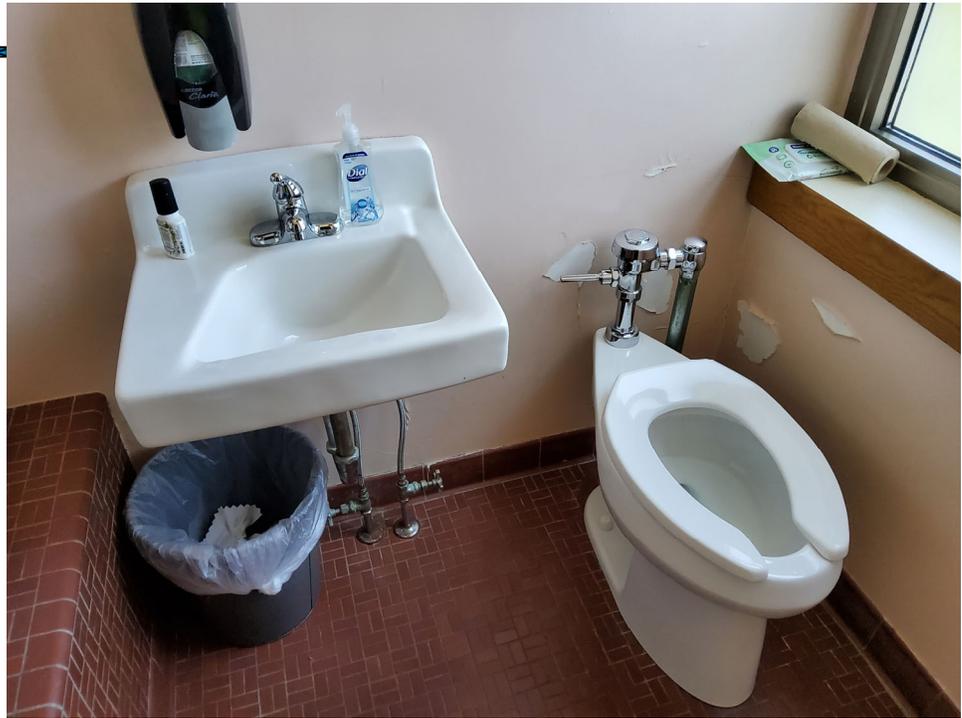
Photo 9:

Lavatory with supply lines and drain piping, toilet with manual flush valve.

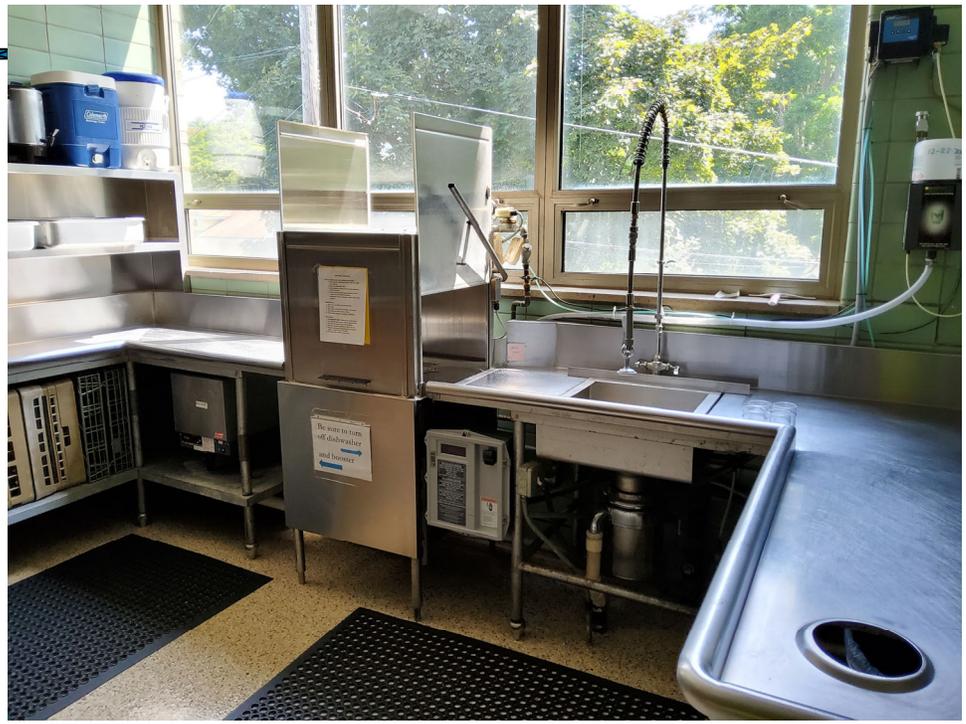
Photo 11:

Location:
Kitchen

Description:
Overview of dish washing area.

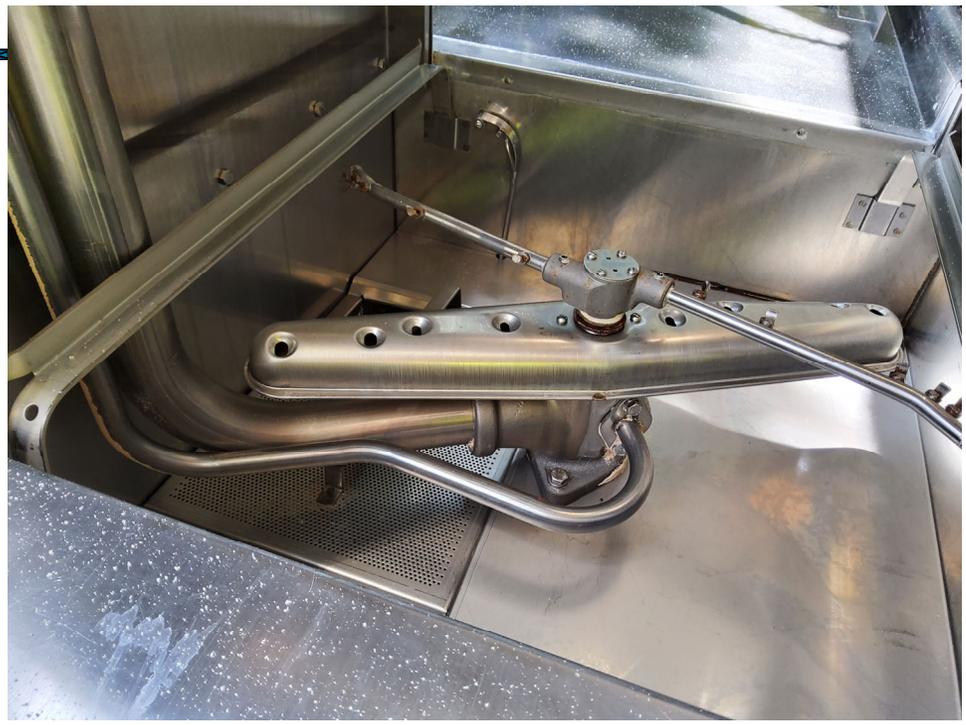
Photo 12:

Location:
Kitchen

Description:
Automatic washing spray arms.

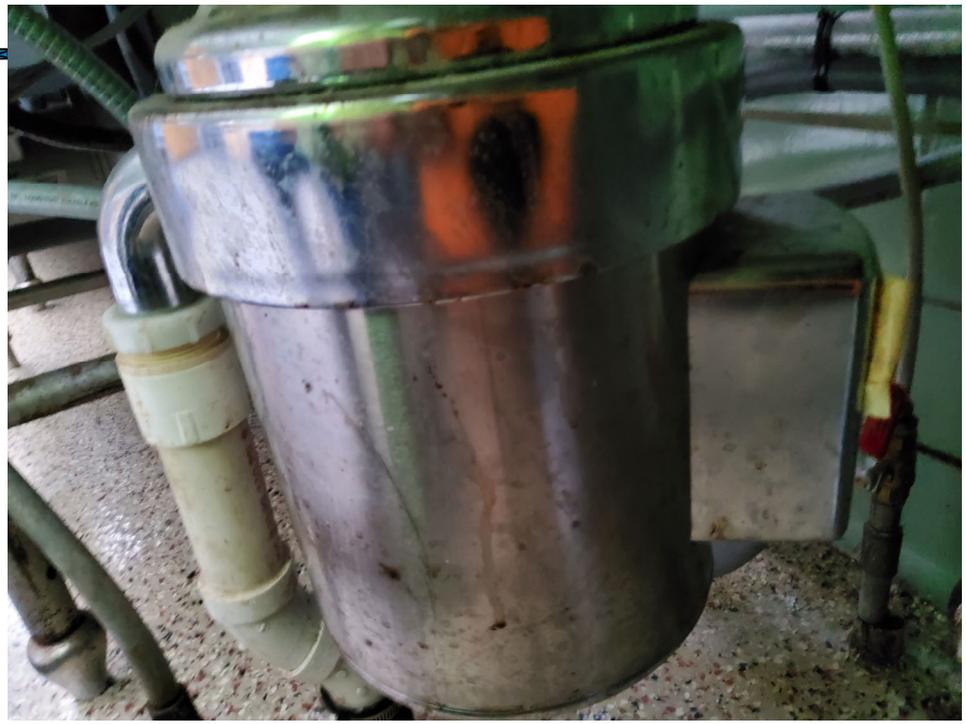
Photo 13:

Location:
Kitchen

Description:
Waste grinder.

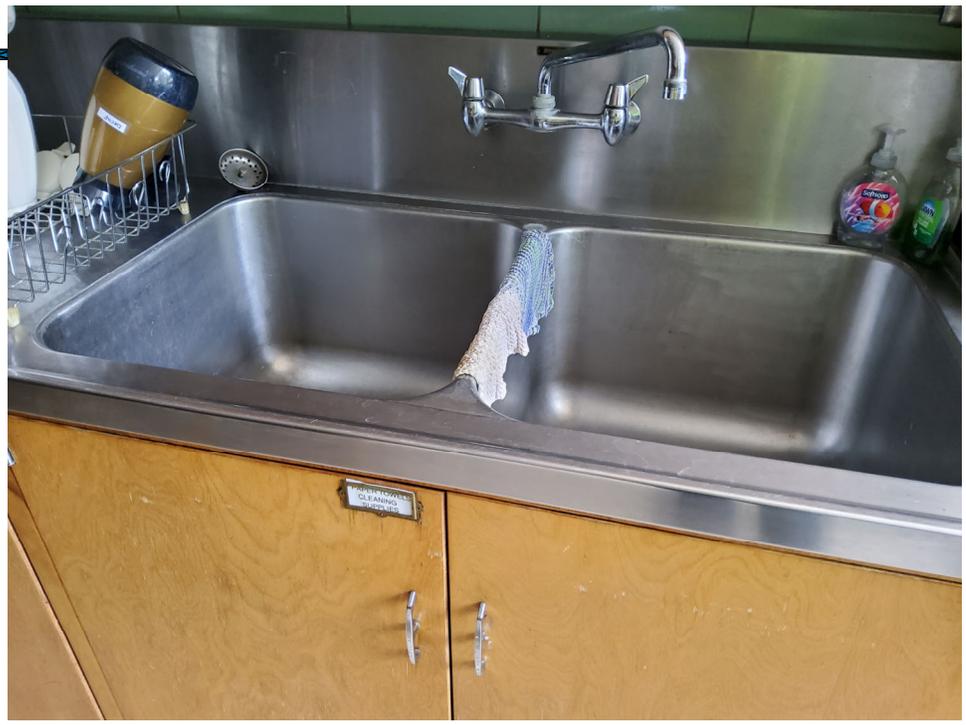
Photo 14:

Location:
Kitchen

Description:
Dual sink.

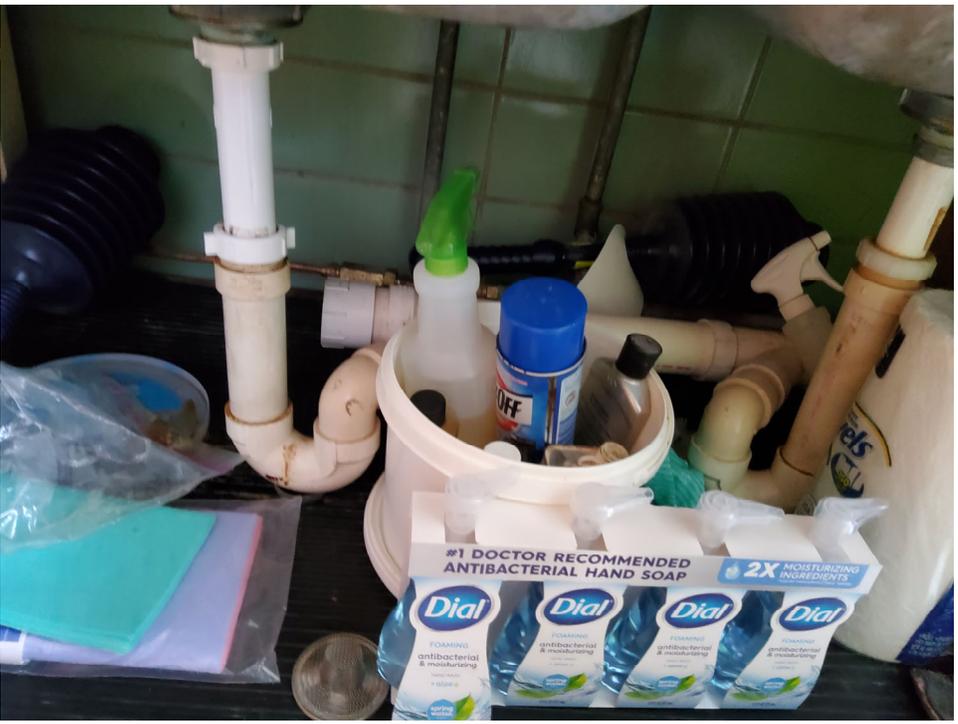
Photo 15:

Location:
Kitchen

Description:
Supply lines and drain piping.

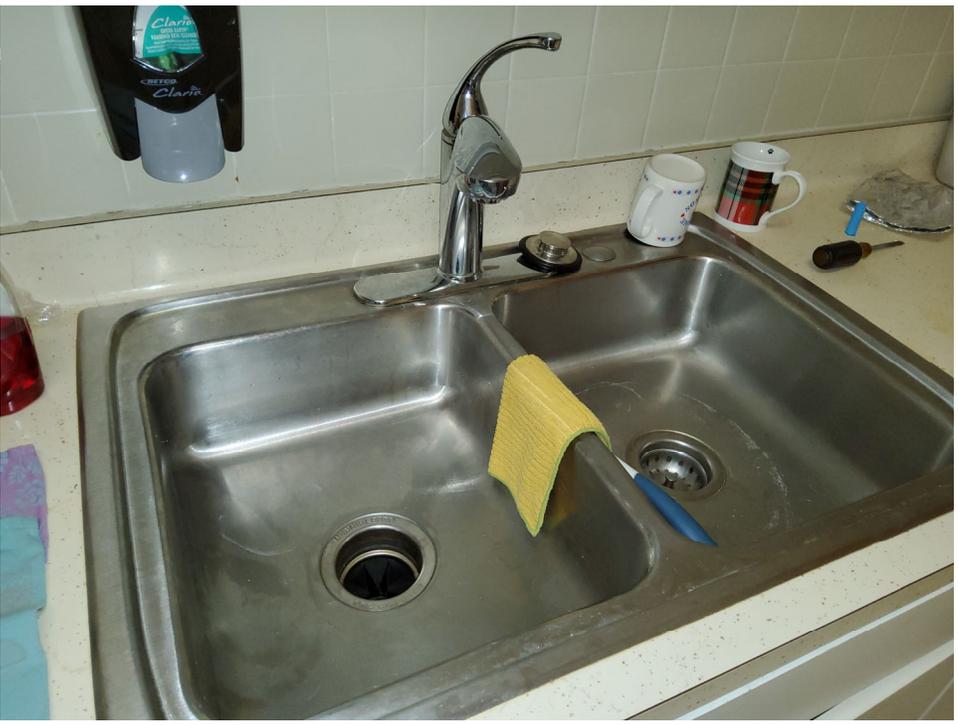
Photo 16:

Location:
Lower level kitchen

Description:
Sink.

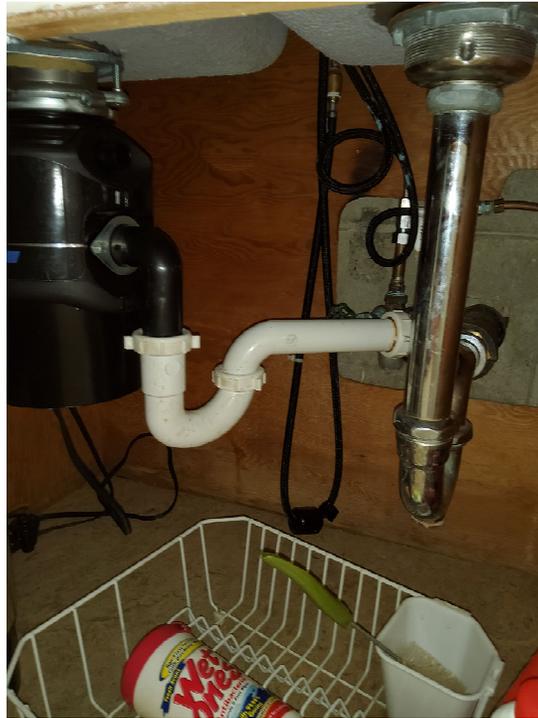
Photo 17:

Supply lines, drain piping and disposal.

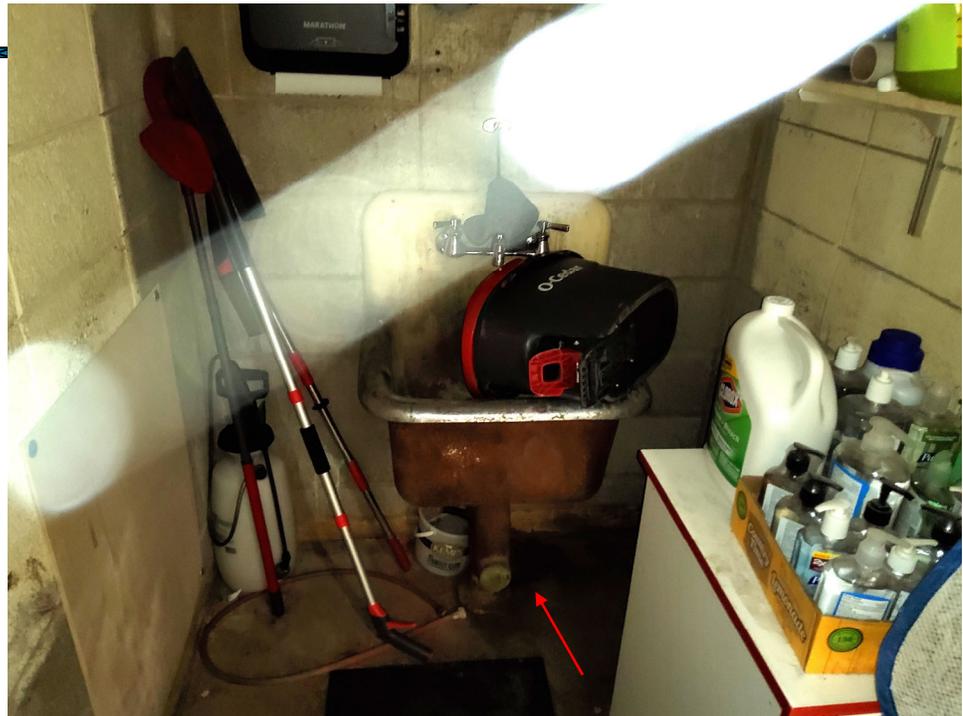
Photo 20:

Enameled metal utility sink.

Note: Moisture at floor.

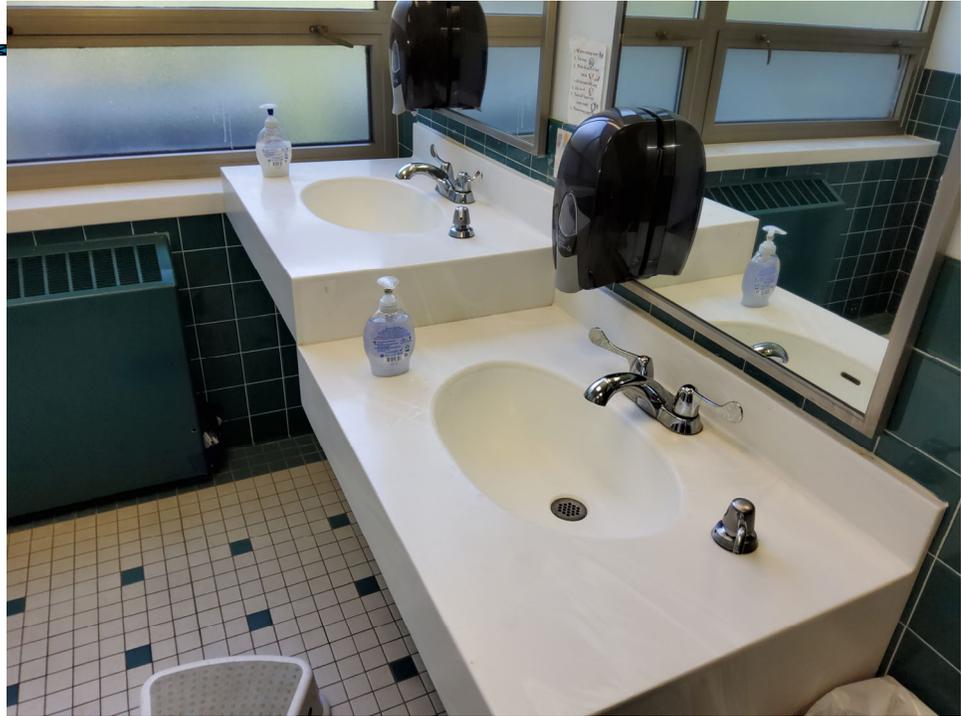
Photo 21:

Lavatories.

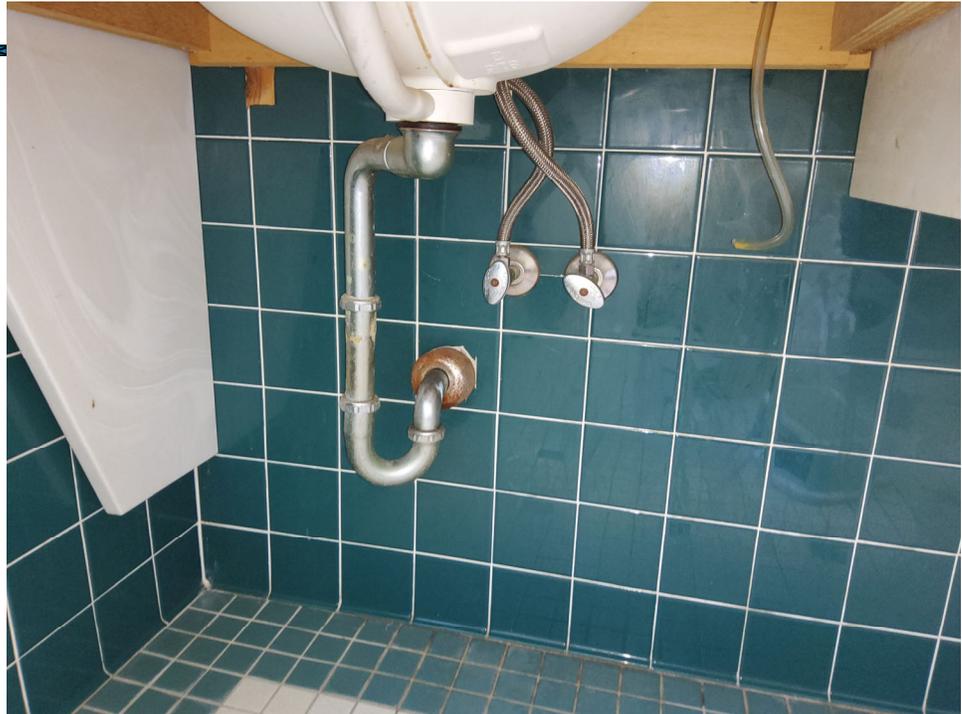
Photo 22:

Supply lines and drain piping.

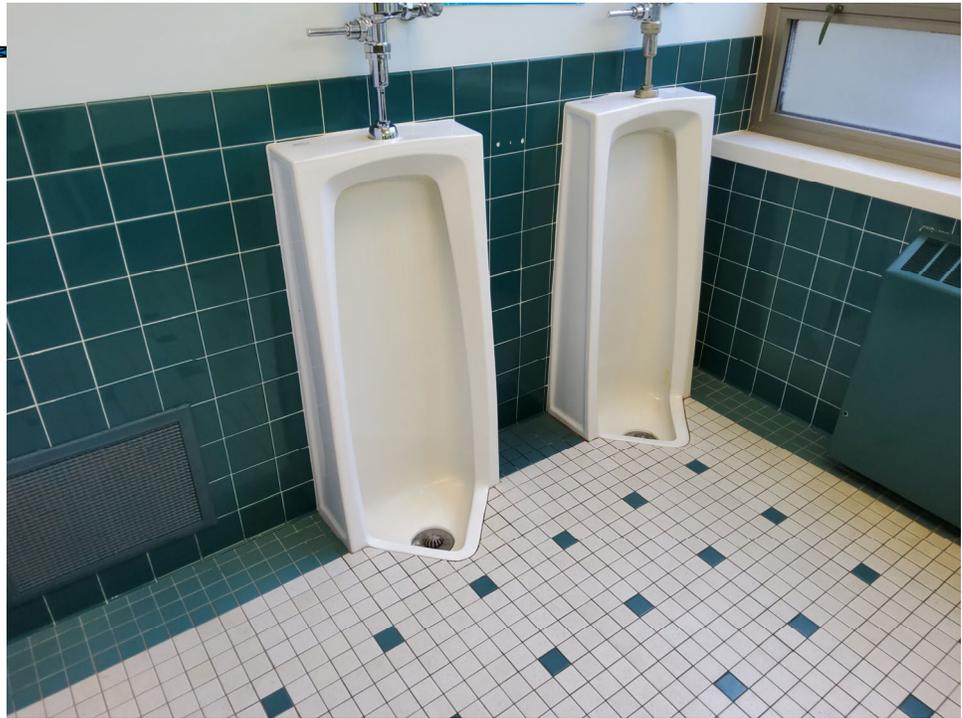
Photo 23:

Urinals with manual flush valves.

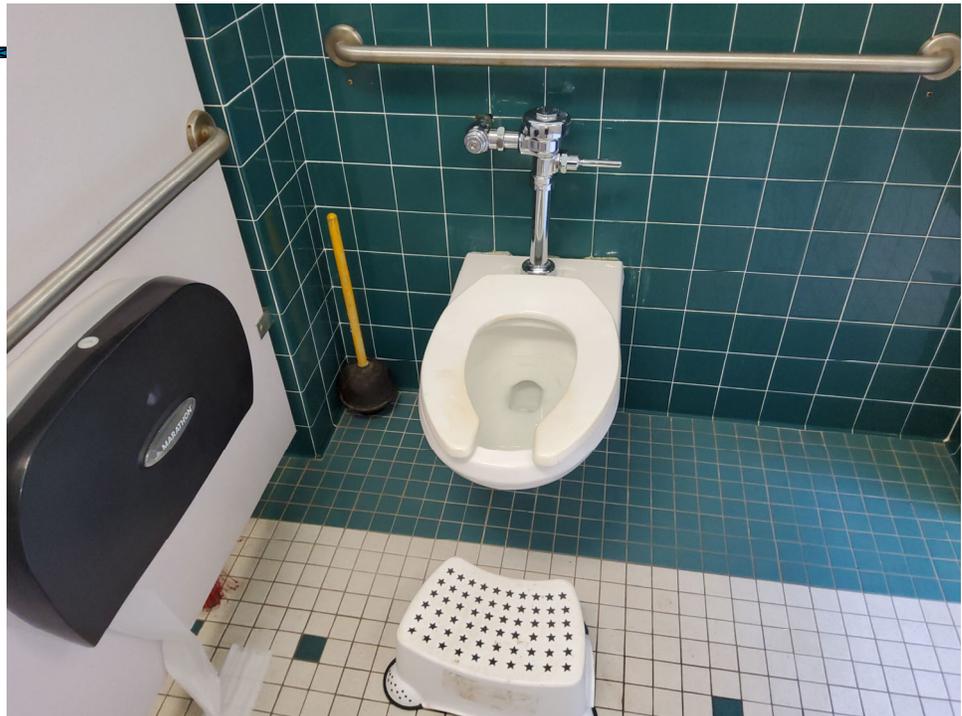
Photo 24:

Toilet with manual flush valve.

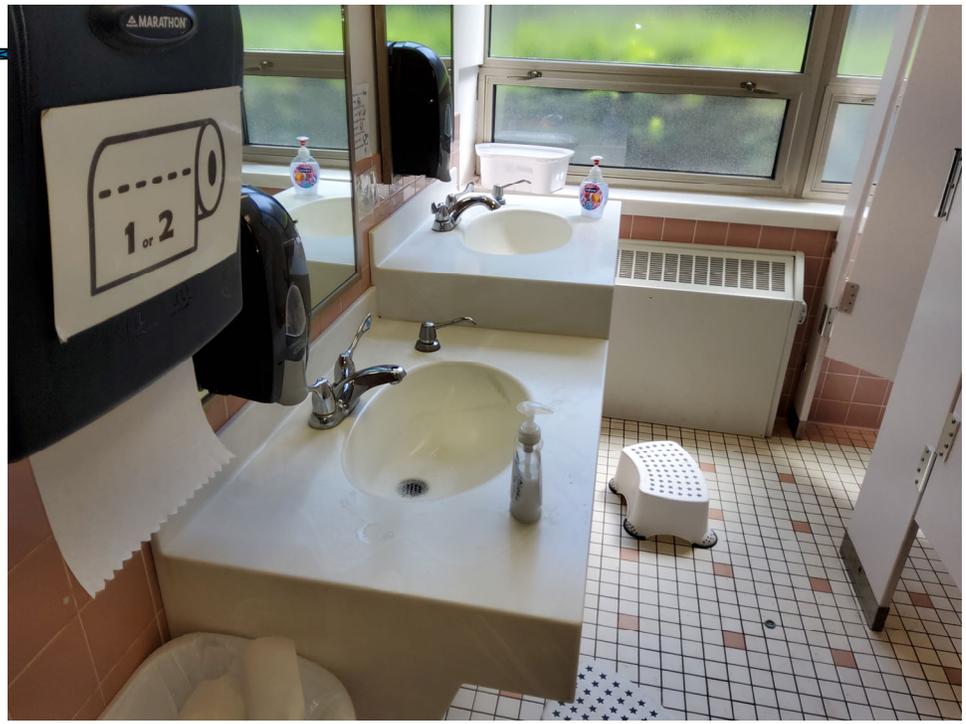
Photo 25:

Location:
Lower level women's room

Description:
Lavatories.

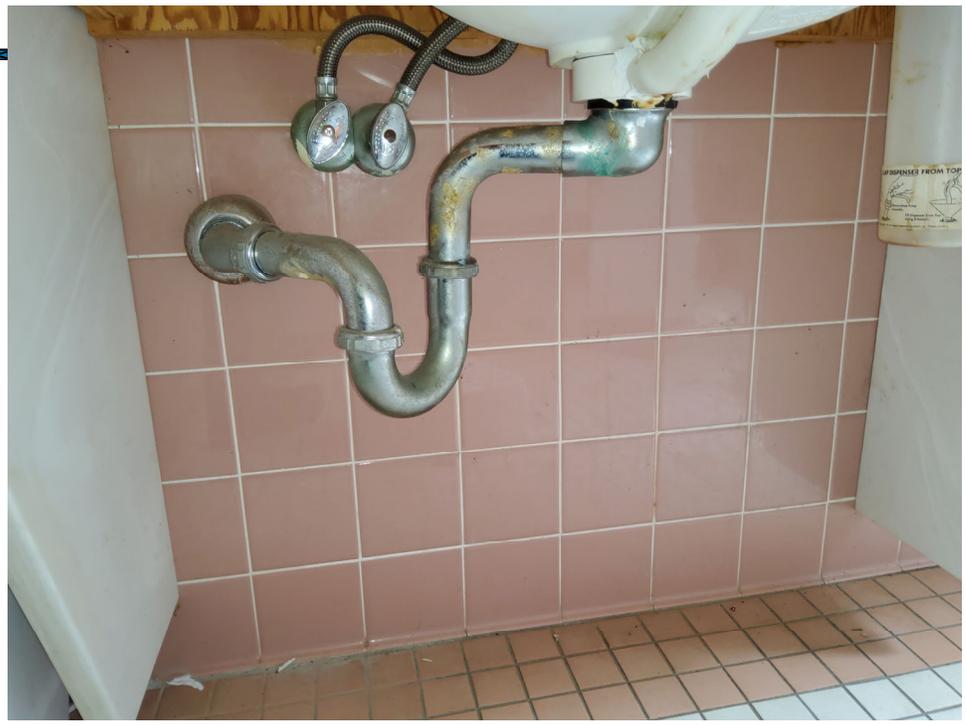
Photo 26:

Location:
Lower level women's room

Description:
Supply lines and drain piping.

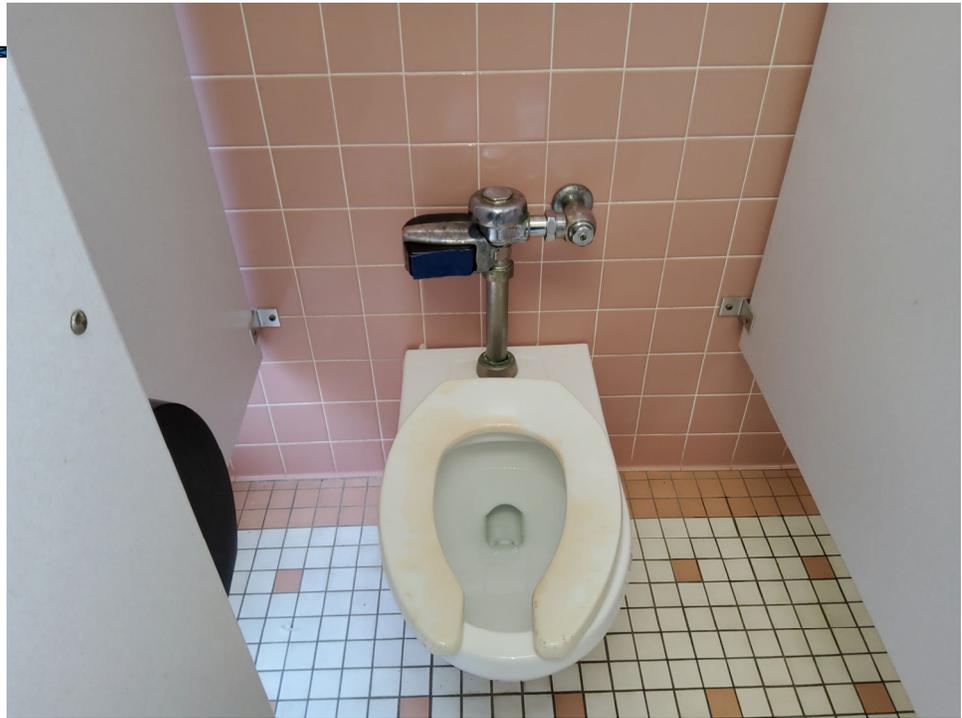
Photo 27:

Toilet with automatic flush valve.
