BECTEST

Property Condition Assessment For:

First Congregational Church of Christ

RE: Property Condition Assessment (PCA) For:
2503 Main Street, La Crosse, WI 54601

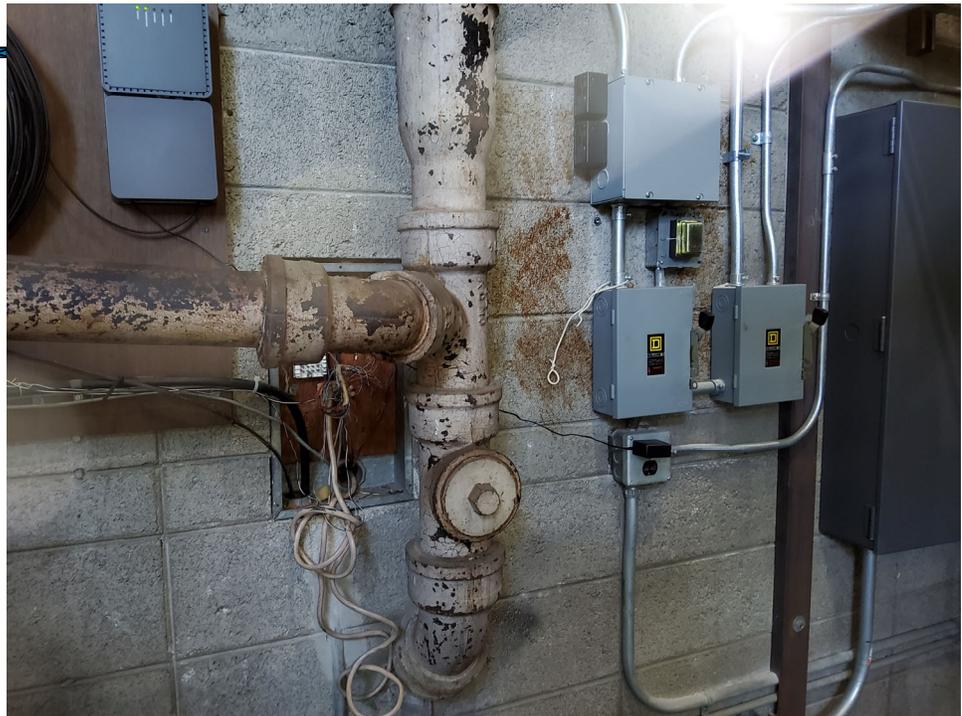
Photo 28:

Soil piping.

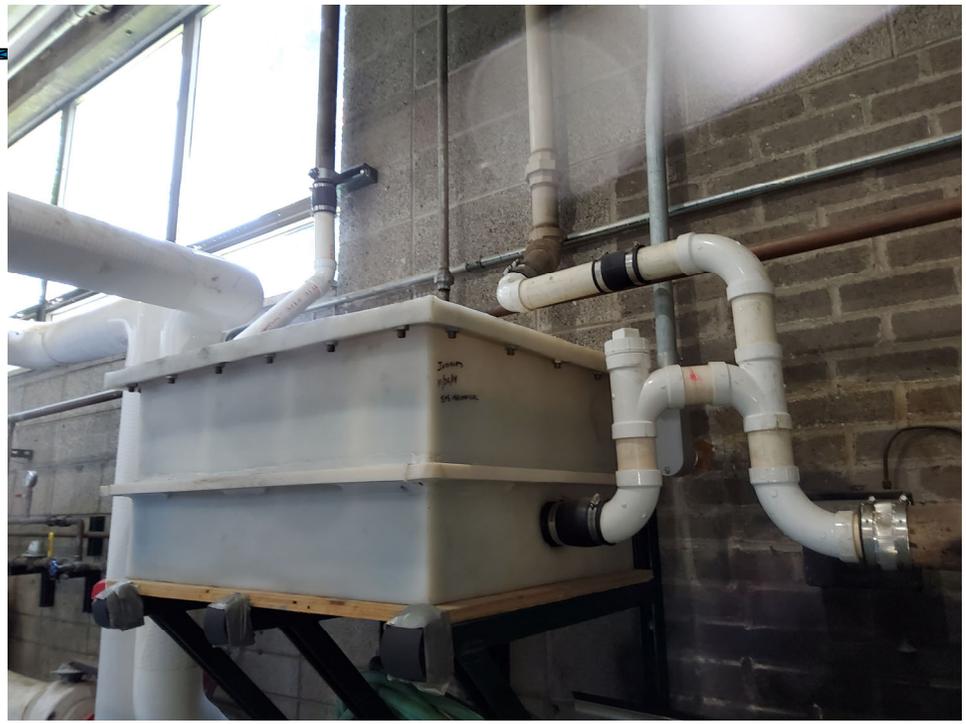
Photo 29:

Location:
Boiler room

Description:
Kitchen waste collection system.

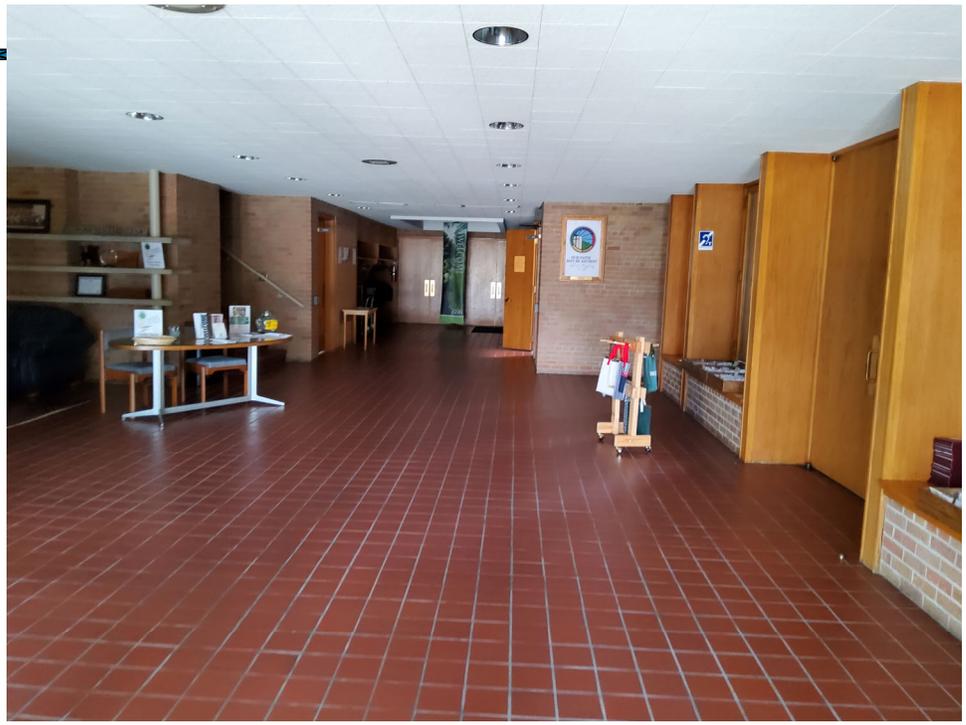
Photo 2:

Description:
Main hallway north view

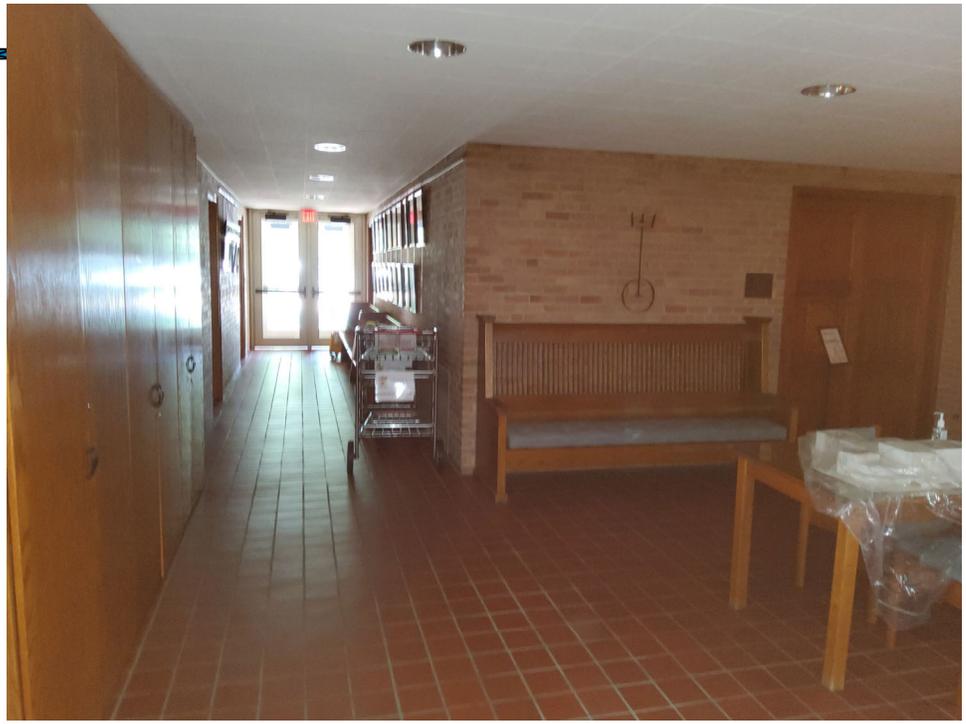
Photo 3:

West wing view towards chapel

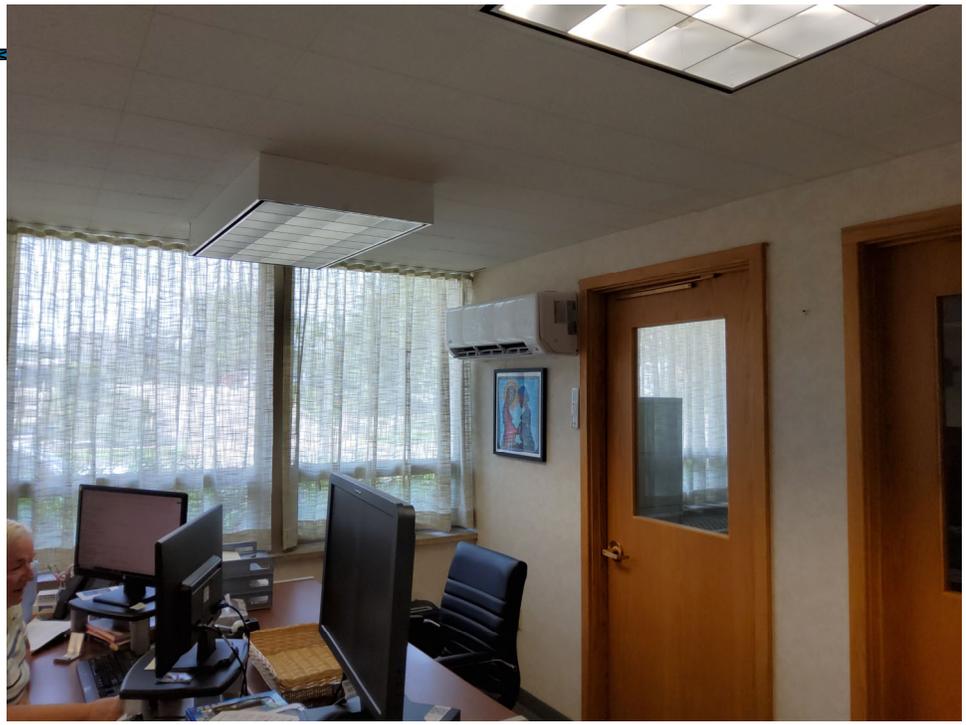
Photo 4:

Main office

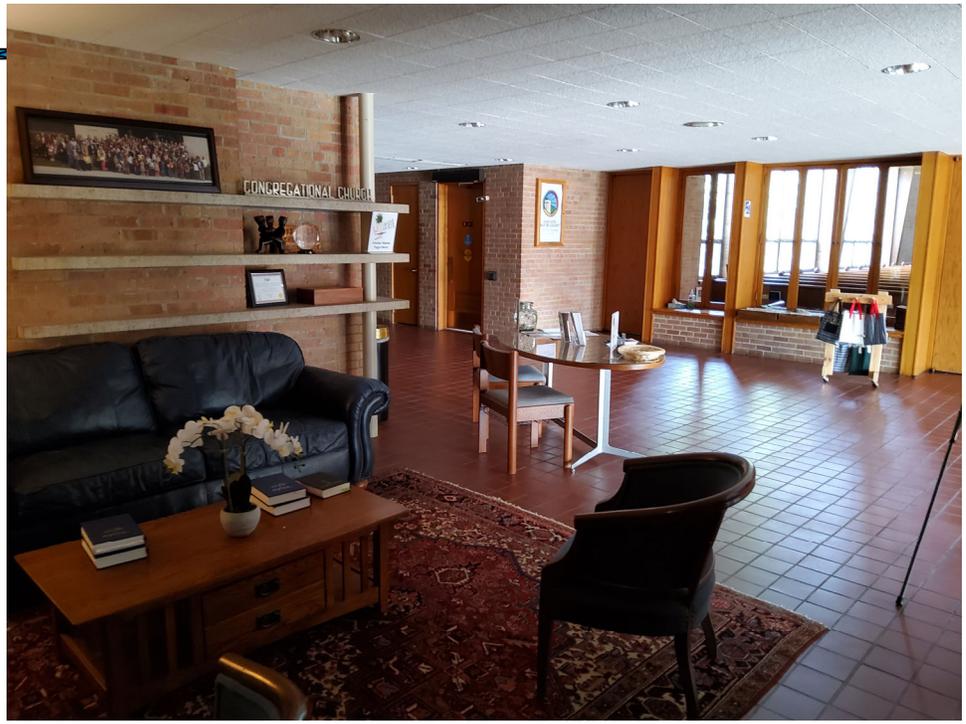
Photo 5:

Description:
Sitting area and
sanctuary entrance to
east

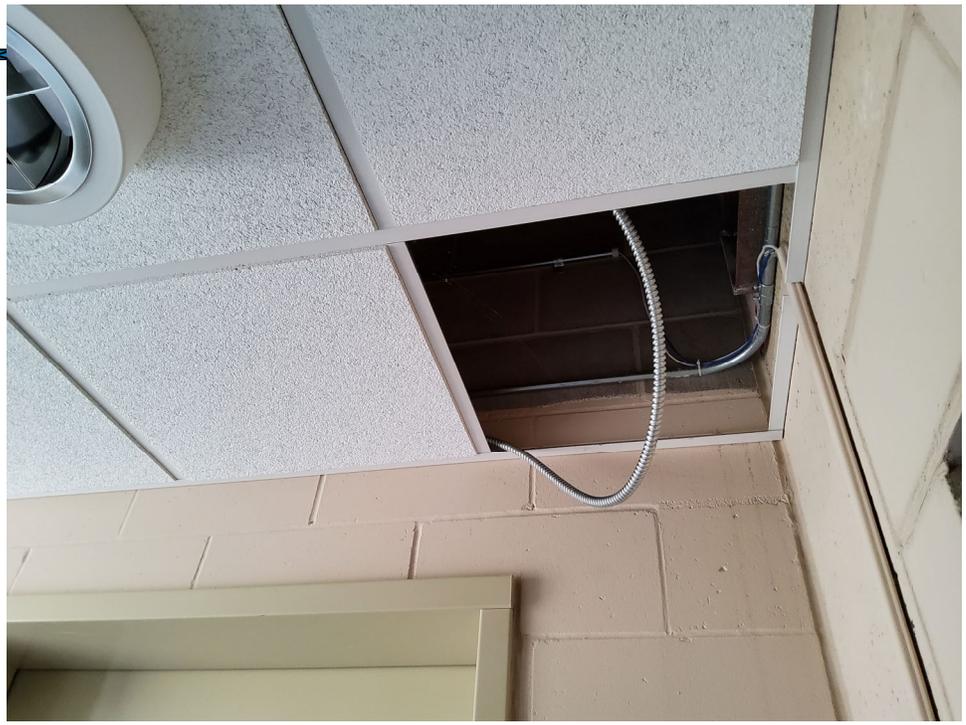
Photo 8:

The upper hallway above the main entrance featured Vinyl Composite Tile (VCT) flooring, brick veneer or Concrete Masonry Unit (CMU) walls, and drywall or suspended ceilings. Decorative glass inserts were set into the brick veneer in ten places. Near the elevator landing, one ceiling panel was missing, exposing a loose section of armor shielded electrical cable. All other items were in good condition.

Upper elevator landing

Note: Missing ceiling tile, loose armor shielded electrical cable.

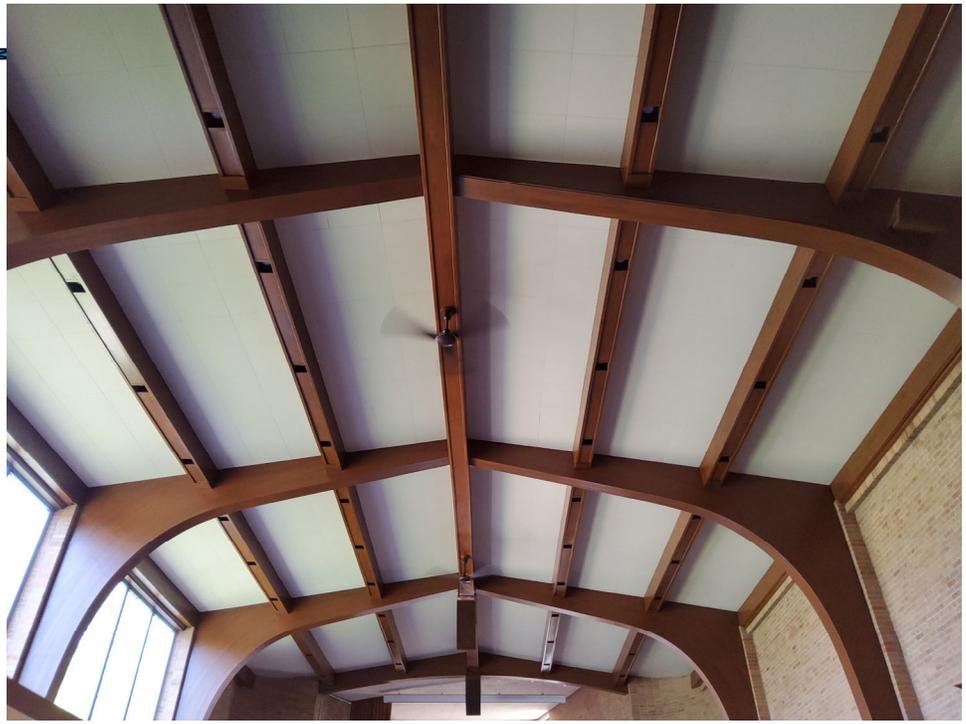
Photo 9:

Description:
Sanctuary ceiling

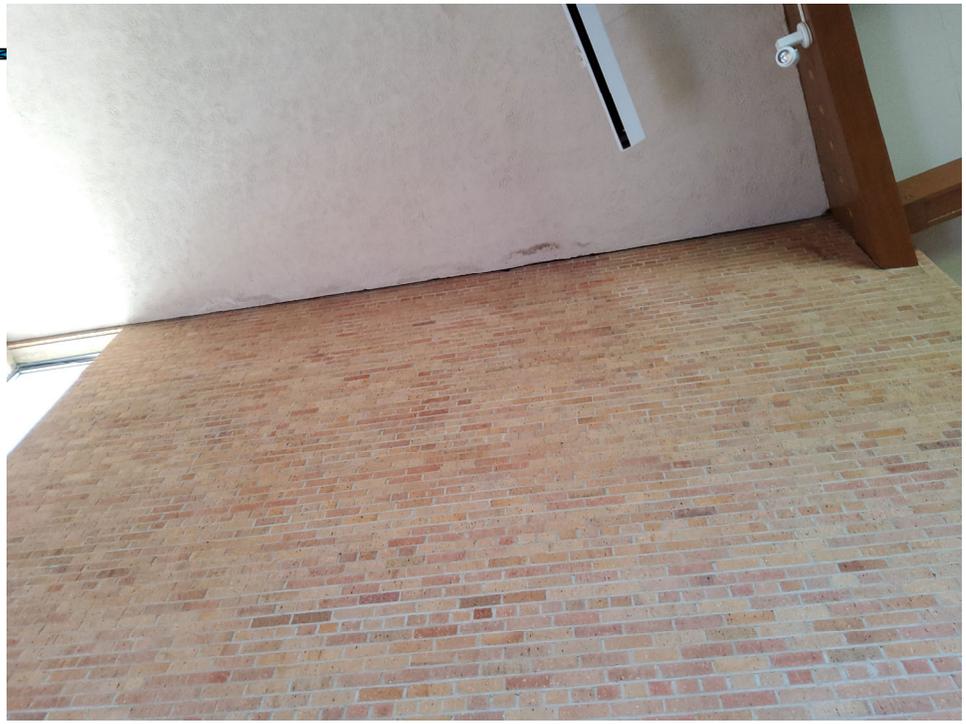
Photo 11:

Ceiling along south wall of altar

Note: Water stains.

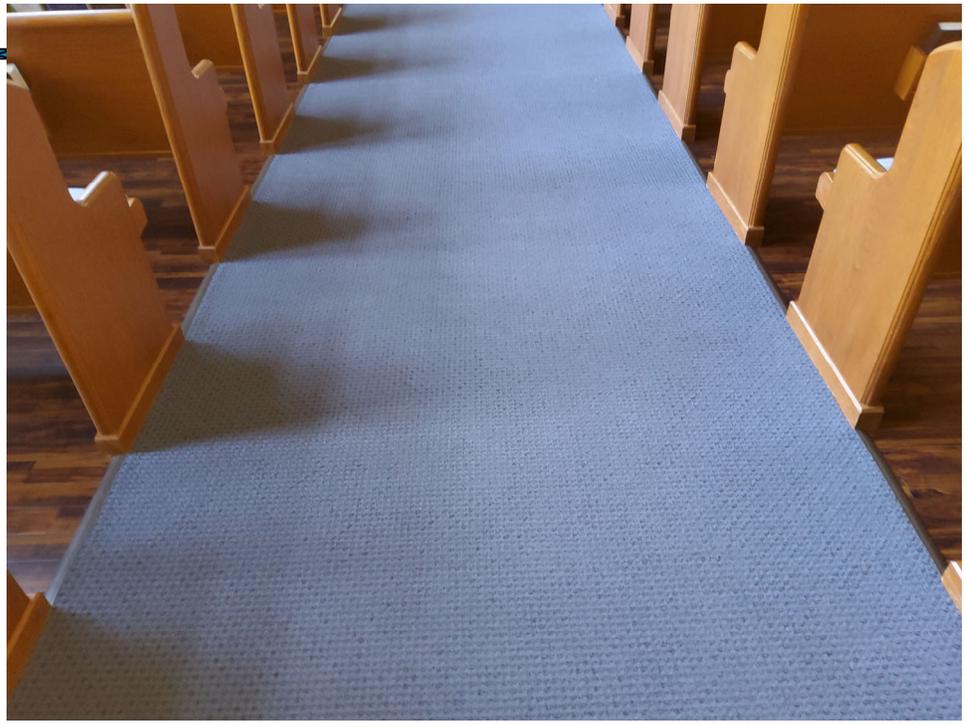
Photo 13:

Description:
Main aisle carpeting

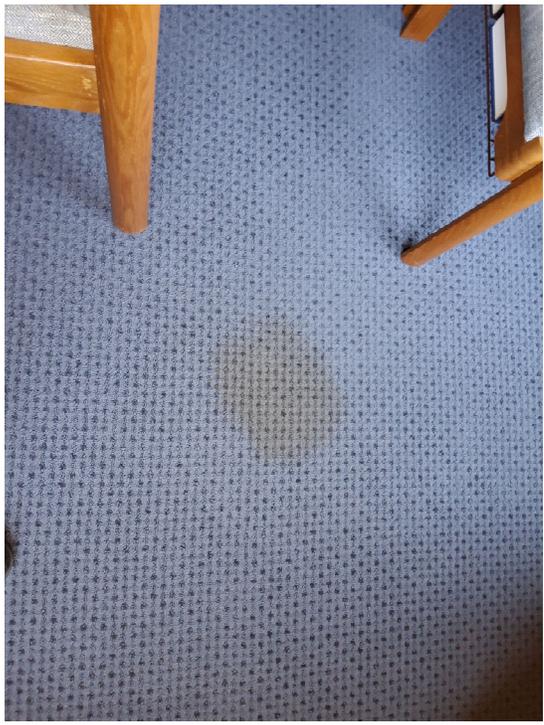
Photo 14:

1. With the exception of ceiling water stains, there were no concerns with main hallway items.
2. With the exception of the missing ceiling tile, there were no concerns with upper hallway items.
3. With the exception of a carpet stain and ceiling water stains, there were no concerns with sanctuary items.
4. There were no concerns with community room items.
5. With the exception of mosaic tile floors in vestibules, there were no concerns with lower level hallway, office, or classroom items.
6. With the exception of the activity room carpet seam, there were no concerns with other lower level room items.

Description:
Carpet stain

1. The water stains on the sitting area ceiling are addressed in the Roof and Façade sections and those recommendations should be followed.
2. The ceiling panel in the upper hallway should be replaced.
3. The mosaic floor tile in the lower level vestibules should have spot repairs where needed and the areas regrouted.
4. The water stains on the altar ceiling are addressed in the Roof and Façade sections and those recommendations should be followed.
5. The carpet stain in the sanctuary aisle should be deep cleaned as soon as possible to prevent deterioration of the carpet fibers and backing material.
6. The separated carpet seam in the activity room should be mended by a qualified carpet installer to prevent further damage or possible injury to occupants.

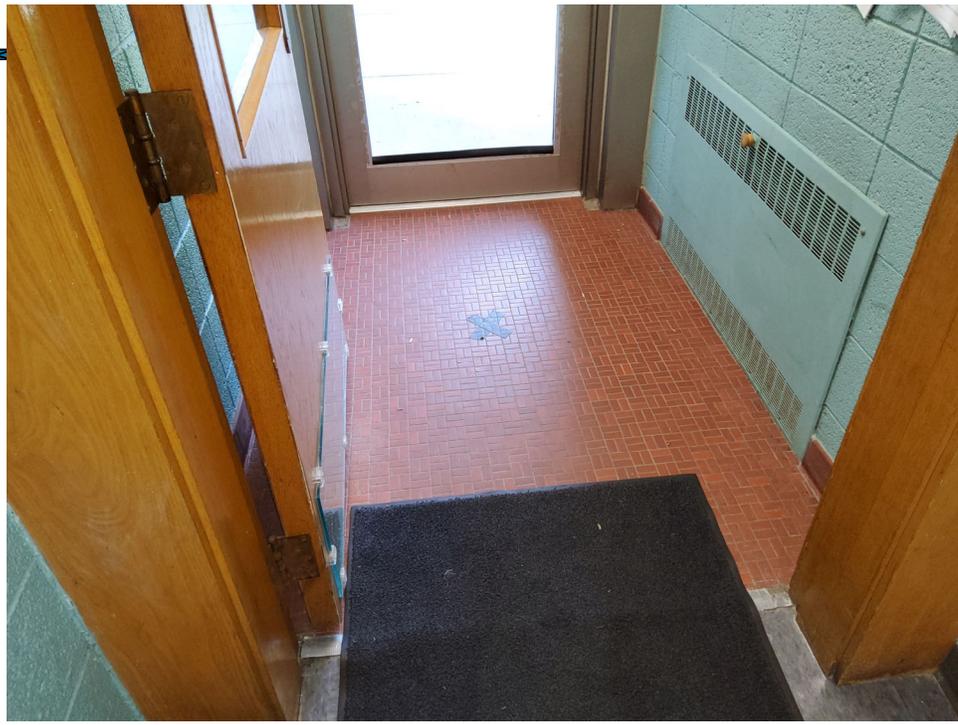
Photo 20:

West vestibule

Note: Defects in mosaic tile and grout.

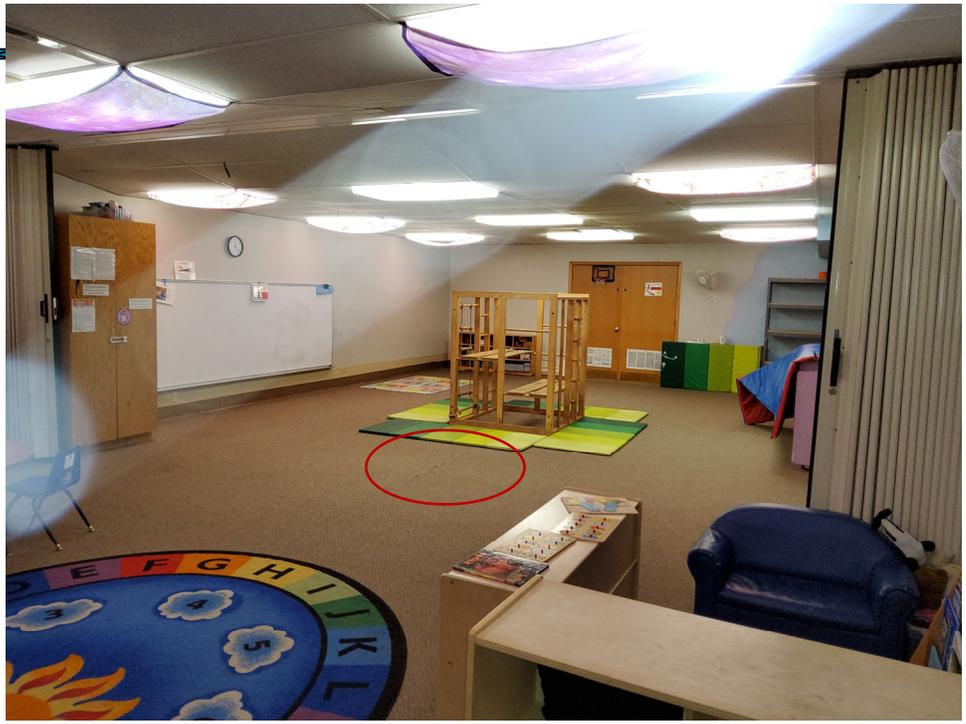
Photo 25:

Activity room, west view

Note: Separated carpet seam.
